**OAK HOLLOW/SHEFFIELD VILLAGE PUBLIC
IMPROVEMENT DISTRICT BOARD MEETING
CROSSPOINT CHURCH OF CHRIST, 3020 BARDIN ROAD
THURSDAY, MAY 16, 2024 AT 6:30 PM**

TITLE: Discuss the Engineering report from Lerch Bates on the condition of the wall that runs along Magna Carta Blvd and Claremont Drive.

R01000050391
Sheffield Village Screen Wall –
Grand Prairie, Texas

PROJECT NUMBER: R0100050391
PROJECT NAME: Sheffield Village Screen Wall
PROJECT LOCATION: Grand Prairie, Texas

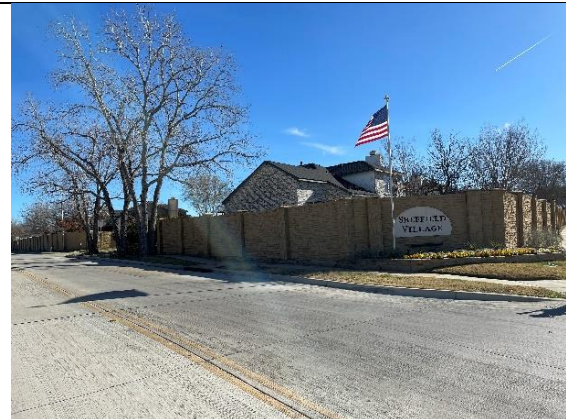
- Eight (8) panels and nine (9) columns spanning 84 feet of Section 1, inclusive of a monument sign on the corner of Magna Carta Boulevard and Claremont Drive (**Figures 1 - 2**). Panel 1 started to the north of the monument sign, continuing north on Magna Carta Boulevard to Chanute Drive.
- Separations between the monument sign panel, adjacent columns, and adjacent panels (**Figures 3 - 4**).
- Raised landscape bed adjacent to the southwest face (street side) of the monument sign panel (**Figure 5**).
- All columns visibly leaning.
- Cracks and separations at the mow strips and column foundations. Upward displacement of the mow strips and trees were observed at these locations (**Figures 6 - 7**).

Figure 1 - Wall Section 1 corner of Magna Carta Boulevard and Claremont Drive.

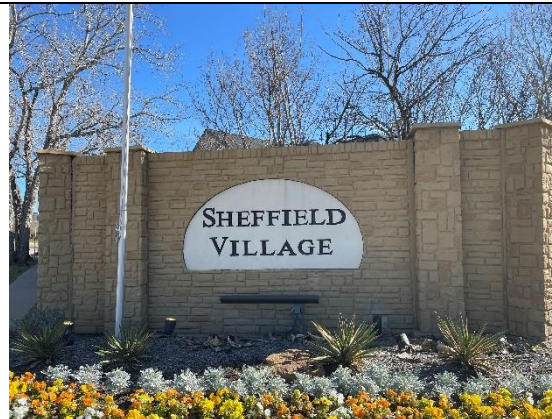
Figure 2 - Monument sign on corner of Magna Carta Boulevard and Claremont Drive.

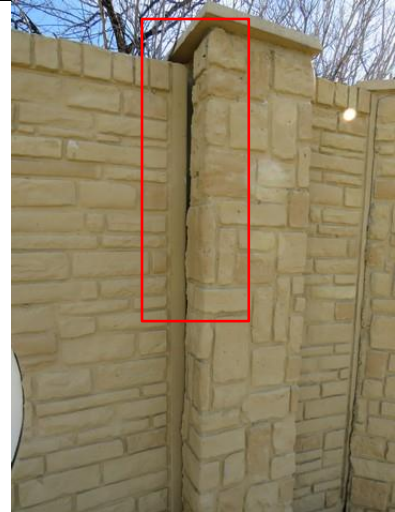
Figure 3 - Right side of monument sign panel (annotated by Lerch Bates).

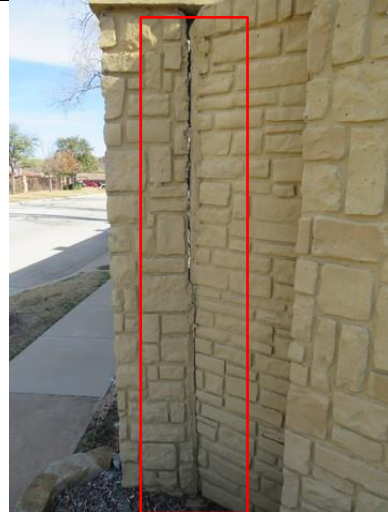
Figure 4 - 2-foot panel section at north end of monument sign, separation from column channel (annotated by Lerch Bates).

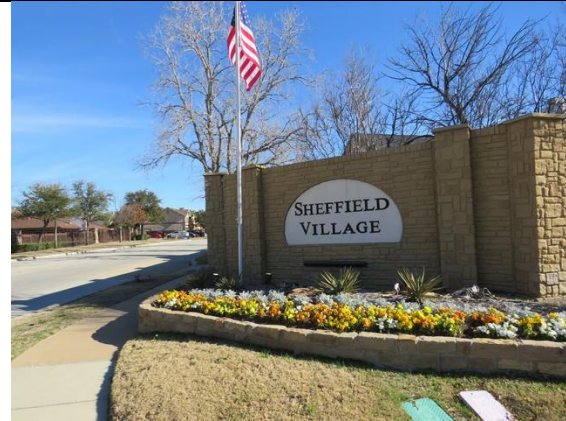
Figure 5 - Landscape bed adjacent to monument sign at south property line.

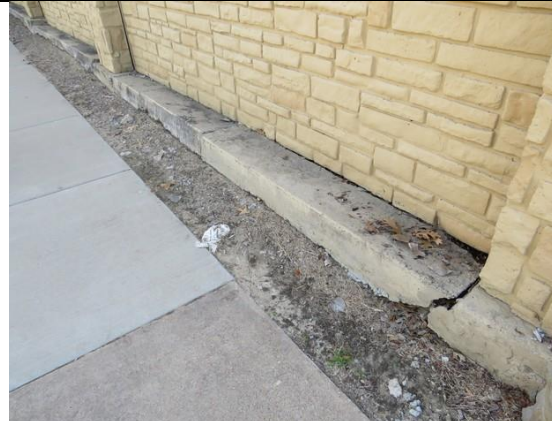
Figure 6 - Cracks and separation at mow strip and column foundation.

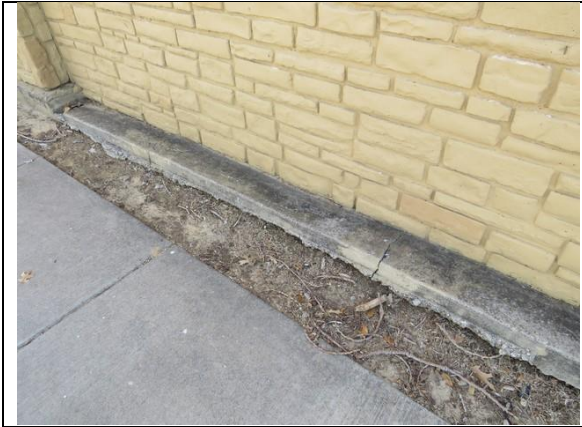
Figure 7 - Cracks and soil erosion at mow strip.

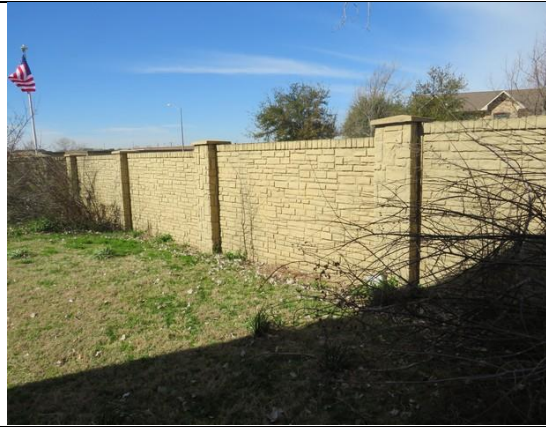
- All panels in Section 1 bordered the rear yard of this residence (**Figure 8**).
- Overgrown brush and tree growth at the base of the wall, behind the monument sign panel and adjacent columns (**Figures 9 - 10**).

Figure 8 - Interior view of screen wall at backyard of 2959 Chanute Drive.

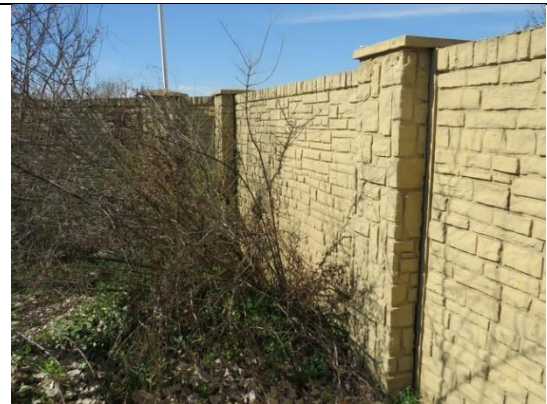
Figure 9 - Overgrown brush adjacent to wall panel 1

1. Remove and replace visibly leaning columns and their respective support foundations. The adjacent panels of the columns will have to be removed and reset after the columns and their foundation have been replaced. **(2)**
2. Remove and replace the mow strips along Magna Carta Boulevard and at the monument sign. The wall panels will have to be removed and reset to accommodate the replacement of the mow strips. **(2)**
3. Remove vegetation and debris adjacent to the base of the screen wall. **(3)**

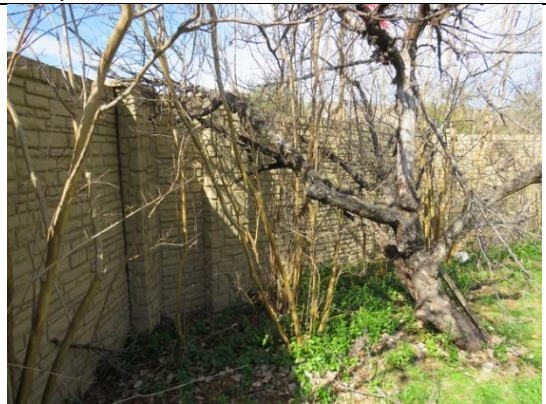
Figure 10 - Tree growth at base of wall adjacent to monument sign panel and at columns.

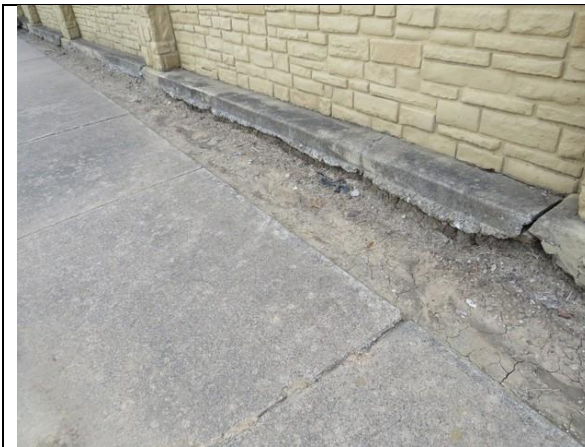
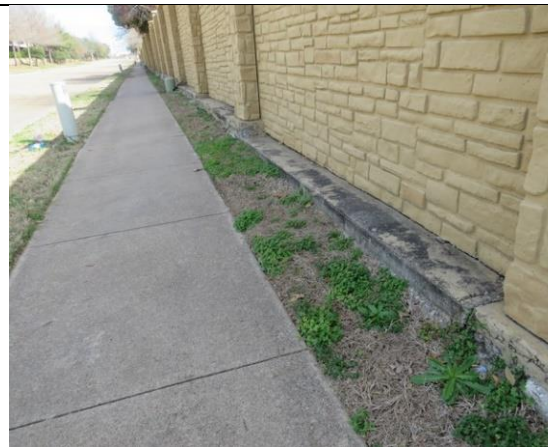
Figure 11 - Typical condition of mow strip along wall.

Figure 12 - Typical condition of mow strip along wall.

3. Remove and replace the mow strip for the full length of the section wall. The wall panels will have to be removed and reset to accommodate the replacement of the mow strips. **(2)**

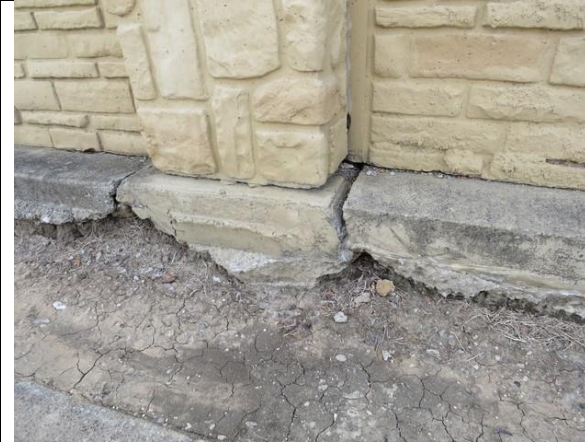
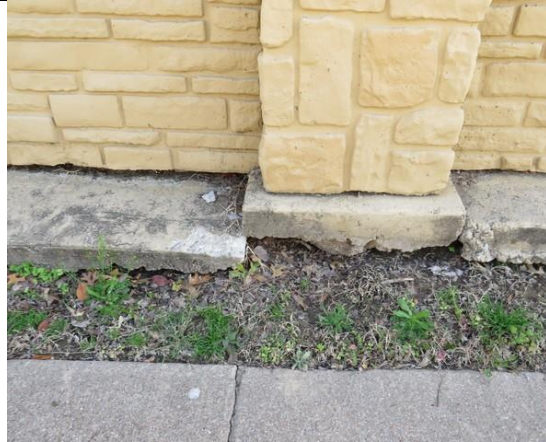
Figure 13 - Typical condition of column foundation and mow strip interface along wall.

Figure 14 - Typical condition of column foundation and mow strip interface along wall.

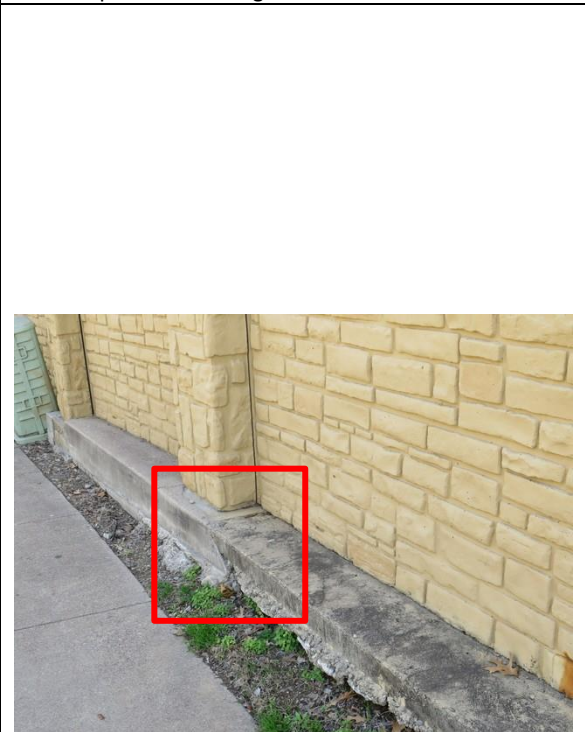
- Consisted of 62 panels and 63 columns spanning approximately 830 feet from Chanute Drive to the south alley entrance of Spinner Lane. Panels 1 through 6 spanned east-west along Chanute Drive, and panels 7 through 62 continued north along Magna Carta Boulevard.
- Out-of-plumb columns with separations between columns and adjacent panels.
- Cracks and upward movement at the mow strip along the entire length of the wall with separations between the columns and wall panels (**Figures 11 - 14**).
- Reported previous repairs at the mow strip of 4133 Stinwick Lane to 4117 Stinwick Lane. Cracking at the mow strip and separations between the mow strip and adjacent column foundations were observed (**Figures 15 - 16**).

Figure 15 - Previous repairs of mow strip starting at panel 3.

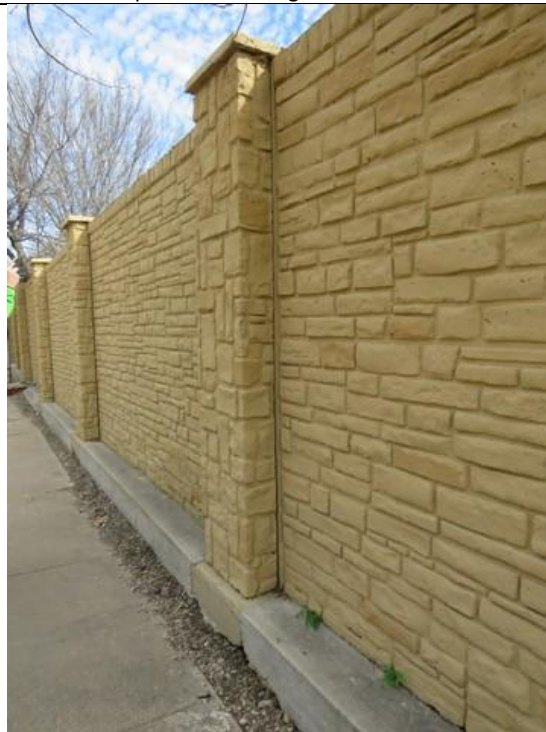
Figure 16 - Previous repair at mow strip along panels 35 through 62 .

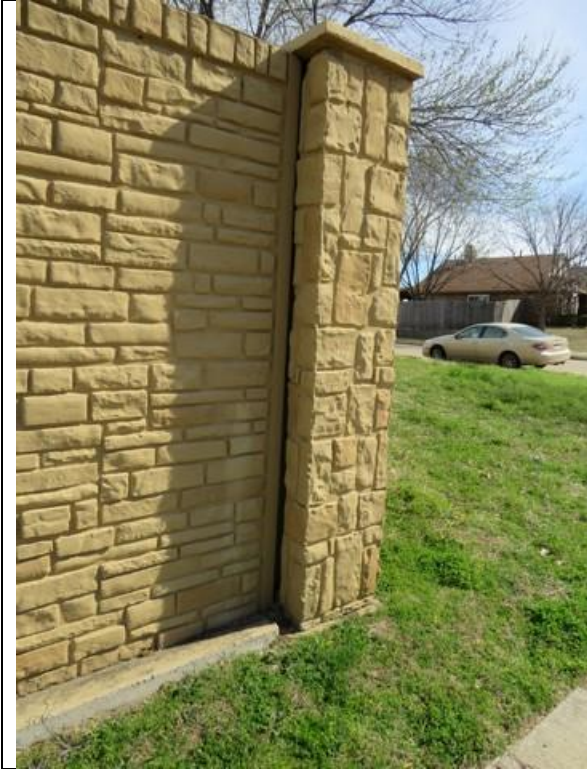
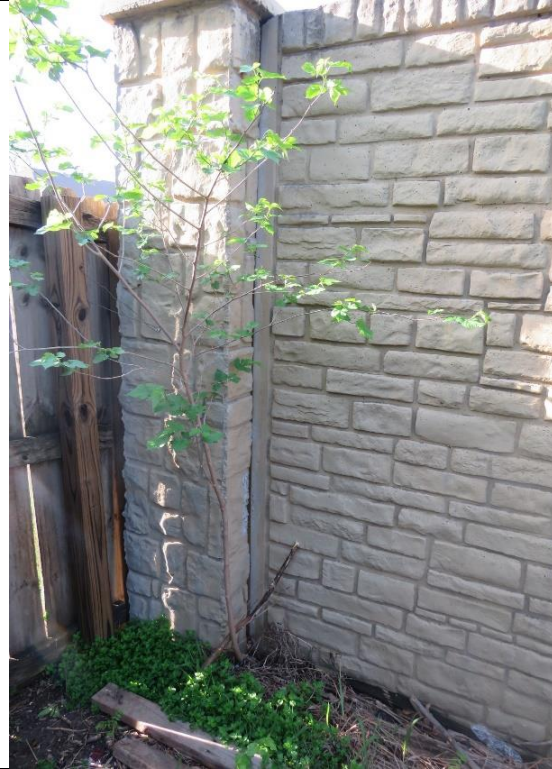
- Panels 1 through 10 spanned the rear yard of this residence. Panels 1, 6, and 7 were separated from the column channel (**Figures 17 - 20**).
- Cracking on both sides of wall panel 5. (**Figures 21 - 22**).

Figure 17 - Panel 1 at exterior of 4129 Stinwick Lane. Panel separated from column.

Figure 18 - Panel 1 at interior of 4129 Stinwick Lane. Panel separated from column.

WALL SECTION 2	OBSERVATION	RECOMMENDATION	PRIORITY
Panels 1, 6 and 7	Completely separated from the column channel	Immediate need of shoring	1
Panels 6, 26, and 62	Separated from the adjacent columns	Monitor for future movement	2
	Cracks and upward movement at the mow strip along the entire length of the wall with separations between the columns and wall panels	Remove and replace the mow strip for the full length of the wall. The wall panels will have to be removed and reset to accommodate the replacement of the mow strips.	2
Panels 5, 19, 21, 44, and 62.	Cracking at the interior and/or exterior of wall panels	Remove and replace	2
	Visual voids at the interior and exterior of the panels	Repair panels with isolated visual voids with areas greater than 3 square inches with non-shrink grout.	2
	Out-of-plumb columns with separations between columns and adjacent panels.	Remove and replace visibly leaning columns and their respective support foundations. The adjacent panels of the columns will have to be removed and reset after the columns and their foundation have been replaced.	2

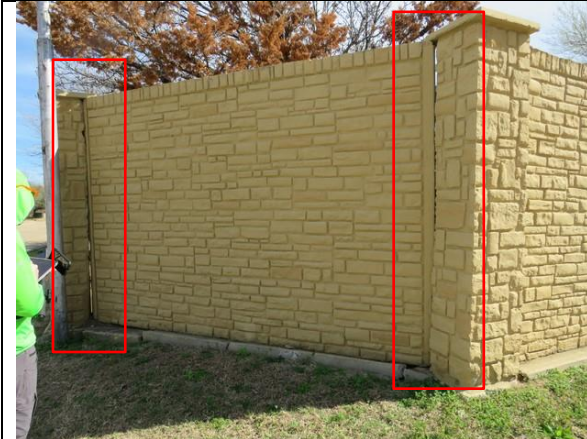
Figure 19 - Exterior view of panel 6 at wall section 2. Panel separated from columns (annotated by Lerch Bates).

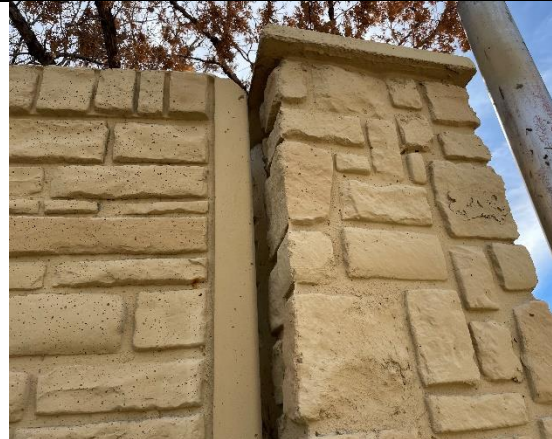
Figure 20 - Exterior view of panel 7 at wall section 2. Panel separated from column.

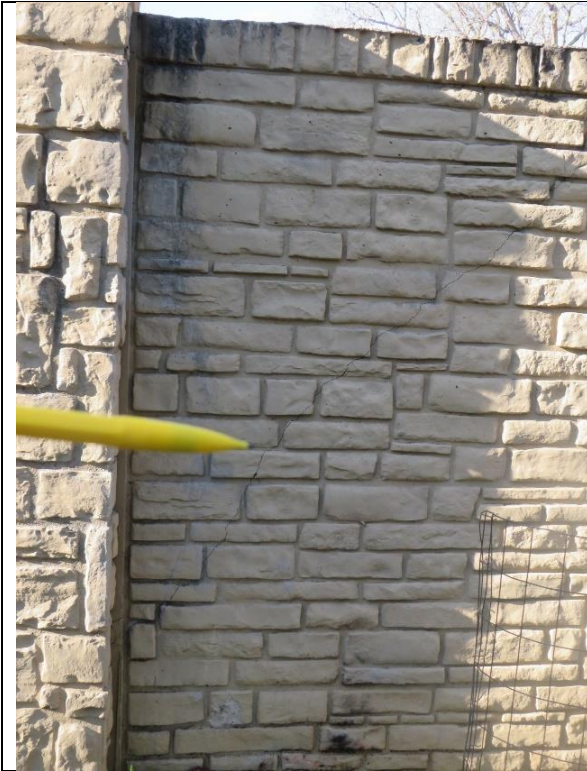
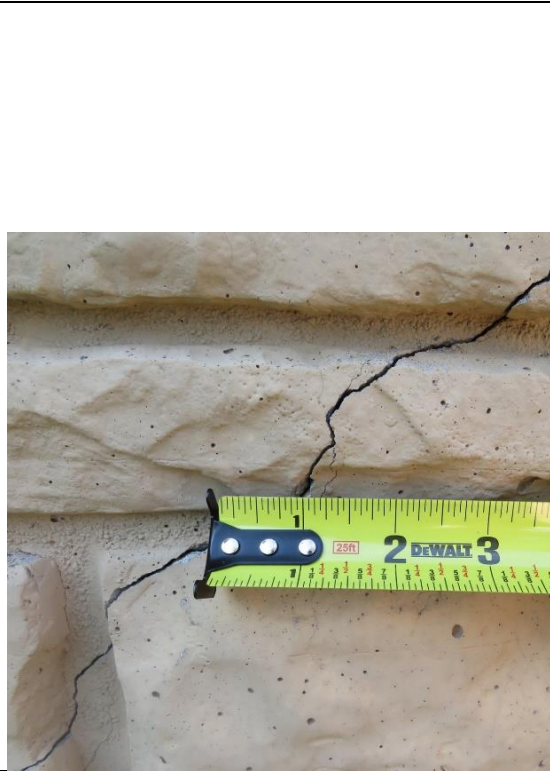
Figure 21 - Crack in Panel 5 and interior of 4165 Stinwick Lane.

Figure 22 - Enlarged view of crack in Figure 21.

4. Remove and replace wall panels 5, 19, 21, 44, and 62. **(2)**
5. Repair panels with isolated visual voids with areas greater than 3 square inches with non-shrink grout. **(2)**

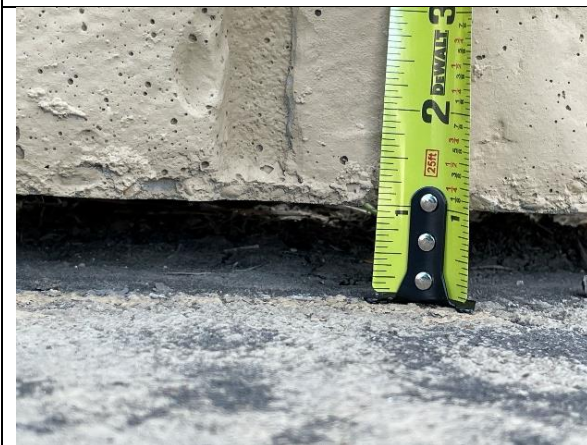
- Panels 34 through 37 bordered the rear yard of the residence.
- Visible 1-inch separation between the panel and mow strip (**Figure 23**).
- Crack at the top of columns 25 and 26 (**Figure 24**).

Figure 23 - 1-inch separation at base of panel and mow strip at panel 18.

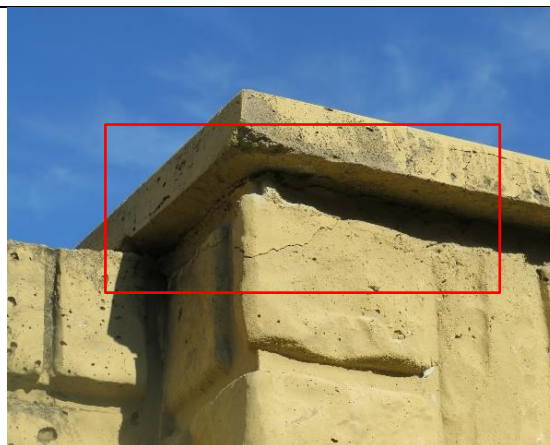
Figure 24 - Crack at top of column 5 (annotated by Lerch Bates).

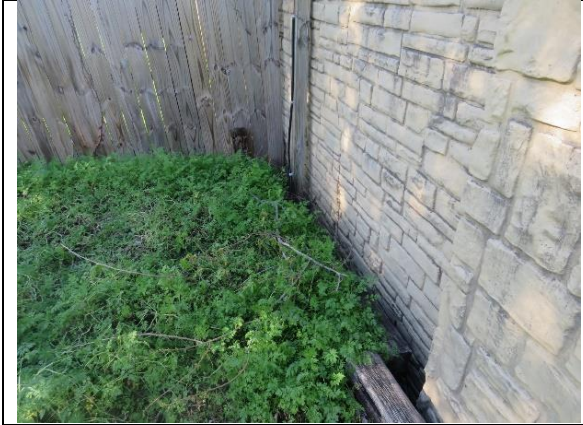
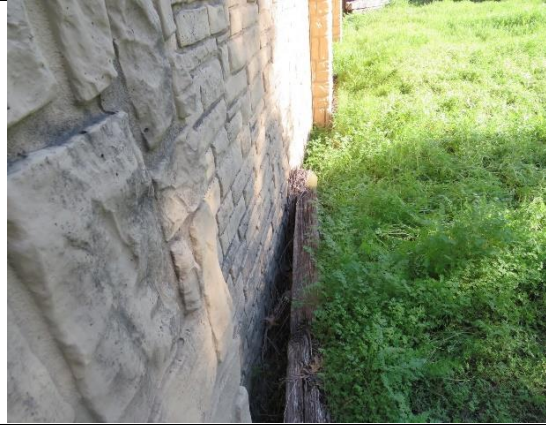
- Panels 38 through 41 bordered the rear yard of this residence.
- A partial 22-inch-tall wood wall adjacent to the subject screen wall. (**Figures 25 - 26**).
- Tree growth adjacent to the interior of wall panel 41. Wall panel 41 was visibly leaning (**Figure 27**).

Figure 25 - 22-inch tall wood wall adjacent to panel 38, from the yard of 4133 Stinwick Lane.

Figure 26 - Wood wall adjacent to panel 39 from yard of 4133 Stinwick Lane.

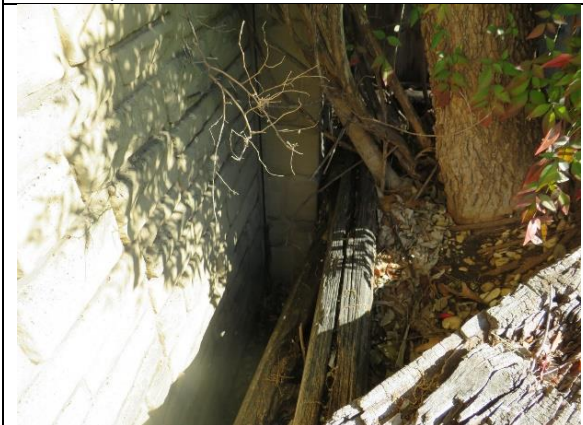
Figure 27 - Tree at corner of panel 41 adjacent to deteriorated wood wall.

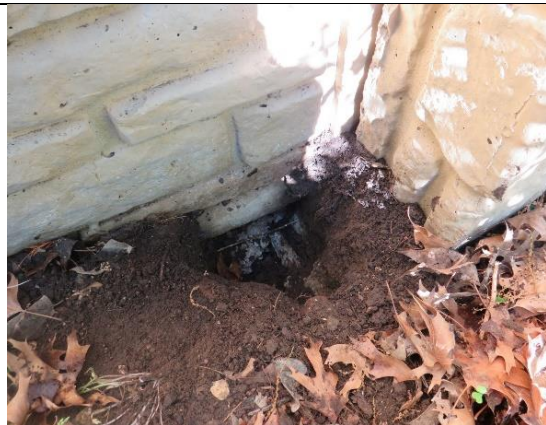
- Panels 42 through 45 bordered the rear yard of this residence. The wall was visibly leaning.
- Column foundation visible at the base of the column, near panel 42 (**Figure 28**).
- Visual voids on both sides of the panels (**Figure 29**).
- Cracking at the west elevation of panel 44. No cracks were observed to the east elevation of the panel (**Figure 30**).

Figure 28 - Column foundation visible at base of column near panel 42.

6. Remove and replace visibly leaning columns and their respective support foundations. The adjacent panels of the columns will have to be removed and reset after the columns and their foundation have been replaced. **(2)**

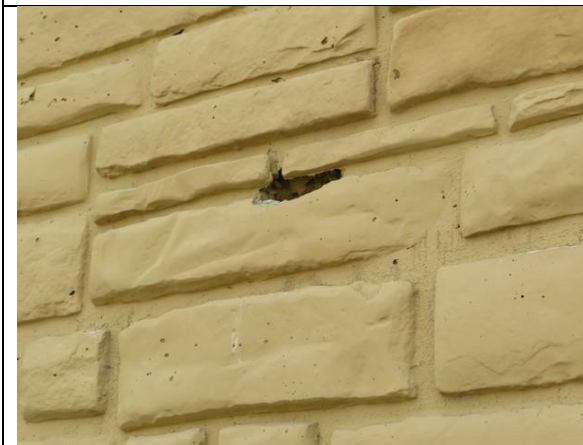
Figure 29 - Void in wall at panel 10.

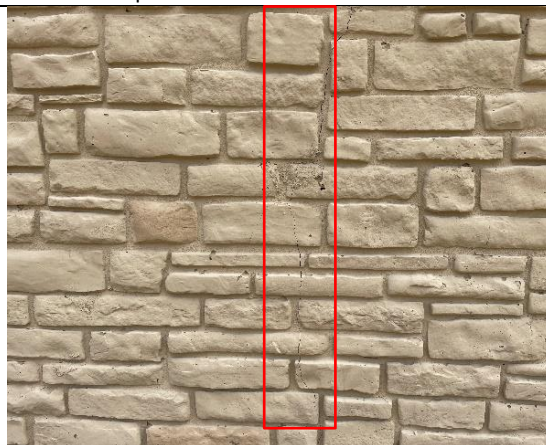
Figure 30 - Full-height vertical crack at center of panel 44 (annotated by Lerch Bates).

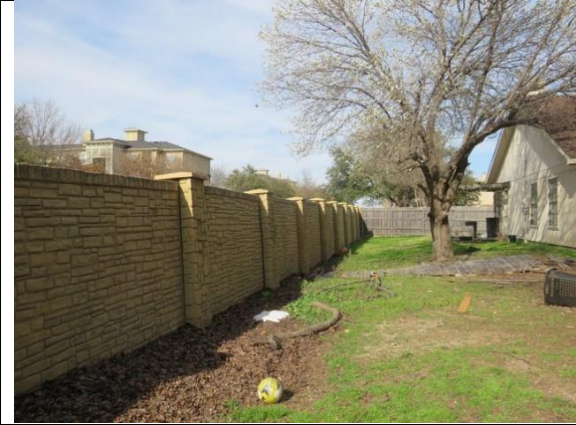
- Panels 50 through 53 bordered the rear yard of the residence.
- Debris adjacent to the base of the screen wall (**Figure 31**).

Figure 31 - Debris adjacent to base of wall at the yards of residences 4121 through 4117 Stinwick Lane.

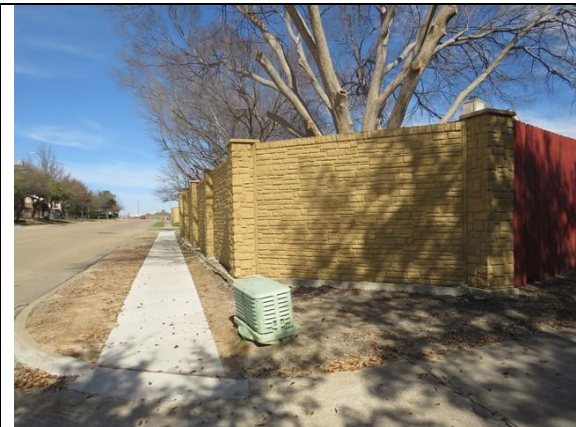
- Five (5) panels and six (6) columns spanned north approximately 74 feet from the alley at the rear of 2925 Spinner Lane along Magna Carta Boulevard (**Figure 32**).
- Visibly leaning and out-of-plumb panel 1. Tree roots were observed protruding from the soil adjacent to the wall panel (**Figure 33-34**).
- Previous concrete repairs made at multiple locations along the mow strip.
- Cracks in the mow strip adjacent to the wall. Upward displacement of the mow strip and separations between the columns, wall panels, and concrete foundation were observed.
- Exposed rebar at the mow strip of panel 3 (**Figure 35**).

Figure 32 - Wall Section 3 at corner of Magna Carta Boulevard and Claremont Drive.

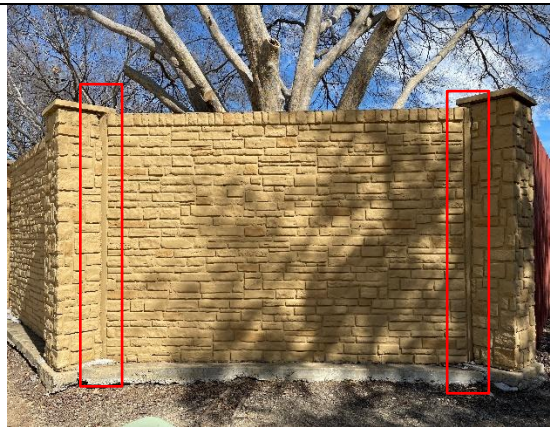
Figure 33 - Panel 1 out-of-plumb and separated from column channel at both sides (annotated by Lerch Bates).

1. Panel 1 was separated from the adjacent columns and should be monitored for future movement. **(2)**
2. Remove and replace the mow strip for the full length of the wall. The wall panels will have to be removed and reset to accommodate the replacement of the mow strips. **(2)**
3. Remove vegetation and debris adjacent to the base of panel 1. **(3)**

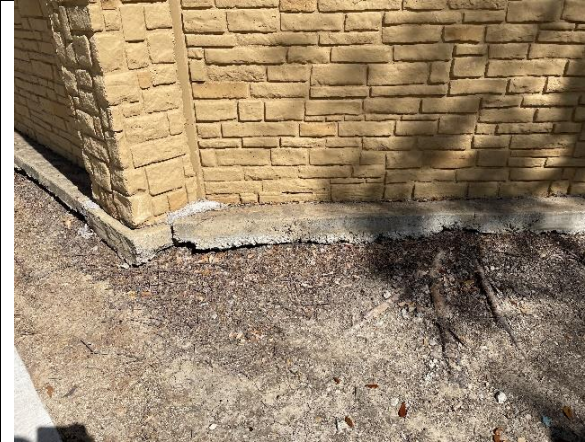
Figure 34 - Protruding tree roots visible at panel 1.

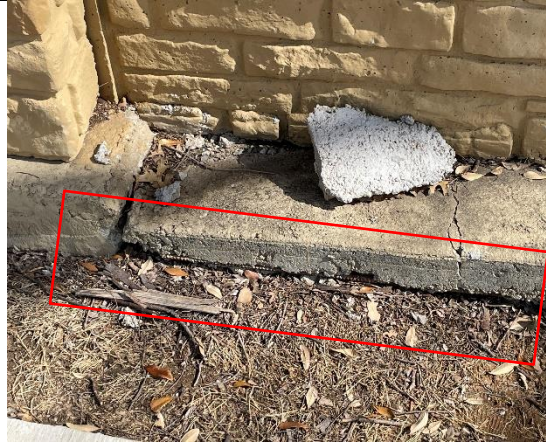
Figure 35 - Exposed rebar at mow strip of panel 3 (annotated by Lerch Bates).

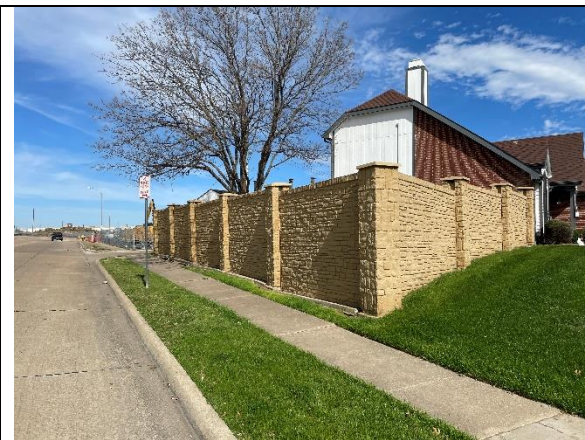
Figure 36 - Wall section 4 at corner of Spinner Lane and Magna Carta Boulevard.

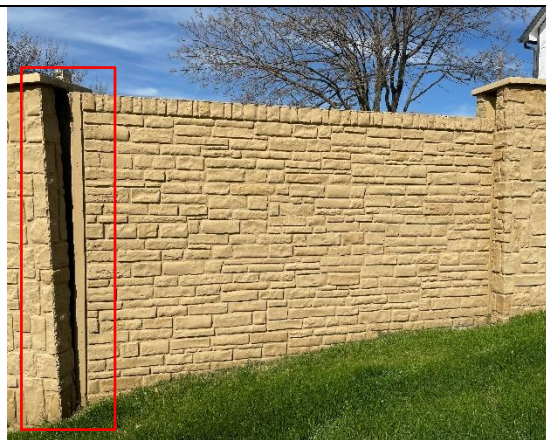
- Vertical cracks at the center of panels 2, 4, 6, and 10.
- Panel 3 out-of-plumb and separated from the north column channel (**Figure 37**).
- Panel 9 out-of-plumb and separated from the north column channel.

Figure 37 - Panel 3 out-of-plumb and separated from left column channel (annotated by Lerch Bates).

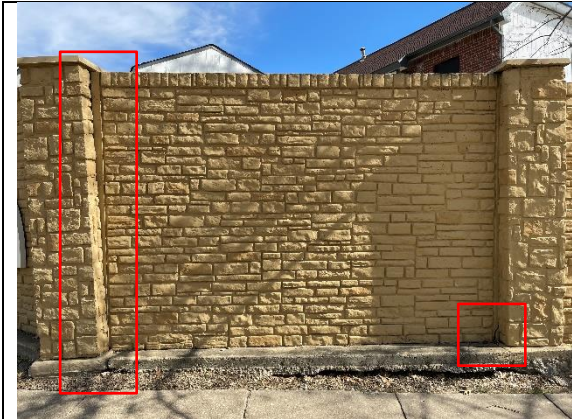
- Panel 8 out-of-plumb and separated from the south column channel. A crack was located on the west elevation at the bottom south corner of the panel (**Figure 38**).

Figure 38 - Panel 8 out-of-plumb and separated from right column channel. Crack is located at bottom right of panel (annotated by Lerch Bates).

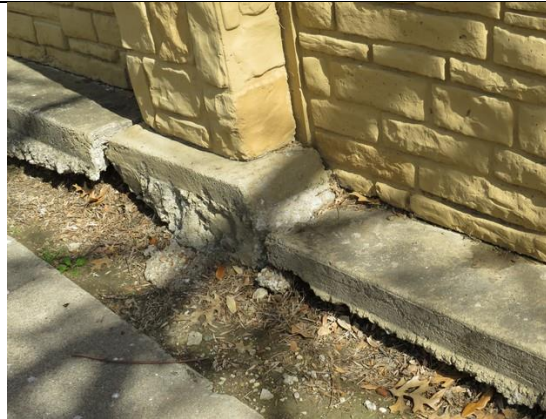
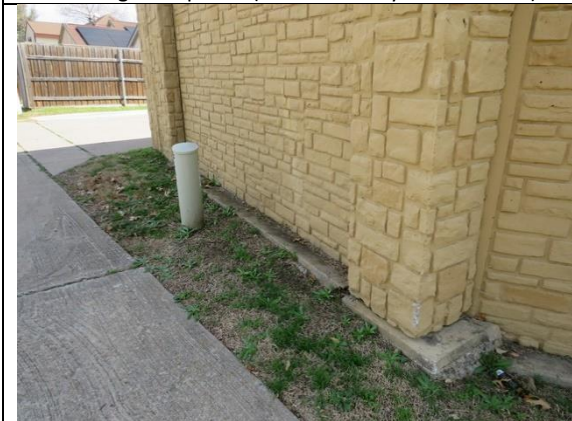
- Cracks at mow strips of panels 4 to 10. Upward displacement of the mow strips and separations between the columns, foundations, and wall panels were observed (**Figure 39-40**).

Figure 39 - Typical condition of mow strip along wall and column foundation at wall section 4.

Figure 40 - Typical condition of mow strip along wall and column foundation at wall section 4.

1. Remove and replace panels 2, 4, 6 and 10. **(2)**
2. Remove and replace visibly leaning and cracked columns and their respective support foundations. The adjacent panels of the columns will have to be removed and reset to accommodate the replacement of the columns and their foundations. **(2)**
3. Remove and replace mow strips panels 8 through 10. **(2)**

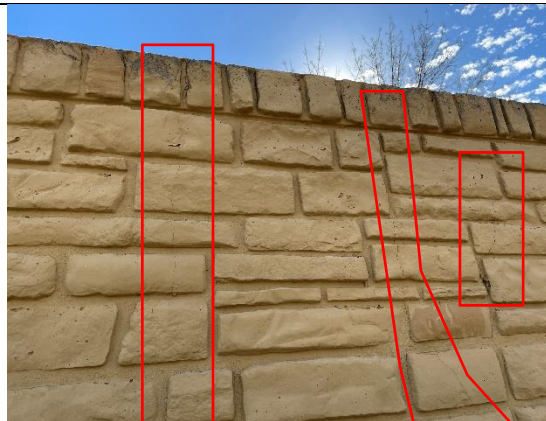
- Cracking at both elevations of Panel 10 (**Figure 41**).

Figure 41 - Vertical cracks in exterior of panel 10. (annotated by Lerch Bates).
