# SPECIAL CITY COUNCIL MEETING

April 06, 2021 at 5:00 PM AA Comeaux Recreation Center, 300 AA Comeaux Drive, Suite 200, Abbeville, Louisiana 70510

RE: 1003 Prairie Avenue

RE: 824 South Kibbe Street

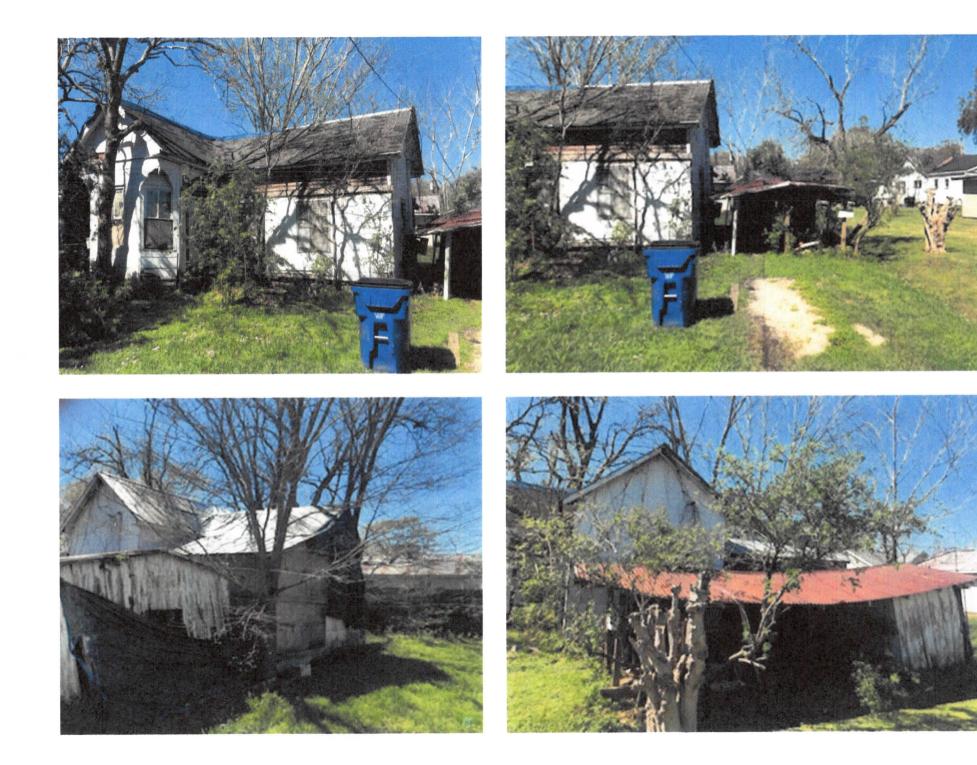
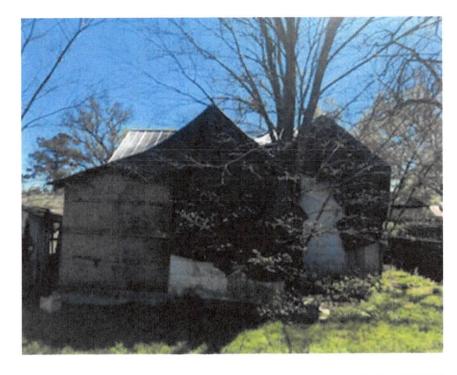
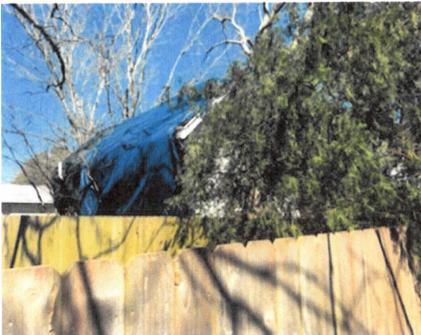
The residence at 1003 Prairie was inspected on March 22, 2021. Based on the inspection done, the structure is covered with a tarp and determining the structure's integrity cannot be made at this time. Enclosed are the photographs taken of the residence.

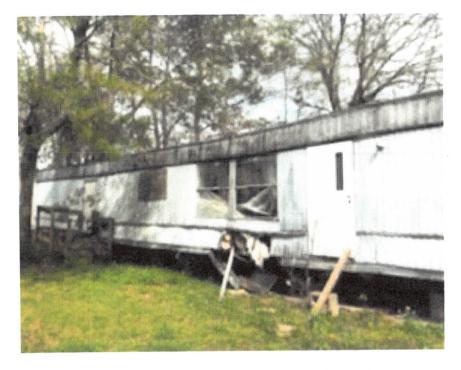
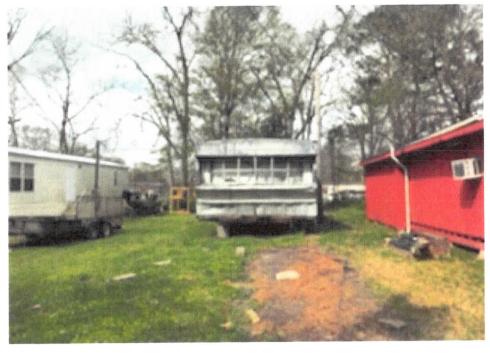
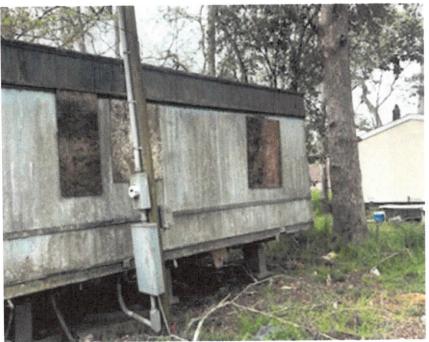
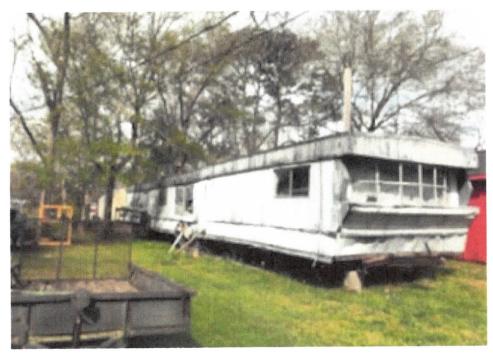
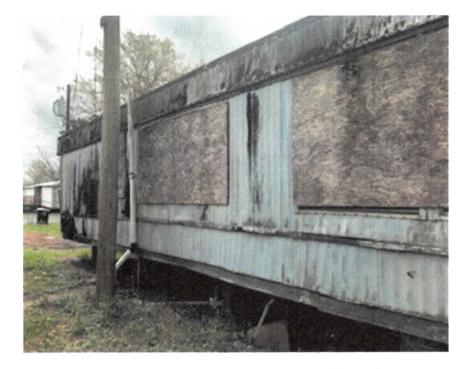
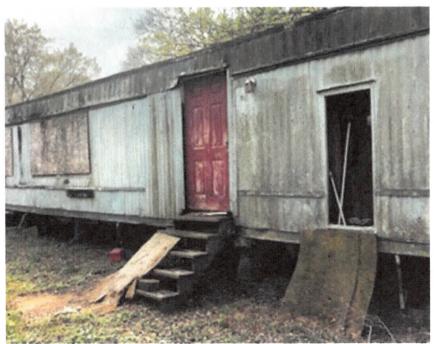
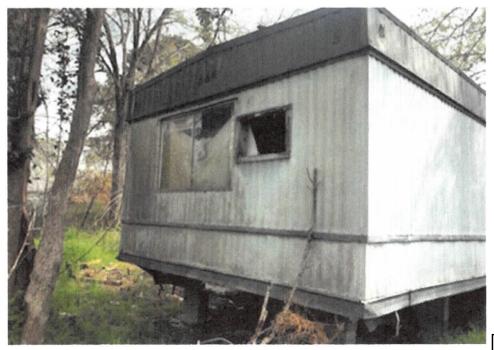
The residence at 824 South Kibbe Street was inspected on March 22, 2021. Based on the inspection done, the residence does have some damage which can be repaired. The residence can be secured and repaired. Enclosed are the photographs taken of the residence.

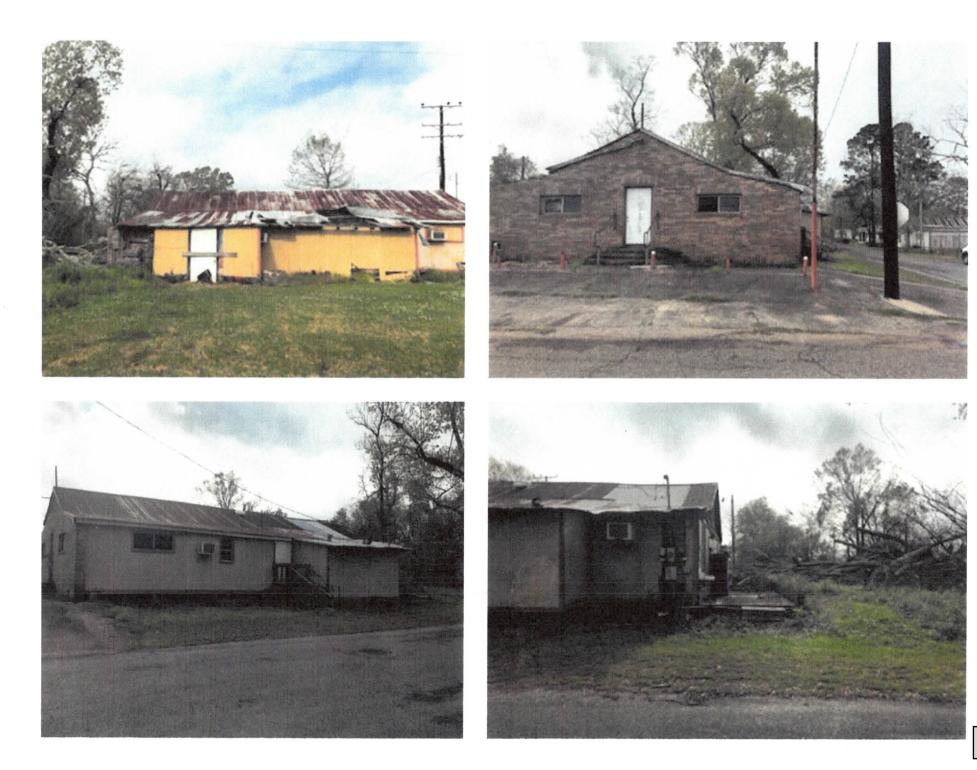
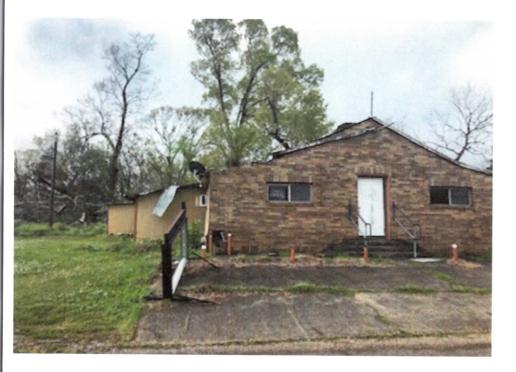
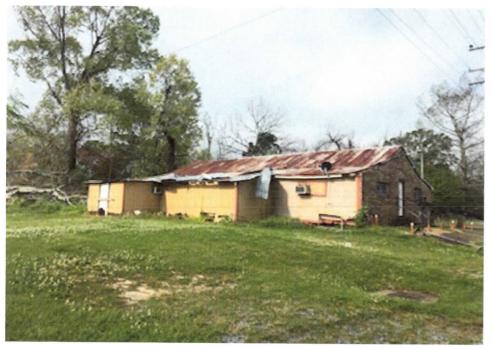
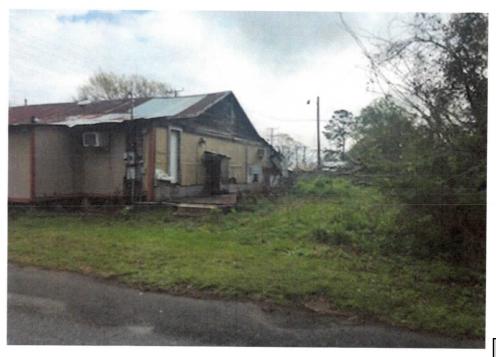
The structure at 900 Graceland was inspected on March 24, 2021. Based on the inspection done, the structure needs to be secured and repaired. Enclosed are the photographs taken of the structure.
