## Historic Preservation Commission Regular Meeting

- 2. Public hearing and consideration of approval of COA2024-011: Application for a Certificate of Appropriateness for Phase 1 Stabilization of the home located at 100 Old Fitzhugh Rd in the Old Fitzhugh Rd Historic District. Applicant: Pamela Bosco.**
  1. Presentation
  2. Staff Report
  3. Public Hearing
  4. COA2024-0011
- 3. Presentation on Stars of Dripping Springs Public Art Project. Lisa Sullivan, People & Communications Director**
- 4. Update on Downtown Restrooms Project. Michelle Fischer, City Administrator**

100 Old Fitzhugh Road structure is a house constructed in the mid to late 1920s with later mid-century additions and minor alterations. The current condition of the home is poor after years of water and pest damage and needs to be stabilized before Phase 2, finishes.

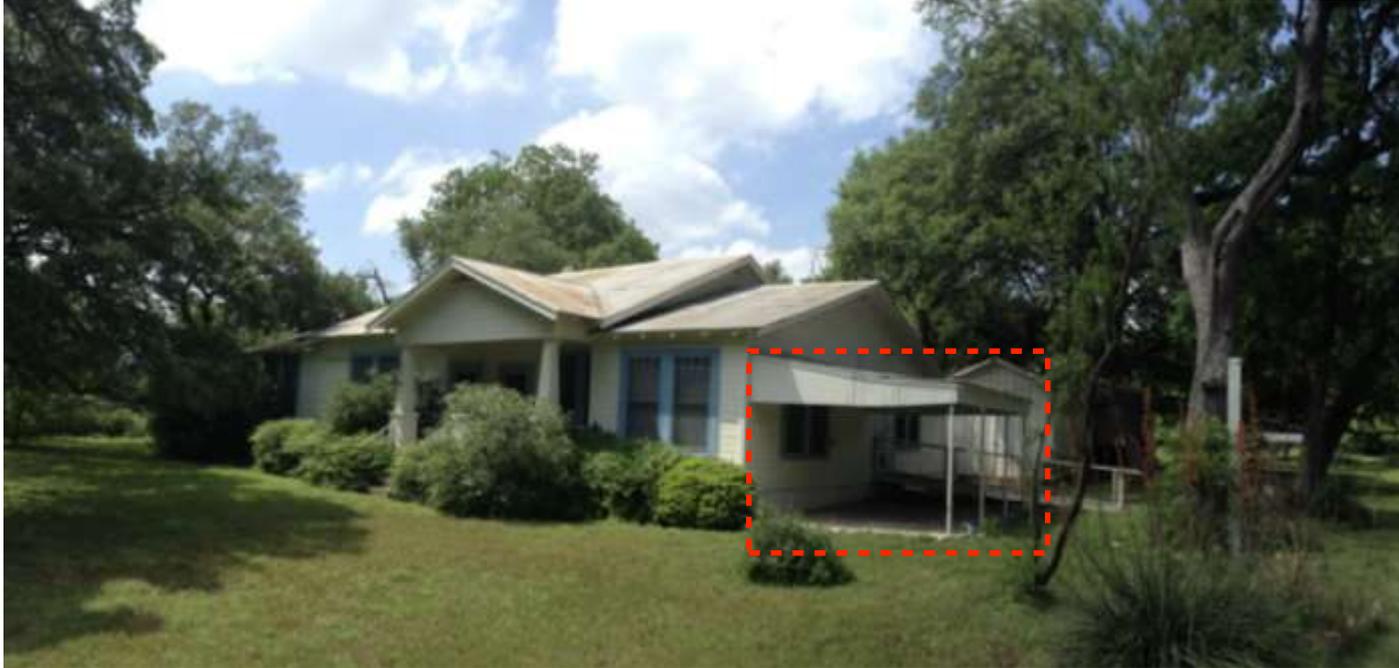
Red box indicates proposed removal of later (midcentury) addition to be removed.

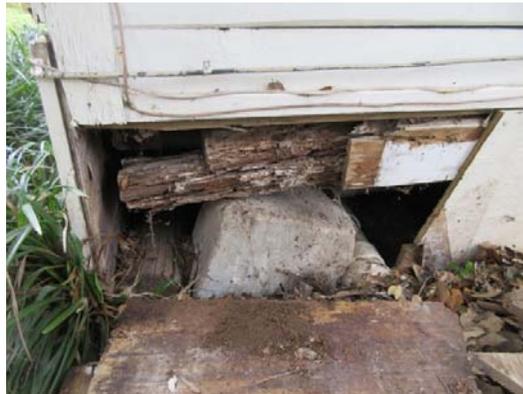
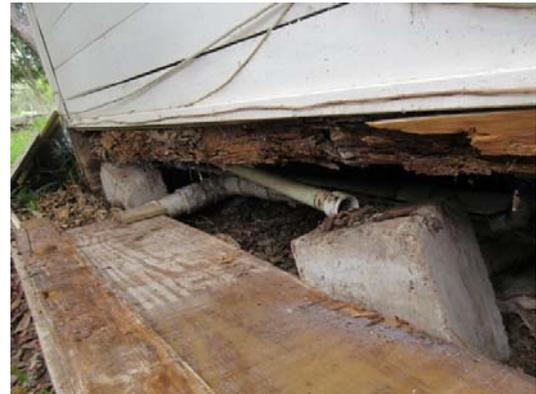
**Support inadequate at back left corner:** The beam at the back left corner of the structure has sustained significant damage from water and termites. In addition, the pier at this location is failing. Support for this corner is insufficient and structural damage is anticipated.

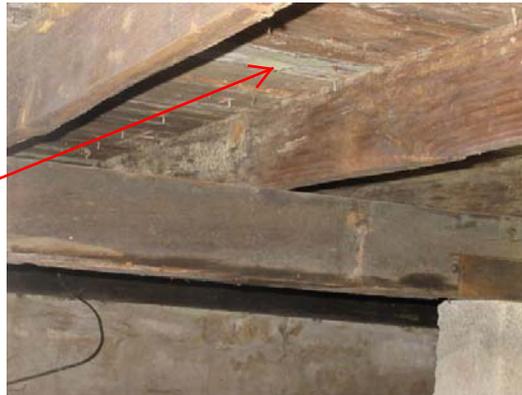
**Under ventilated:** The ventilation under the house does not appear to meet modern ventilation requirements. Lack of proper ventilation can contribute to excessive moisture in the crawl space which can be conducive for mold, termites and other problems. There should be a minimum of 1 square foot of ventilation per 150 square feet of crawl space.

possible mold from  
underventilation

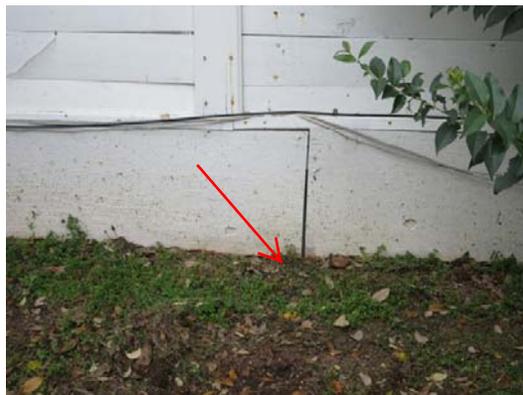
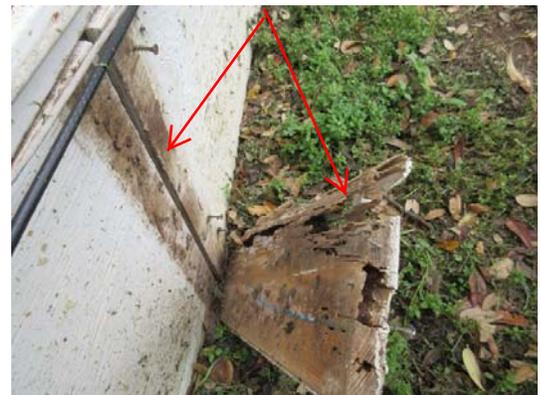
**Wood touching ground at perimeter:** The skirting is wood that is touching the ground at various locations around the perimeter. Water damage and termite infestations are possible when wood is in contact with the ground. Excessive wood rot and termite damage were observed at some areas. I recommend having this evaluated by a pest control company and have all wood-to-ground areas treated.

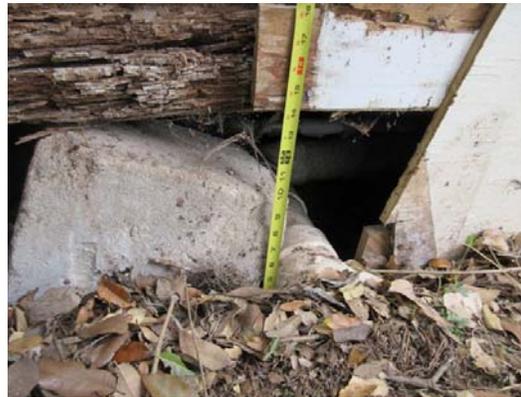
**Crawlspace not accessible:** The foundation crawlspace was not accessible as there is no door or access. Most of the crawlspace could not be inspected. The minimum clearance under the house should be 18 inches. The crawlspace was observed from back left corner where skirting was removed. Since most of the crawlspace was not accessible, there will be some items not discovered in the process of this inspection. It should be noted that limited access under the house may prevent or limit access for foundation repairs, termite treatment, and plumbing and electrical repairs, if such repairs are needed.

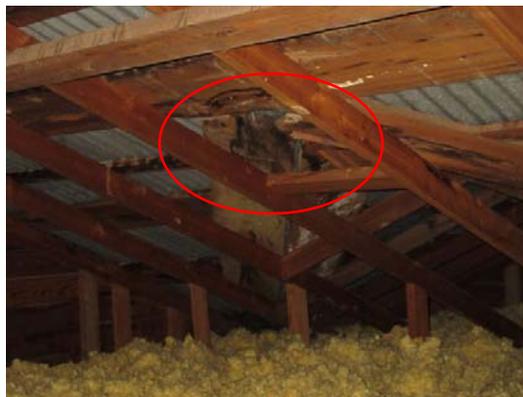
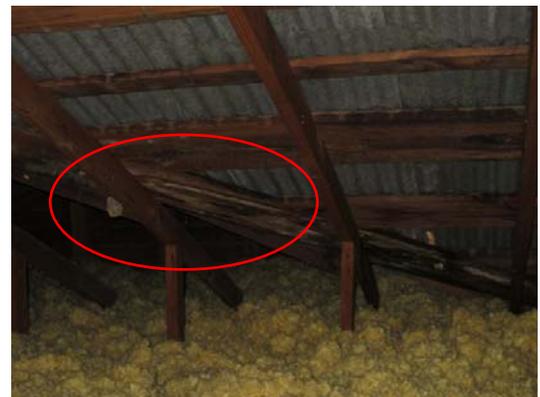
**Possible roof leak at valleys:** There appears to be evidence of roof leaks at the roof valleys. Water evidence was observed in the attic at framing. Recommend confirmation by a roofing contractor and repair as necessary.

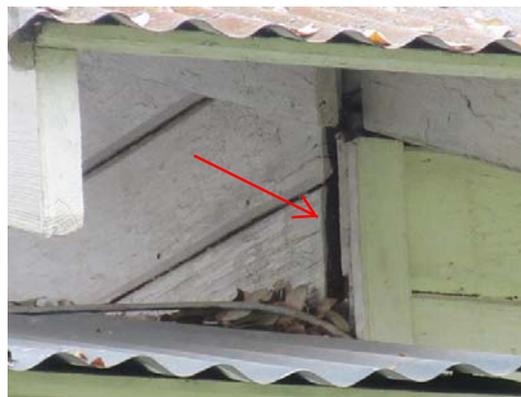
**Flashing missing:** There doesn't appear to be any counter flashing at the roof wall connections at various locations. There is a possibility of water damage to the siding and framing where ever flashing is missing.

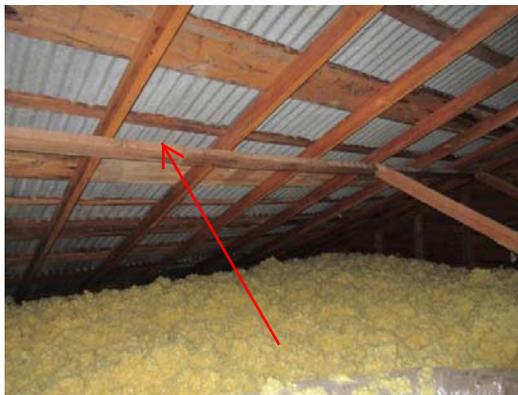
**Rafter supports missing:** Mid-span roof rafter supports or purlin bracing appears to be missing is some areas. According to modern construction standards mid-span roof rafter supports should be located every 48 inches. Proper support would include pulrins and purlin braces. Purlins, which are horizontal framing members should be placed on edge and not flat, under the rafters, and purlins should be braced with struts or kickers. Lack of adequate rafter support can contribute to depressions or deflections in the roof.

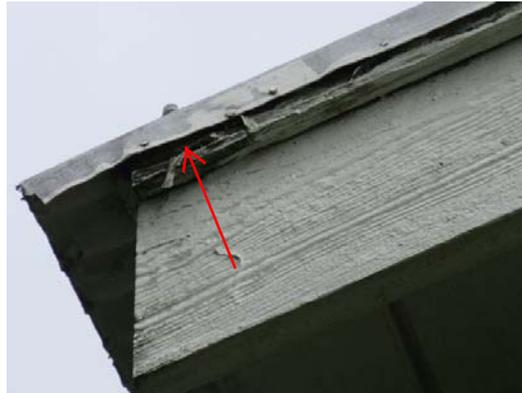
**Fascias need maintenance:** Some of the roof fascia boards need caulking and painting. Recommend caulking and painting as needed.

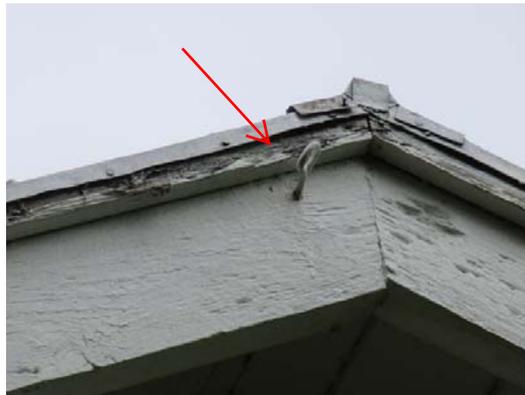
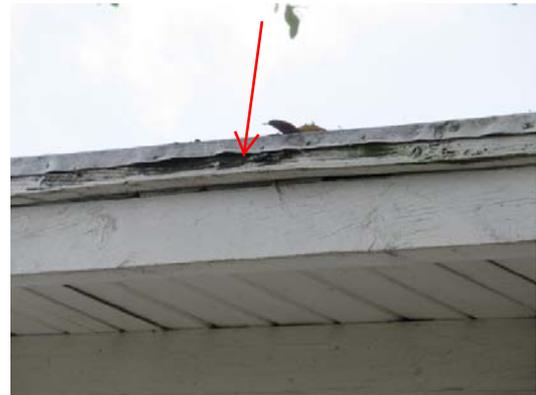
**Fascias water damaged:** The roof fascia boards are water damaged at some locations. Recommend replacement of water damaged wood, and recommend caulking and painting fascias as necessary.

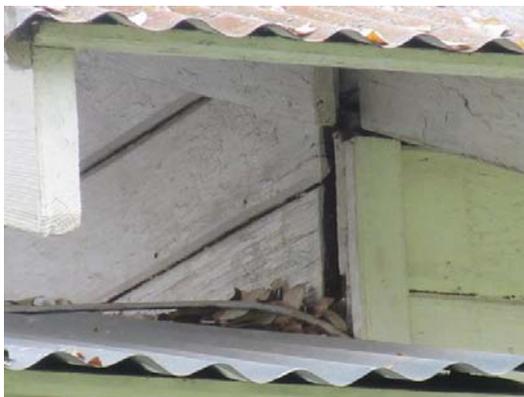
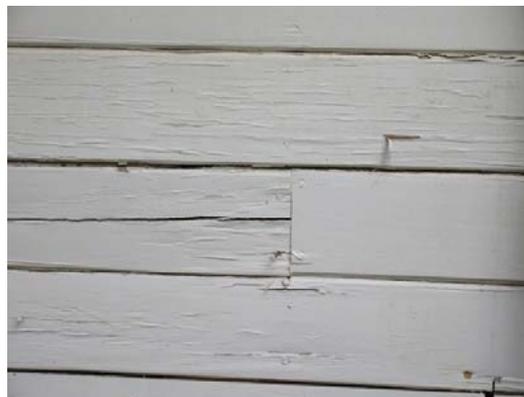
**Exterior needs maintenance:** The exterior trim and siding is in need of maintenance. The exterior siding and trim has open seams and gaps that are not sealed. In addition, the exterior paint is in poor condition at some areas. General maintenance is needed at various locations around the exterior to prevent moisture intrusion and water damage. Recommend caulking and painting as needed to prevent water damage. See additional comments below:

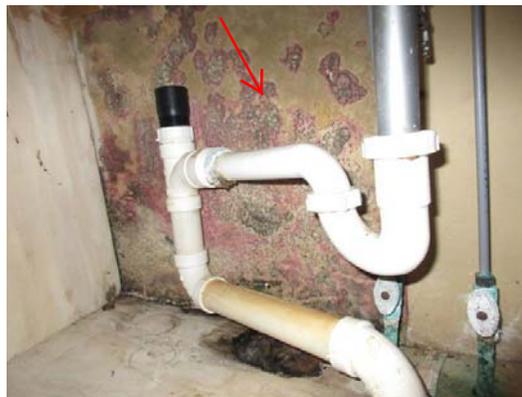
**Possible mold like substance:** There appears to be a mold like substance on the interior walls at master bathroom (sink cabinet). This appears to have been caused by a current moisture or water issue possible due to leaks at this area. All water damaged or mold damaged drywall should be removed.

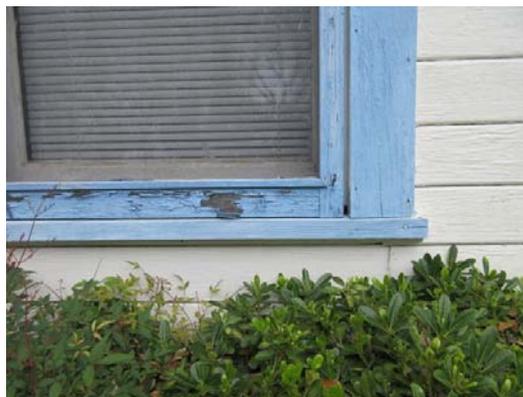
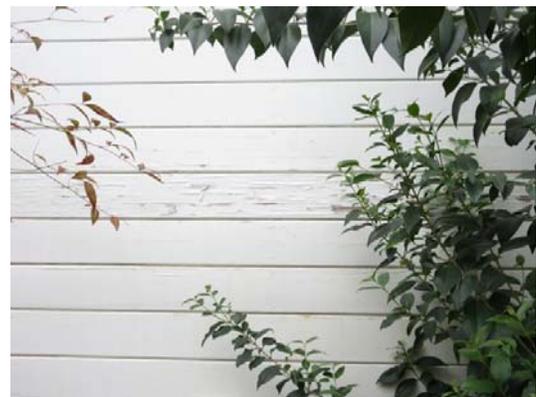
**Paint chipping:** Chipping of exterior paint was observed at some locations around the exterior. Recommend caulking and painting as needed.

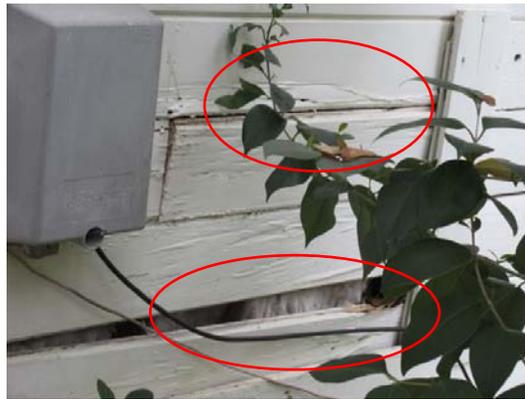
**Siding damage:** Siding shows signs of damage and is loose in one area at the left side of the house.

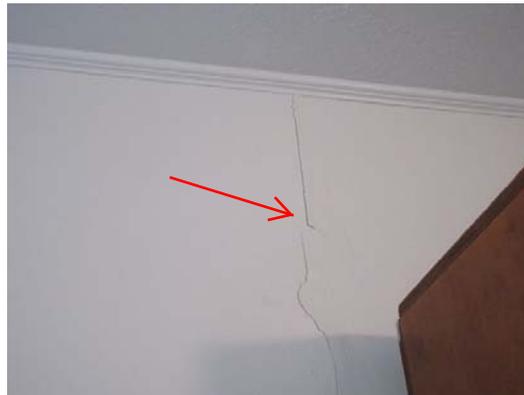
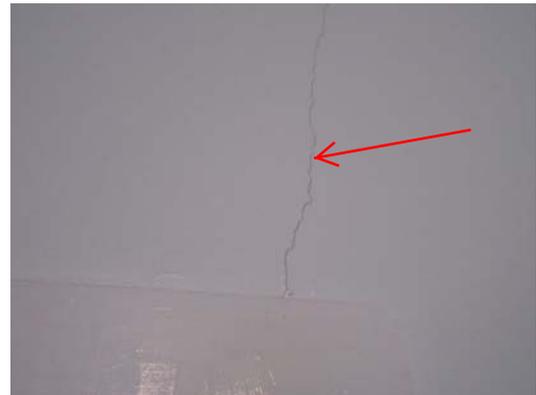
**Settlement cracks in walls:** There are cracks (and possible crack repairs) in the interior walls at a various locations. These cracks appear to be an indication of structural settlement or foundation movement.

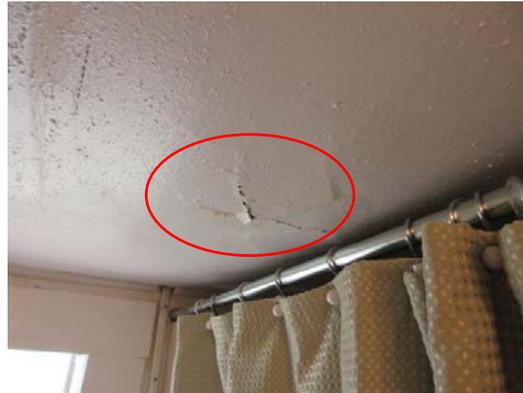
**Water damage from roof leak:** The ceiling appears to have water damage at the master bathroom. The cause of this damage appears to be related to a roof leak at this area. See roofing section of this report.

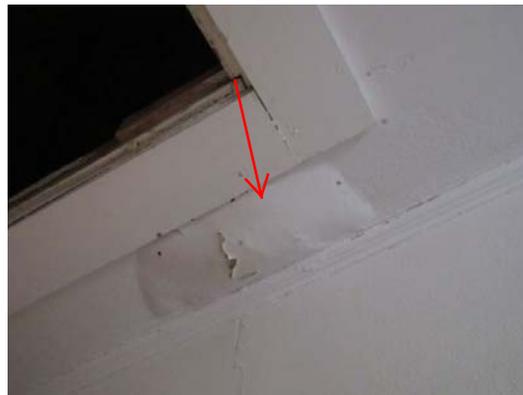
**Ceiling water damage:** There appears to be water damage on the ceiling at the hallway near attic access. Since the HVAC system may be over this area, this may be related to a past AC/drain backup or other water related HVAC problem.

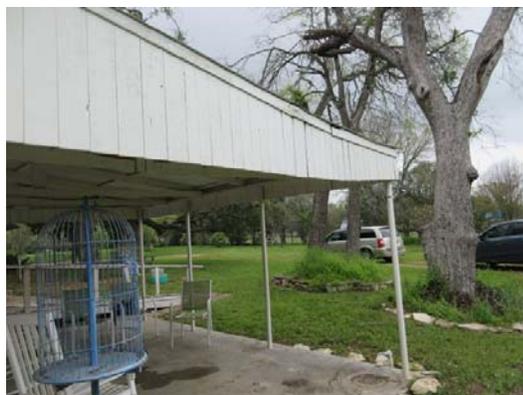
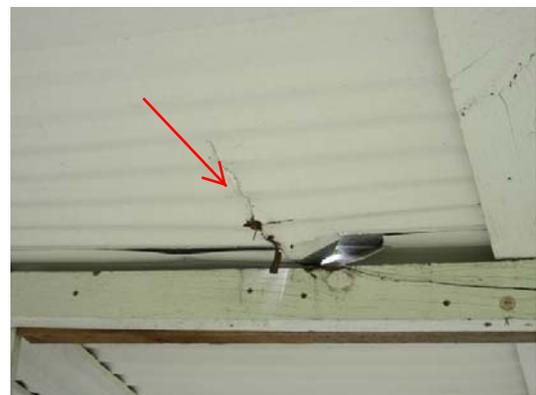
**Patio roof structure poor condition:** The right patio roof structure is in poor condition. Rafters are damaged, broken and not providing sufficient support and the roof is damaged and leaking. Roof structure is not safe in present condition.

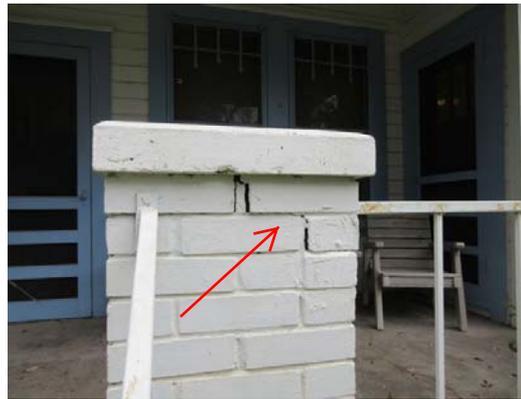
**Masonry cracking:** The masonry at the front porch is cracking and shows signs of general settlement.

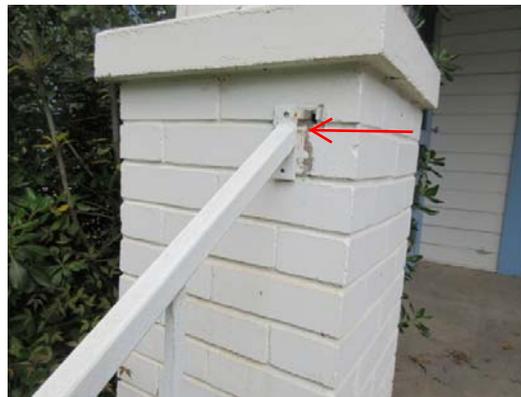
**Railing loose:** The railing at the front porch is loose.

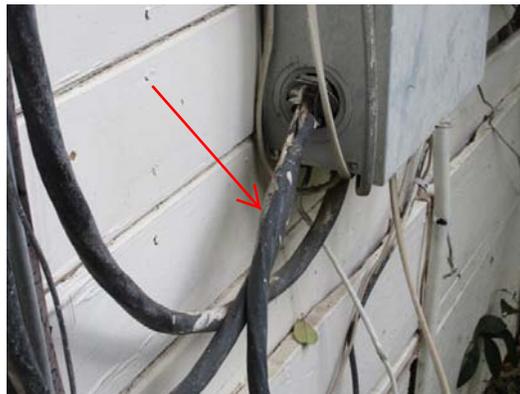
**Conductors not in conduit:** The conductors routed at the exterior are not in conduit. Although some conductors are approved for exterior use it is always better to route conductors in conduit.

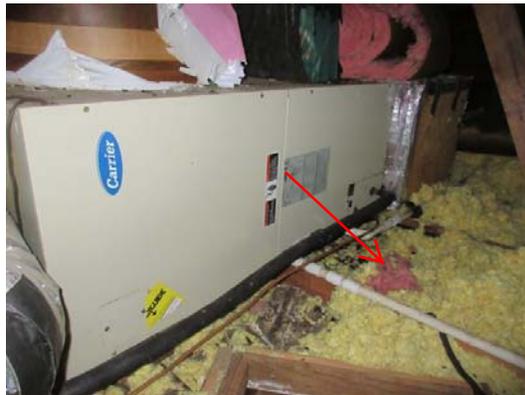
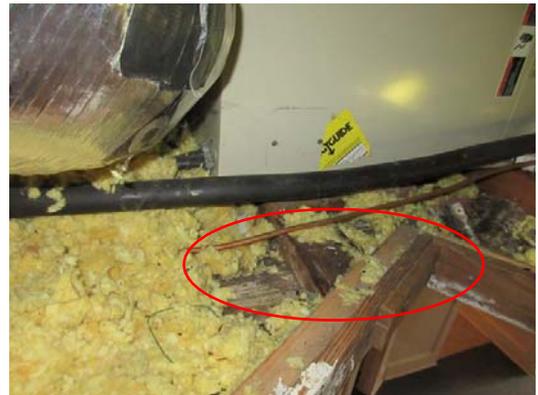
**Pan missing:** There should be a pan under the coils in the attic. Without the secondary protection of a pan under the system, water can potentially damage the house in the event of a failure of the AC coils or drain line. It should be noted that there is evidence of a past coil or drain failure. Water damage was observed under system. Future damage may occur.

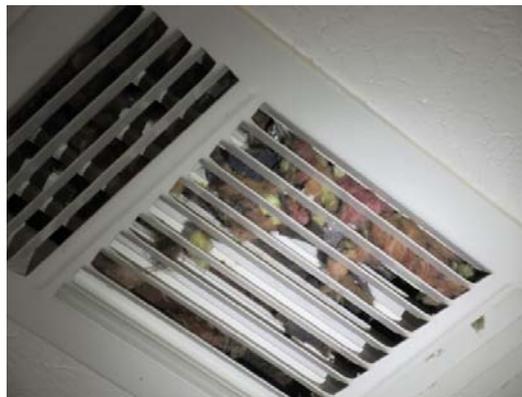
**Insulation pieces in registers:** There appears to be insulation pieces in the registers at various locations. This may be an indication of damage to ducting.

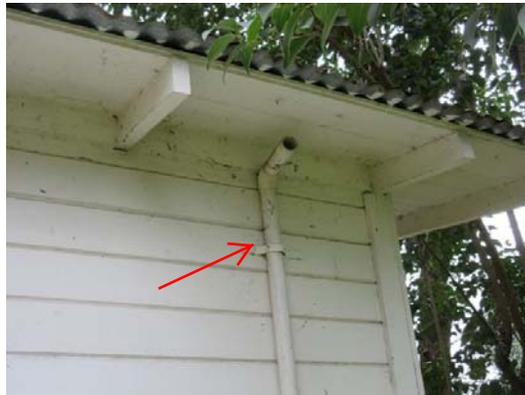
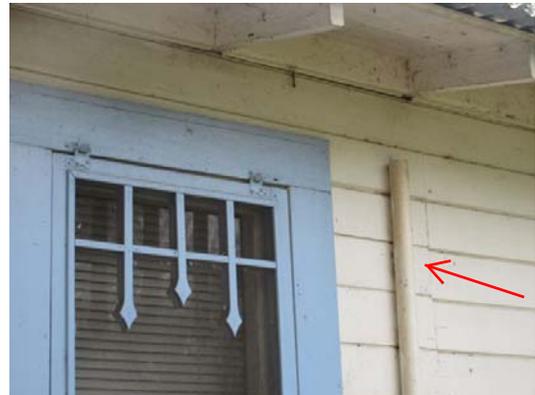
**Vent pipe termination:** The plumbing vent pipe at back exterior does not appear to terminate correctly. Should terminate above roof.
