AGENDA
CITY OF LAKE WORTH BEACH
CITY COMMISSION WORK SESSION - BEACH COMPLEX
CITY HALL COMMISSION CHAMBER
WEDNESDAY, JANUARY 26, 2022 - 4:00 PM

LAKE WORTH BEACH COMPLEX | THE ART OF FLORIDA LIVING
NEW POOL COMPLEX CONCEPTUAL PACKAGE

Property Condition Assessment

RE: *Aquatics and Beach Complex Baseline Property Condition Assessment*
KH Job #140335001

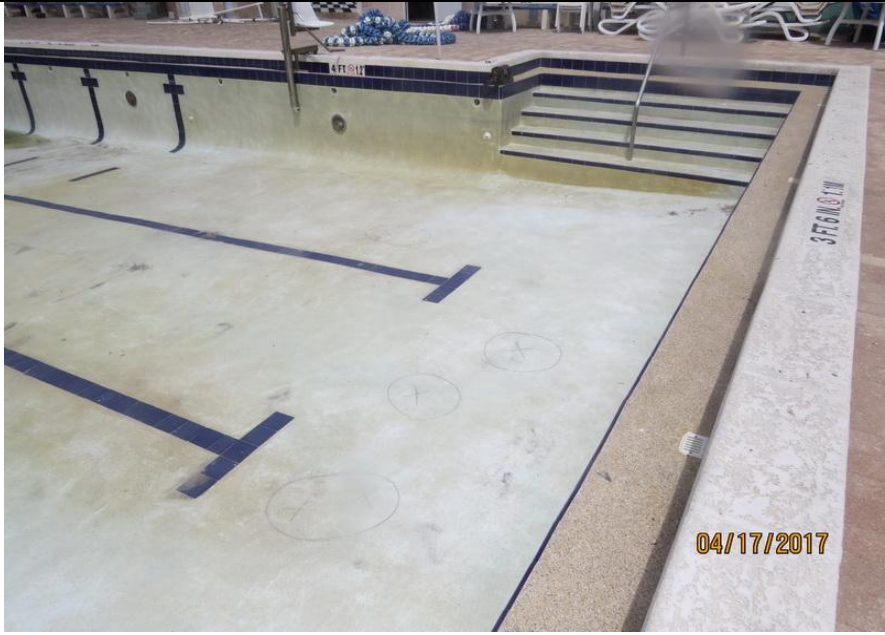
Photo No. 2

Remarks: Delaminated pool patches. No cracks observed in the finish below the gutter.

Location: Main Lap Pool

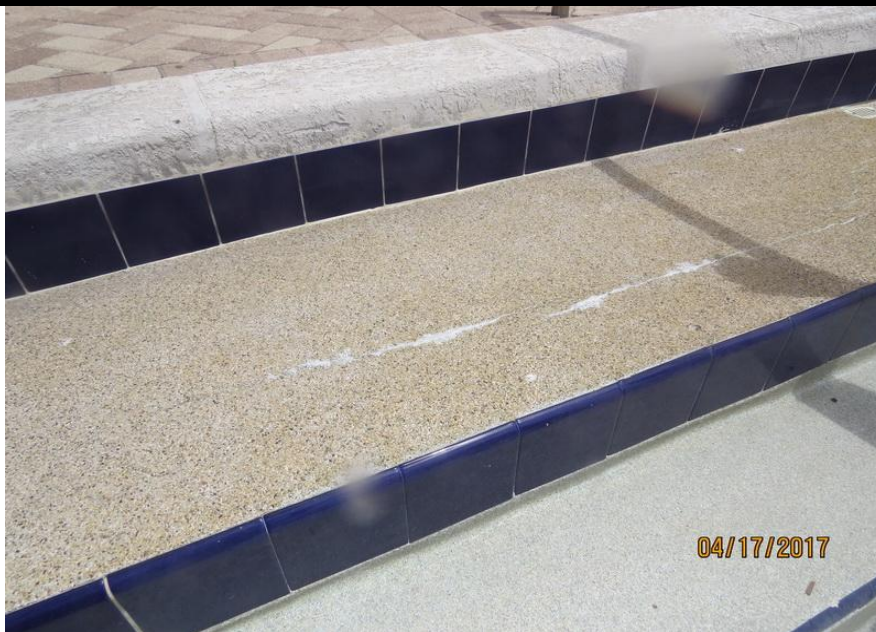
Photo No. 3

Remarks: Cracks with mineral stains on top tread of the pool stairs.

Location: Main Lap Pool

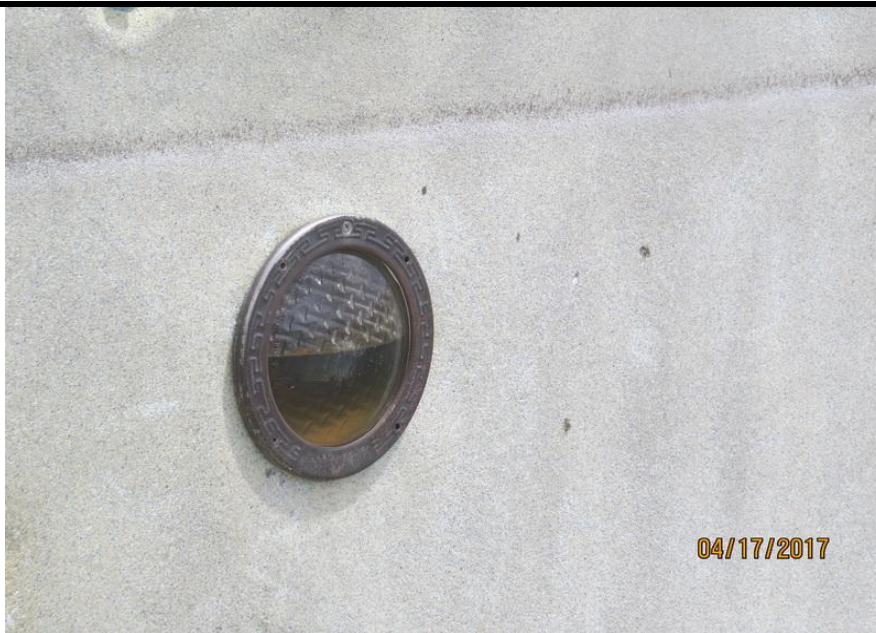
Photo No. 4

Remarks: Water leaks into the housing of the underwater lights.

Location: Main Lap Pool

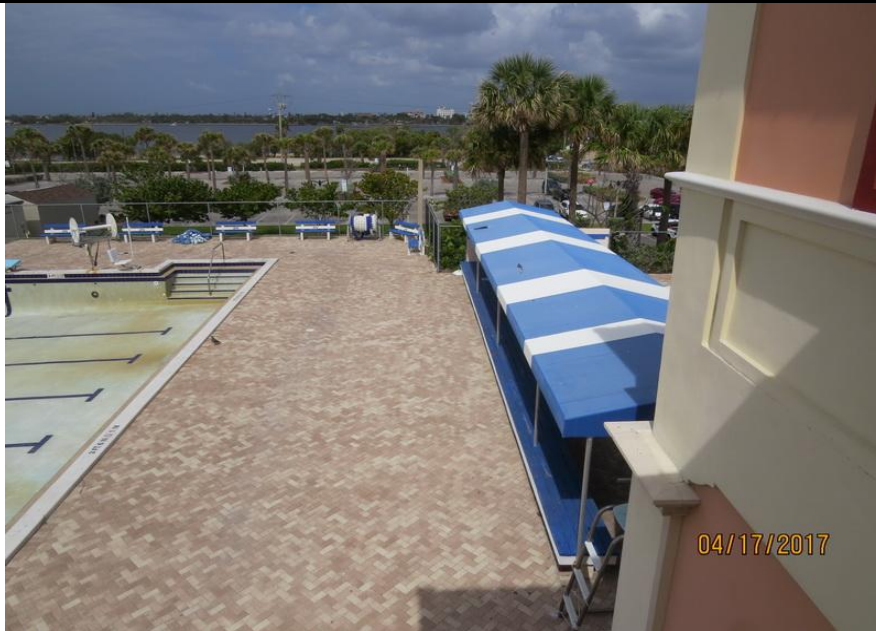
Photo No. 5

Remarks: Pool deck finish is generally in good condition.

Location: Main Lap Pool

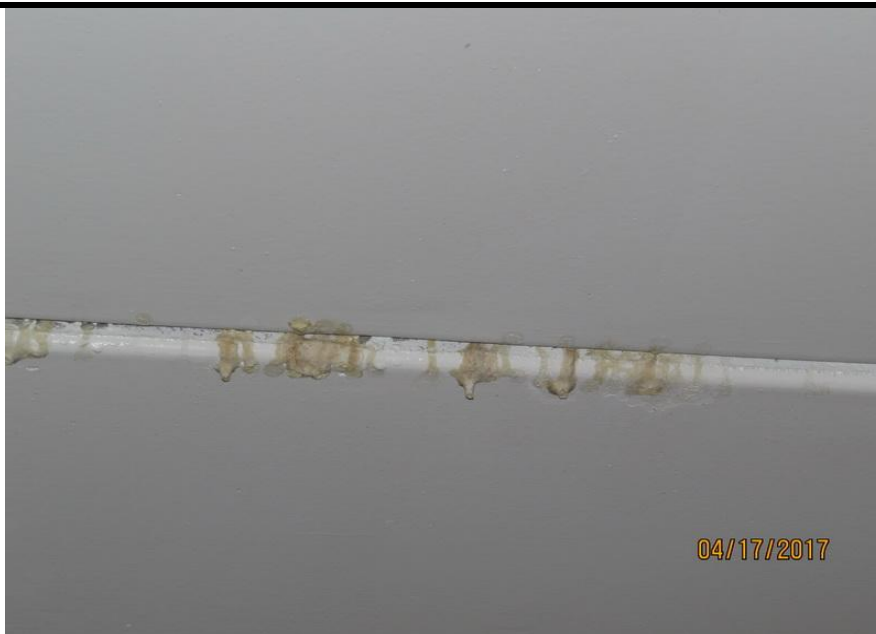
Photo No. 7

Remarks: Mineral Deposits hang from roof joints on men's and women's bathrooms.

Location: Pool Restrooms

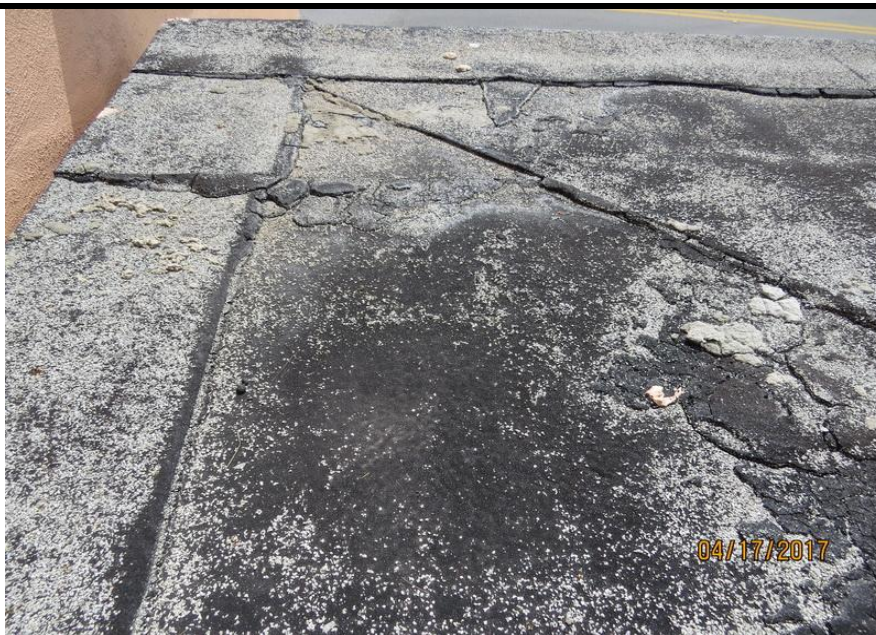
Photo No. 8

Remarks: Protective mineral granules on roof have been lost due to wear and foot traffic.

Location: Pool Restrooms

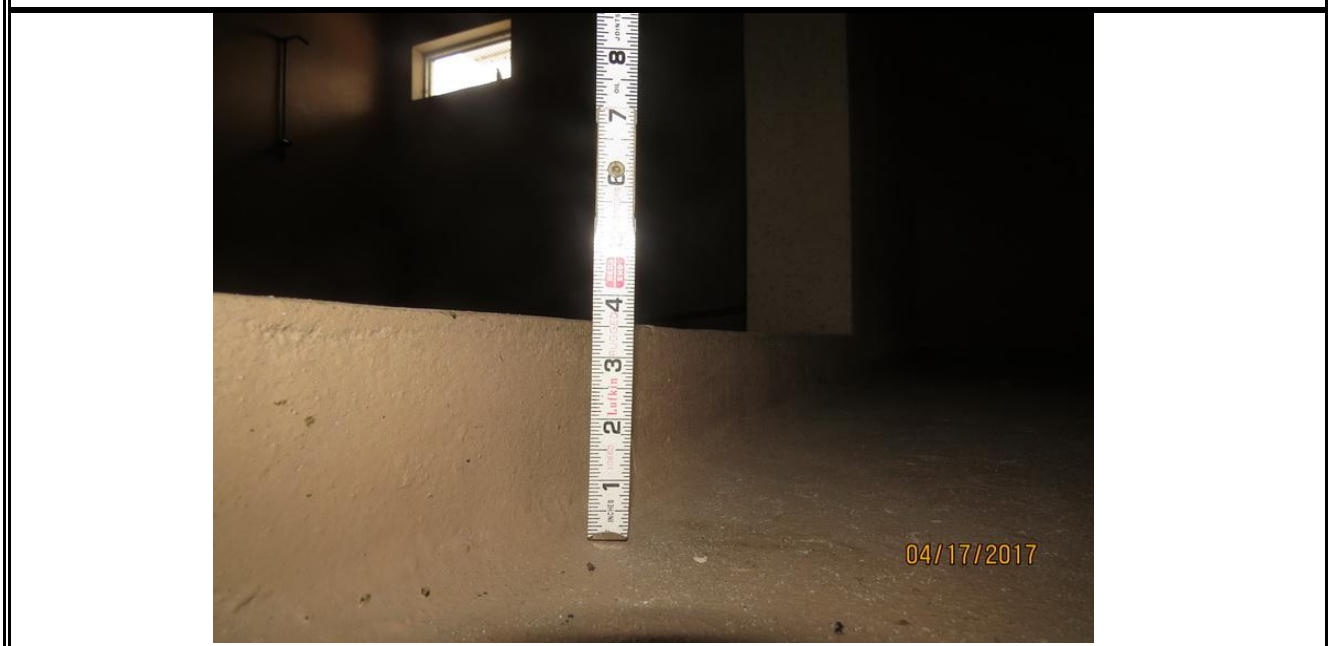
Photo No. 11

Remarks: Tripping hazard preventing ADA access to men's shower room.
Location: Pool Restrooms

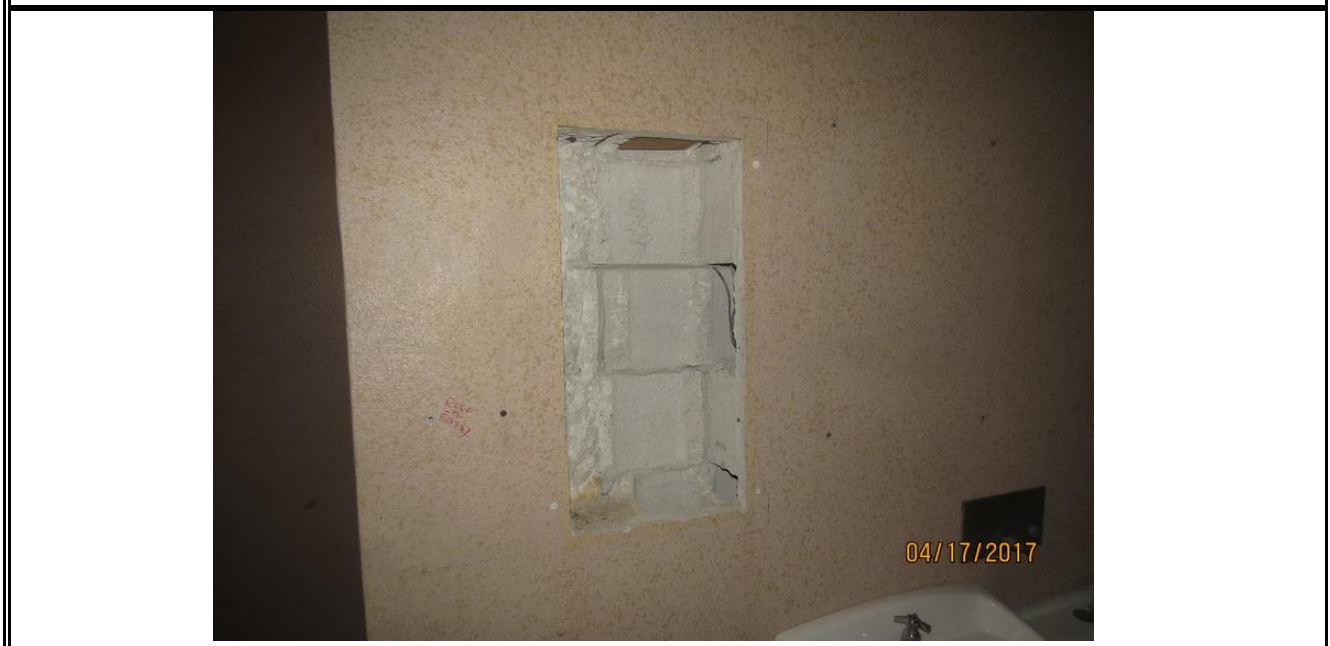
Photo No. 12

Remarks: Steel reinforcement was cut on masonry partition on women's bathroom.
Location: Pool Restrooms

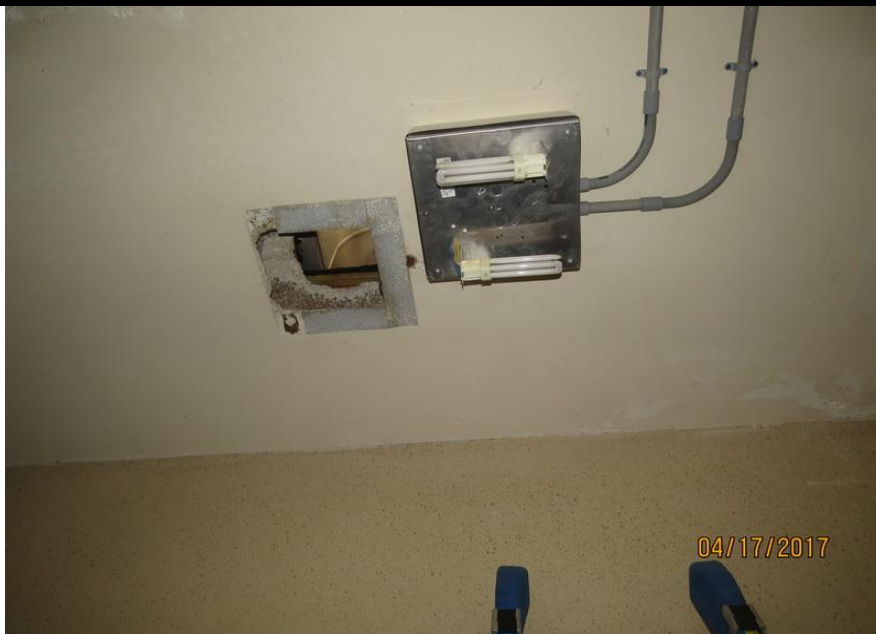
Photo No. 13

Remarks: Life Guard room bathroom lacks mechanical ventilator per FBC. The light fixture lacks a diffuser.

Location: Pool Restrooms

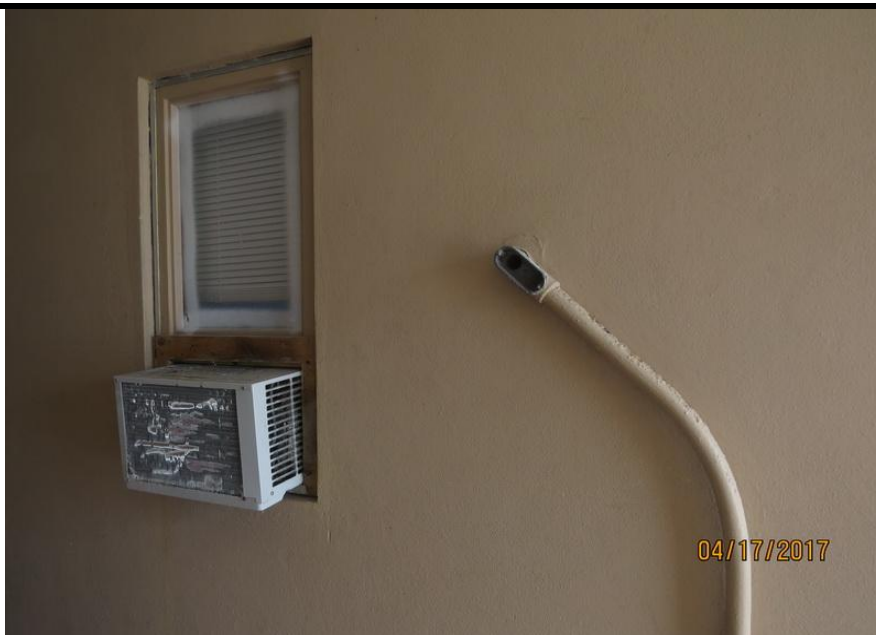
Photo No. 14

Remarks: Pool Office air conditioner is positioned to discharge waste heat into the public entry corridor.

Location: Pool Restrooms

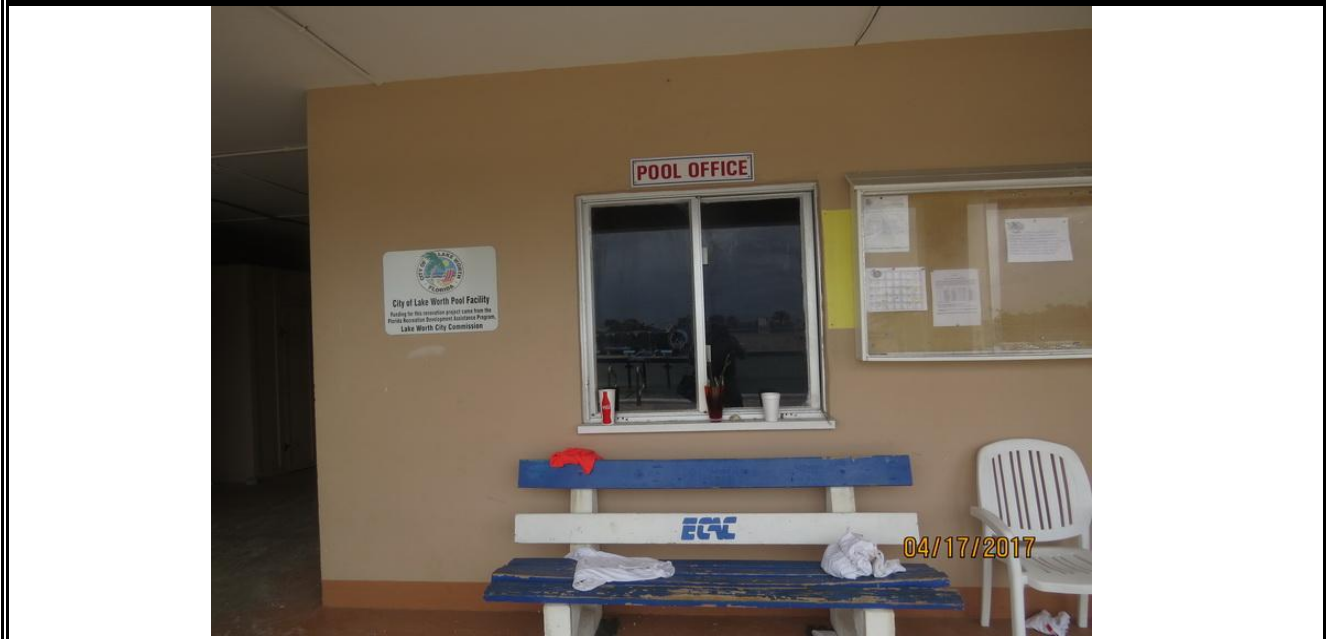
Photo No. 15

Remarks: Non-impact rated windows and door lites on the Pool Office, Life Guard room and Manager Office.

Location: Pool Restrooms

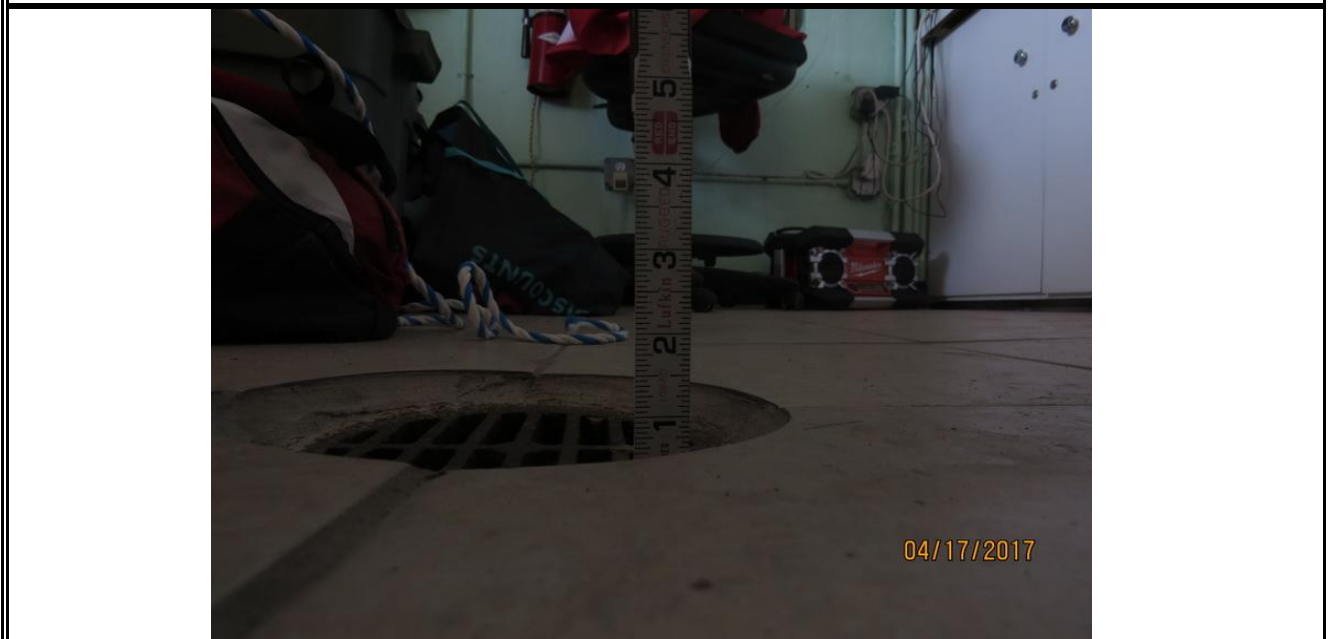
Photo No. 16

Remarks: Pool drain on the Pool Office floor is not flush with the tile surface and creates a tripping hazard.

Location: Pool Restrooms

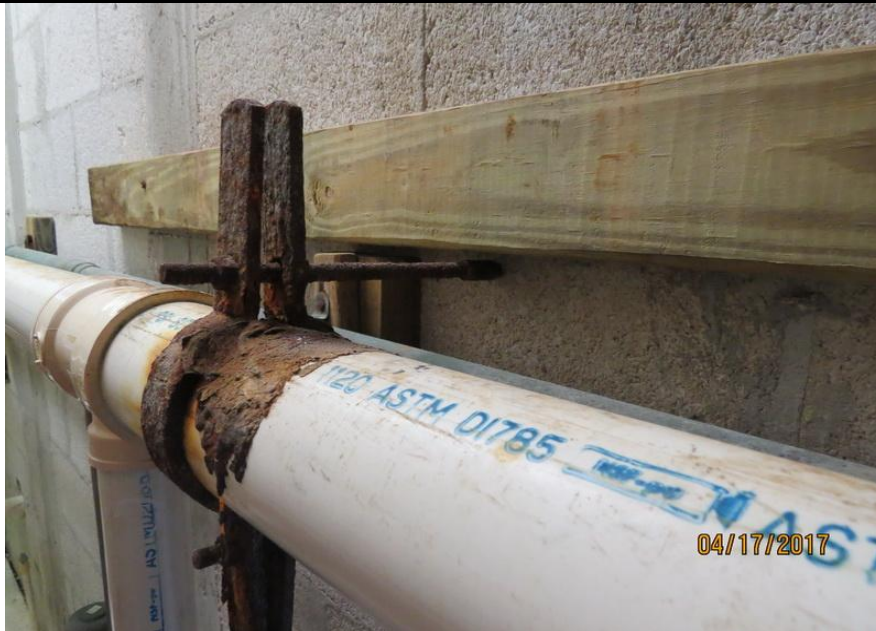
Photo No. 19

Remarks: Drain, waste, vent piping is poorly supported. Brackets are severely corroded.

Location: Beach Restrooms

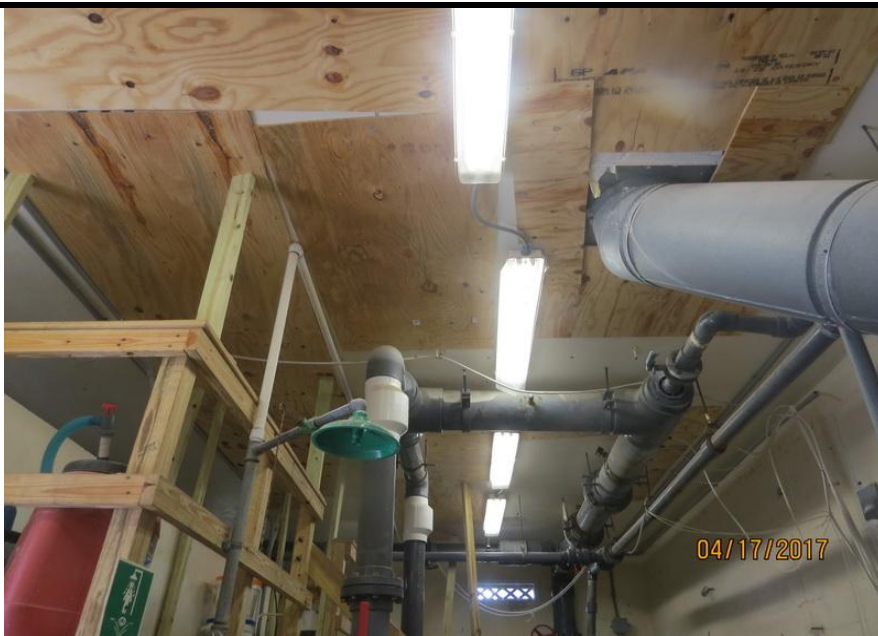
Photo No. 21

Remarks: Spalling at many roof locations mostly covered by half inch-thick plywood.

Location: Pool Filter Equipment Building

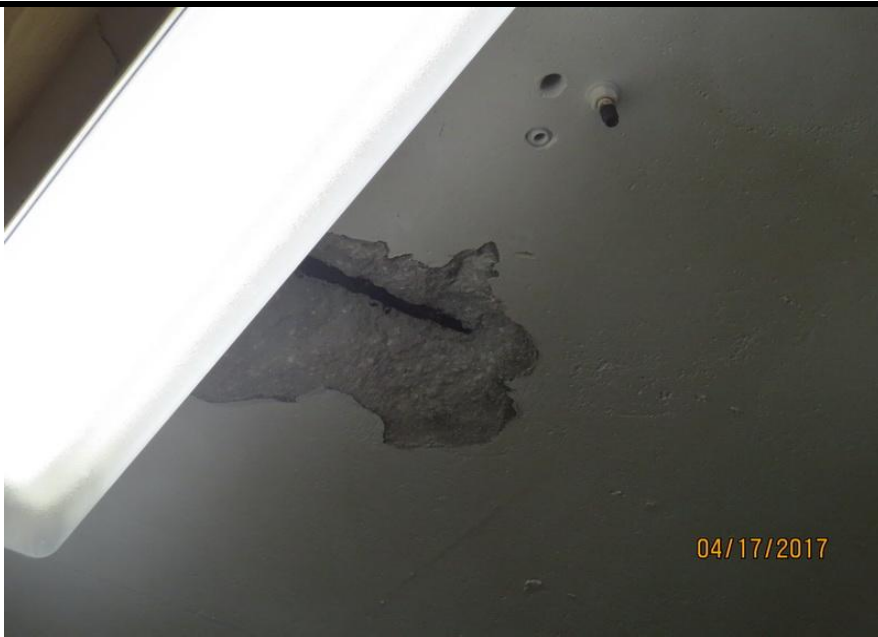
Photo No. 22

Remarks: Exposed reinforcing steel.

Location: Pool Filter Equipment Building

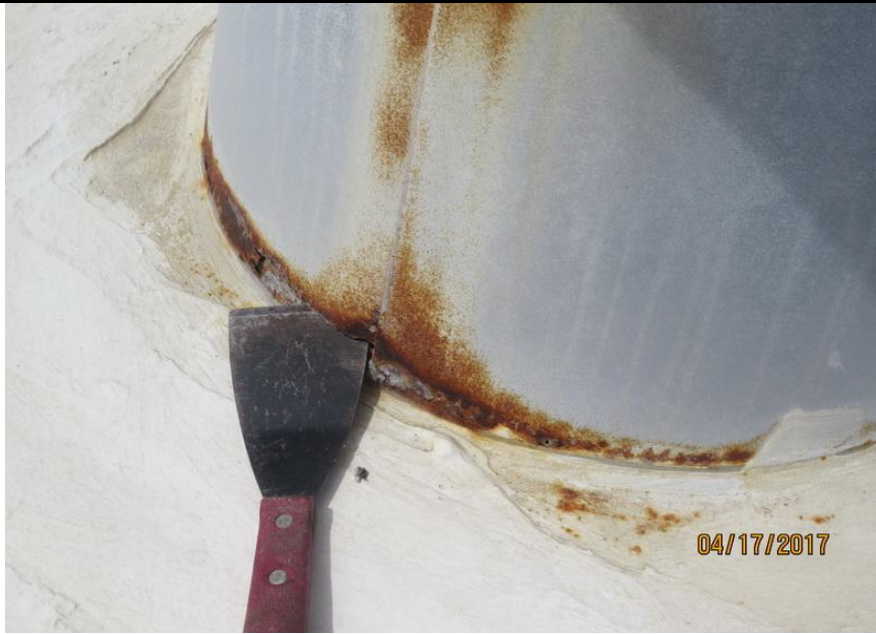
Photo No. 23

Remarks: Exhaust stacks on the roof are corroded at the base flange allowing water intrusion into the building.

Location: Pool Filter Equipment Building

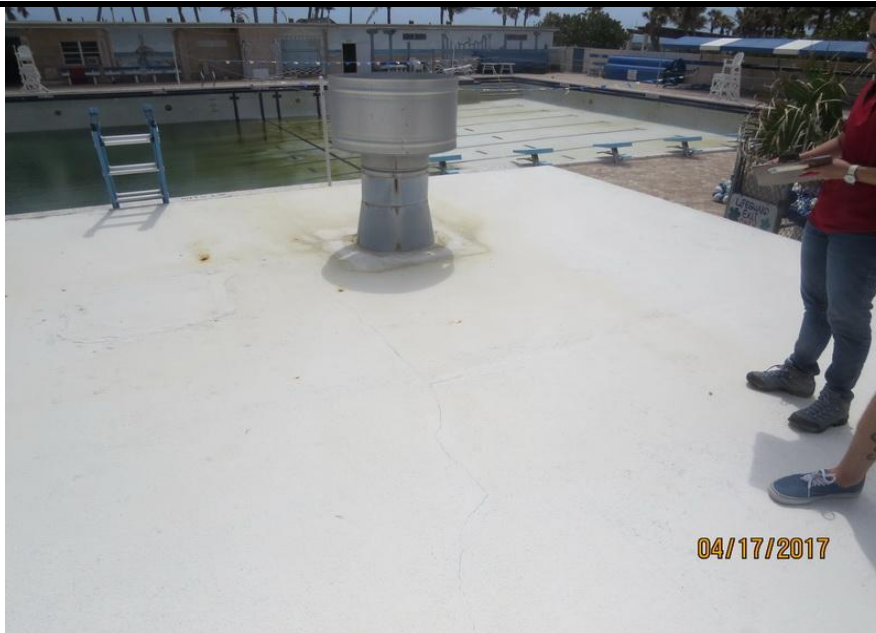
Photo No. 24

Remarks: Roof slab has multiple cracks in the upper surface that have penetrated the roof covering.

Location: Pool Filter Equipment Building

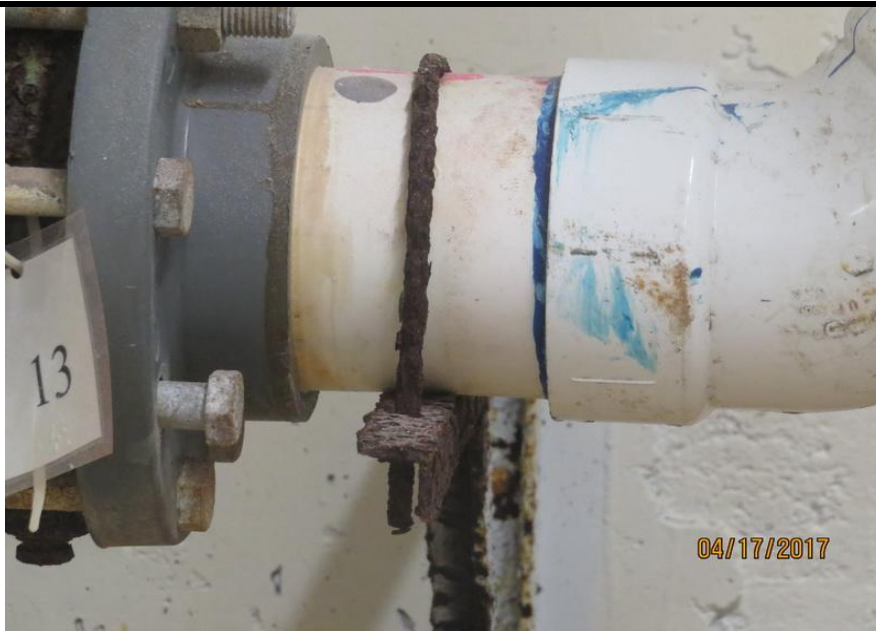
Photo No. 26

Remarks: Numerous repairs have been made to stop leaks including slip lining some pipe interiors.

Location: Pool Filter Equipment Building

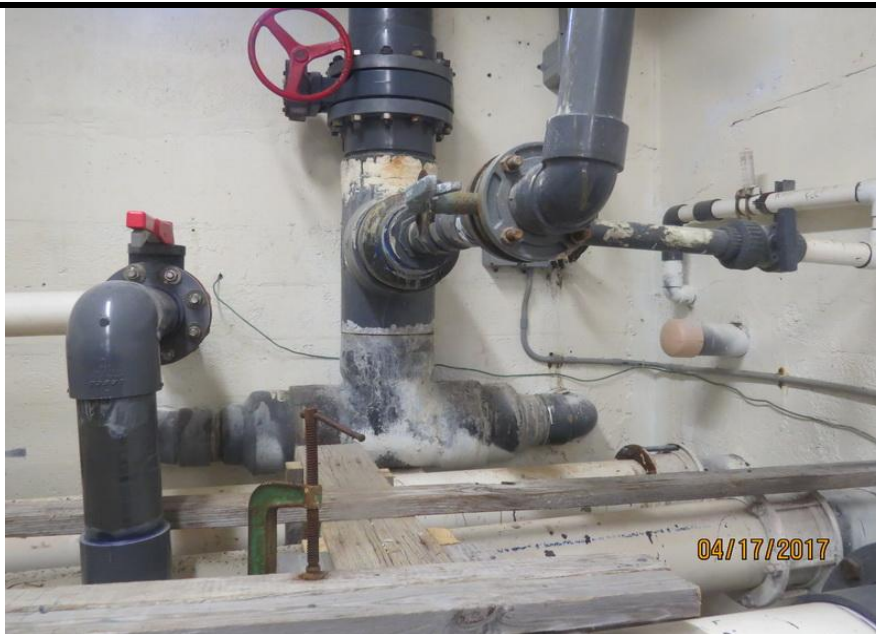
Photo No. 27

Remarks: Numerous repairs have been made to stop leaks including slip lining some pipe interiors.

Location: Pool Filter Equipment Building

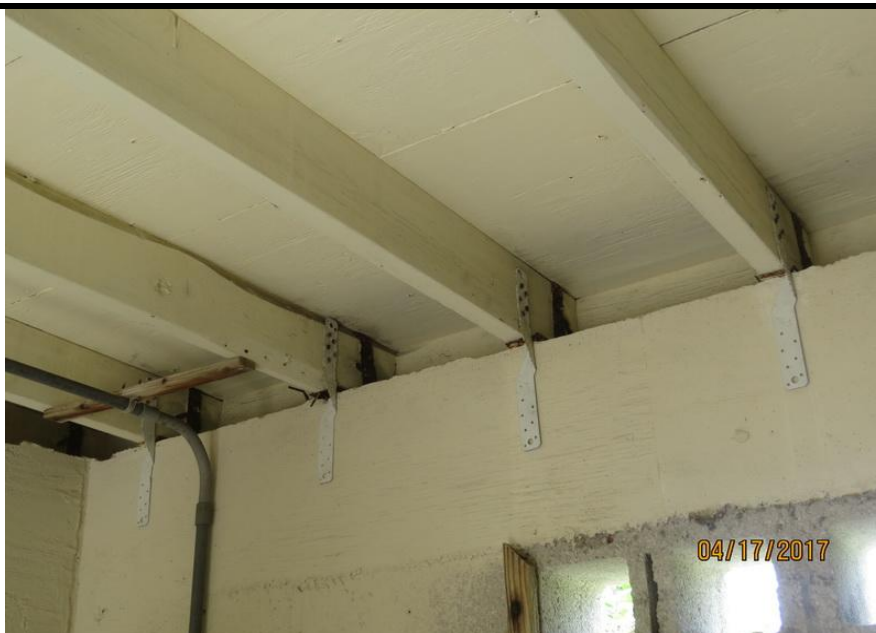
Photo No. 30

Remarks: Hurricane straps connecting the roof joists to the masonry walls are missing fasteners.

Location: Chlorine Storage Building

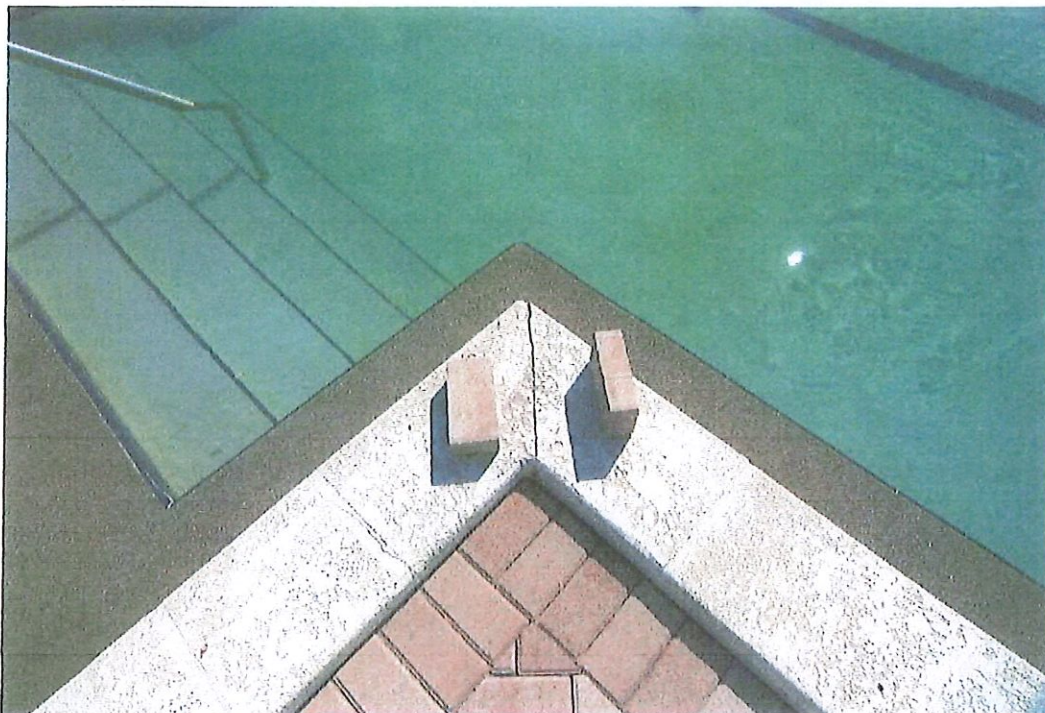
EXHIBIT 5. VIEW OF CRACKED MORTAR JOINT BETWEEN ADJOINING COPING STONES
