**TOWN OF PAONIA**  
**MONDAY, FEBRUARY 28, 2022**  
**WORK SESSION FOLLOWED BY SPECIAL TOWN BOARD MEETING AGENDA**  
**5:30 PM**

2. WORK SESSION: SGM - Capital Improvement Plan/Asset Inventory & System Mapping Presentation

TOWN OF PAONIA

September 2021

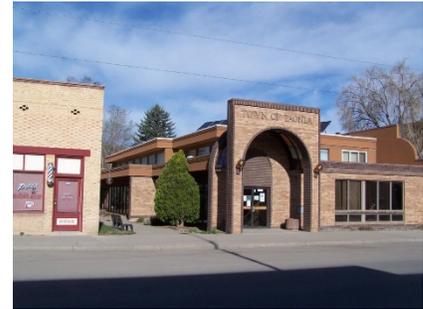
Town Hall was constructed in 1983. It is ~6,200 square feet in size and houses most municipal departments, the Public Works, Town Manager, the Town Clerk, the Town Council Chambers and the Police Department.

- a. Description: The building structure of Town Hall appears to consist of a wood frame roof, masonry and wood frame walls. The floors are a mix of slab-on-grade and engineered floor joists over a crawl space with concrete stem wall and footing foundation. The floors joists showed signs of being inadequately sized. Interior finishes consist primarily of acoustical ceiling tiles, drywall, and carpet and tile floors. A CMU and stucco/EIFS addition was added to the west (back) of building. Overall condition is Fair.

- b. Discussion:
  - i. The TPO roof membrane that was observed appeared to be in good condition, access issues limited the amount of roof to be observed. The age of roof should be compared to standard useful life of similar product and assessed accordingly.

- ii. Retrofit windows on the second floor are not of similar material and color as the original windows. There are exposed fasteners and damaged frames from installation.

- iii. Exterior finishes are damaged in several locations, specifically broken brick veneer at entry pier and several cracks and holes in the EIFS. It is recommended the EIFS be repaired and the stucco patched.

- iv. The floor joists appear to be undersized in several locations. Deflection is evident when walking in meeting room, and signs of similar deflection can be seen in the Public Works area where the floor tiles and grout are cracked and broken. It is recommended that the floors be assessed and repaired to meet minimal deflection criteria.

- 1. Repair inadequate floor joists and replace finishes:
  - Joist repair \$25,000
  - Finished flooring removal & replacement \$10,000
  - Cost estimate: \$35,000**
- 2. EIFS Repair
  - Patch and new finish coat \$12,500
  - Cost estimate: \$12,500**
- 3. Kitchen Replacement
  - Cabinet replacement \$11,500
  - Appliance replacement \$2,500
  - Cost estimate: \$14,000**
- 4. Perform appropriate maintenance to maximize remaining useful life:  
 It is recommended that this facility have an annual maintenance budget, separate from repair and replacement projects, equal to or above the following dollar figure, which includes estimates for basic labor and basic materials.  
*Maintenance examples* – door and hardware repairs/parts, seasonal annual boiler system tune-up. Touch up painting, etc. (budgeted in replacement budget).  
**Cost estimate: \$1,500**
