#### **Historic Preservation Commission Regular Meeting - Amended**

City of Dripping Springs Council Chambers
511 Mercer Street – Dripping Springs, Texas
Thursday, May 02, 2024, at 4:00 PM

# Old Fitzhugh Road Local Historic District Resurvey Historic Resources Survey Report

Project Limits: Old Fitzhugh Road Historic District

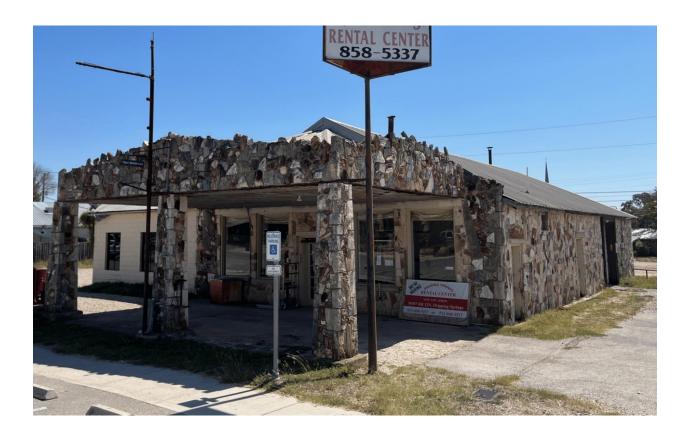
**299 Mercer: "Current Condition"**. Images from Google Maps, 2023.

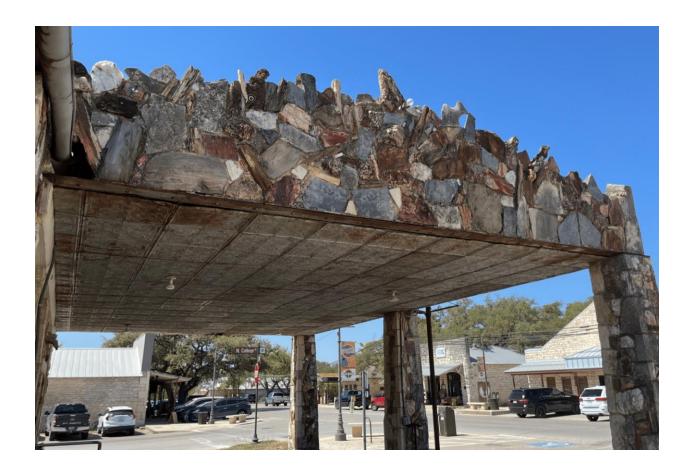
**299 Mercer:** More detailed imagery of the native stone and wood of the structure.

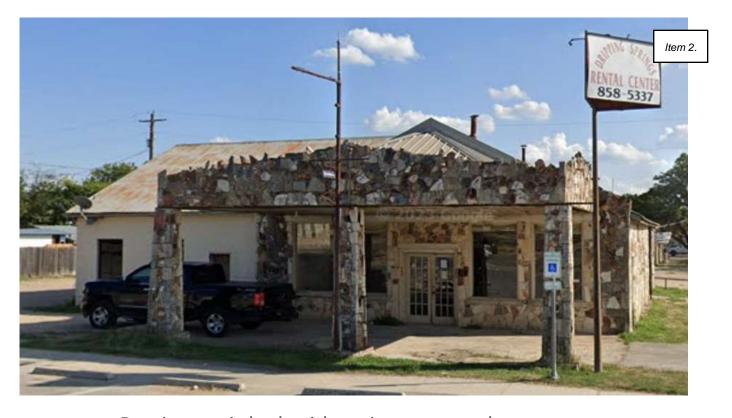
## Existing Conditions

Retains rustic look with native stone and wood paneling. Possesses unique stone pillars. Sloped metal roofing and small signage at front of property.

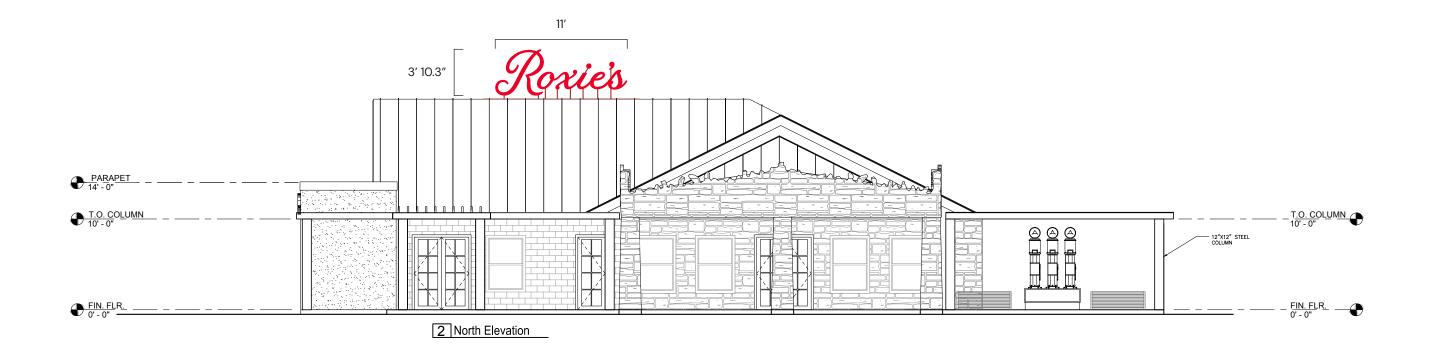
Rooftop Sign Building Elevation View

The applicant is seeking to include the addition of a sign above the apex of the building as well as a sign that sits atop the building. The sign itself is 3' 10" x 11' in size and PMS 185 C in color. Additional signage on barrels 3'8" x 3'8" in size that sit on the corner of Wallace St and College St. The color is PMS 484 C (red). The applicant is also aiming to replace a sign at the front of the building with a Texas State Flag design.

"Muted, rustic Earth Tone Hues" The shades of red are rustic, but the brighter shade of red would need approval. The PMS 185 C is a bright red that stands out from the rest of the building.

Color Palette: "Muted, Rustic Earth Tone Hues" The signage for the building appears to be a bright red, which would go against the guidelines of the Mercer Street Historic District

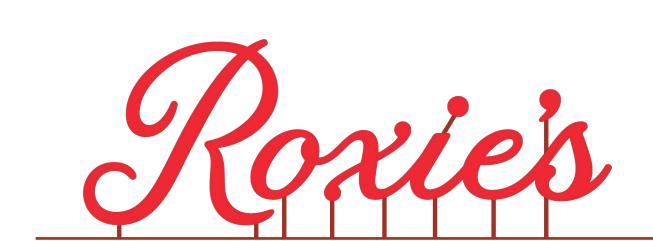
Front

- Unlit channel letters, bottom pin-mounted to a rail
- Pins be installed through center of letters to provide a clean back view
   Letters to be painted to match PMS 185 C

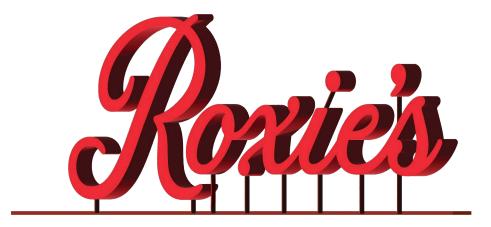
Tank Signage

Hand-painted artwork on existing tank on premise

- 1 color badge painted on 2 sides, PMS 9240 C
- Tank to have a base color applied all over, PMS 484 C

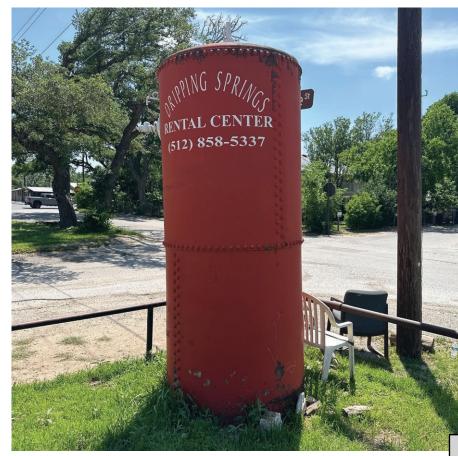
Pole with triangular sign

Hand-painted artwork on the existing three panels of pole sign
- 3-color artwork, on 3 sides, PMS 185 C, PMS 3155 C, and PMS 9240 C

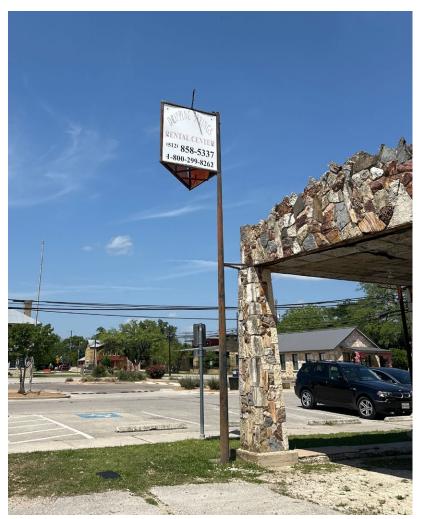
Scale: 1'=3/4"

Roxie's Exterior Signage Building Sign Building Elevation View

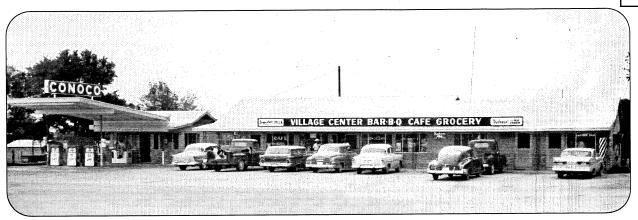
Village Center, 1961

the forerunner of the one-stop shopping center for Dripping Springs. The center included a cafe, grocery, beauty and barber shop. The house became the west end of the main building. The front two rooms became the barber and beauty shops and the back two rooms were used as living areas or storage. When the grocery was expanded to include the rooms previously being the barber and beauty shops, the portion that was the house could be noted by the slanted floor leading to those rooms. The grocery and cafe was run by the Raglands. Bersha McIntyre had the beauty shop and Ira Ruston the barber shop. It opened in August 1961. A Conoco station was separate from the rest of the center and located on the east side of the property. The station was completed by April 1962, and Melvin McNair was the first to run it. Later Fisher would take over. The cafe occupied the east end of the main building with the grocery in the middle and the barber/beauty shops on the west end.

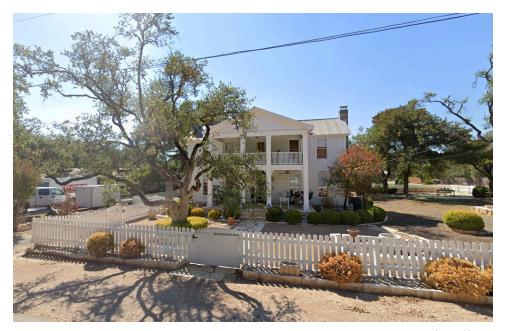
Jones House Google Street View 2023

The Jones House, located within the Hays Street Historic District at 200 Bluff Street, may be individually eligible at the state or federal level as a local example of late nineteenth century residential architecture. While it has lost original integrity of setting as a farmstead surrounded by agricultural land, it otherwise retains good integrity.

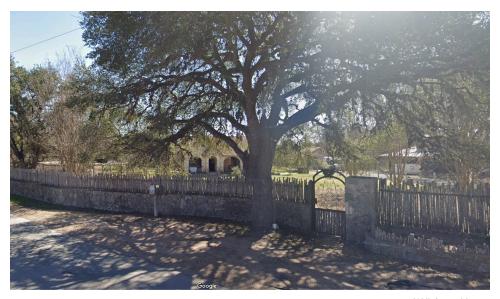
Will Crow House Google Street View 2022

The Will Crow House, located within the Hays Street Historic District at 103 Creek Road, may be individually eligible at the state or federal level as a local example of 1930s field-stone bungalow architecture and for its association with the Milk House Springs.

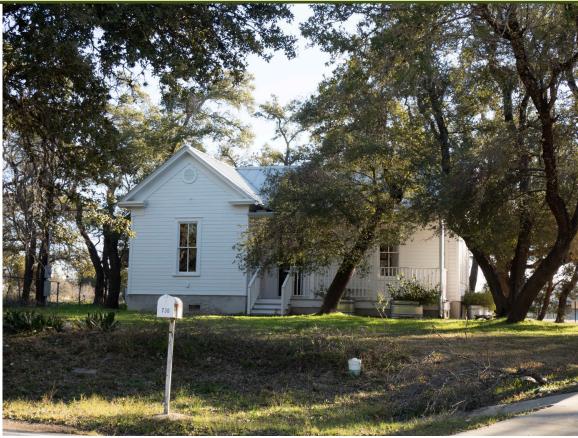
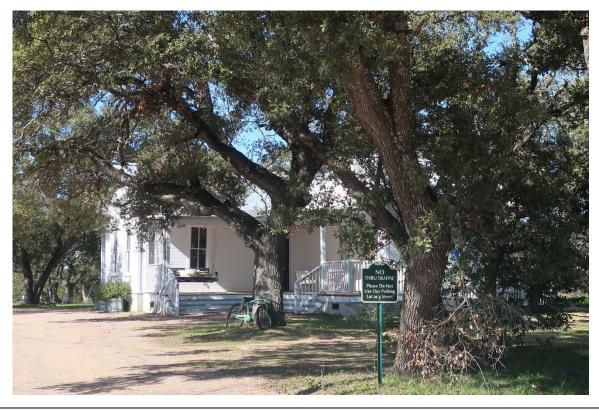
PRIORITY ASSESSMENT
PRIORITY High Medium Low
INTEGRITY  Location  Setting  Design  Materials  Workmanship  Feeling  Association  Not historic-age
<b>ALTERATIONS</b> C. 2015, moved from original location on Rainey Street in Austin; c. 2016, concrete foundation and east/west elevation
porches added.
NOTES Moved outside the period of significance.
ENDANGERED No Yes

View NE | West elevation facing Old Fitzhugh Road

View NW | East (primary) and south elevations

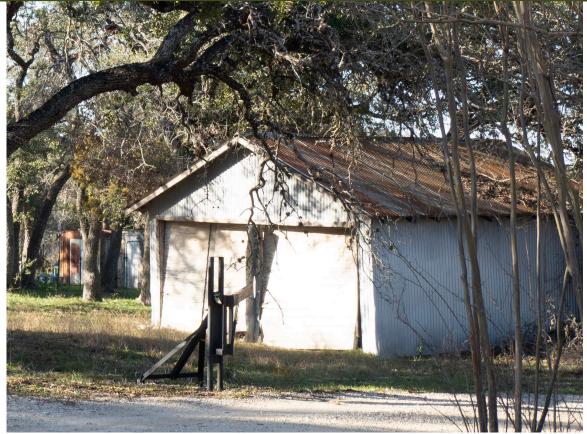
ANCILLARY STRUCTURE #7B	
CATEGORY Building Site Structure Object	CONSTRUCTION DATE c. 1945
CURRENT USE Garage	HISTORIC USE Garage
NO. OF STORIES 1	EXTERIOR WALL CLADDING Corrugated metal
ROOF TYPE Gable	ROOF MATERIAL Corrugated metal
NOTES Likely constructed at the same time as the main building. Roof material, cladding, and doors appear to be replacements.

PRIORITY ASSESSMENT
PRIORITY High Medium Low
INTEGRITY   ☐ Location ☐ Setting ☐ Design ☐ Materials ☐ Workmanship ☐ Feeling ☐ Association ☐ Not historic-age
<b>ALTERATIONS</b> Non-original roof; non-original siding; non-original doors.
NOTES
ENDANGERED No Yes

View SW | North and west elevations

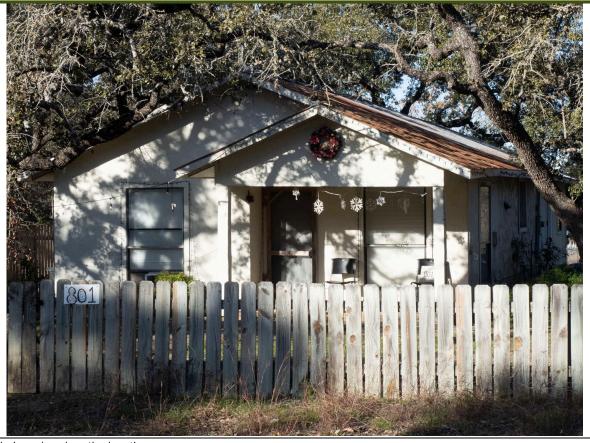
PRIORITY ASSESSMENT
PRIORITY High Medium Low
INTEGRITY   ☐ Location ☐ Setting ☐ Design ☐ Materials ☐ Workmanship ☐ Feeling ☐ Association ☐ Not historic-age
ALTERATIONS Likely non-original siding; likely non-original porch posts.
NOTES
ENDANGERED ⊠No ☐Yes

View SW | East (primary) and north elevations,,

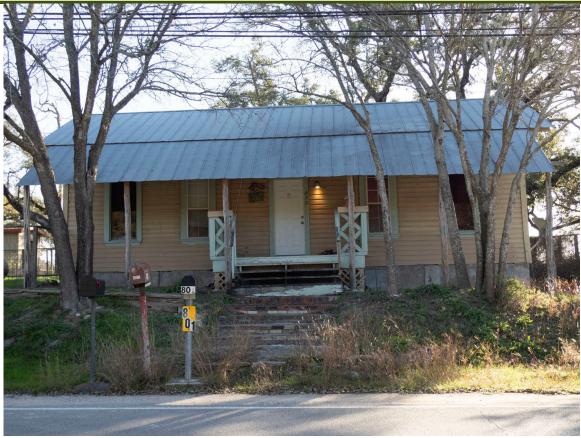
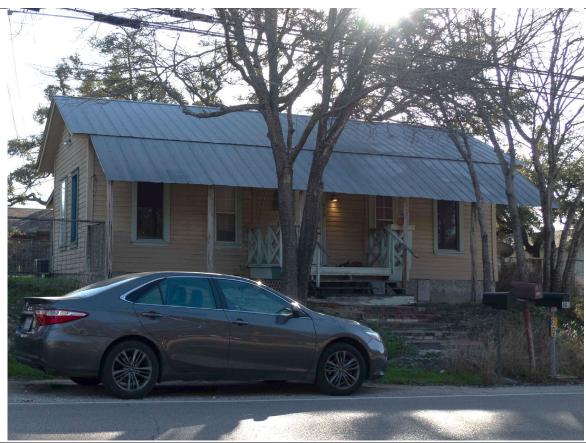
PRIORITY ASSESSMENT
PRIORITY High Medium Low
INTEGRITY   ☐ Location ☐ Setting ☐ Design ☐ Materials ☐ Workmanship ☐ Feeling ☐ Association ☐ Not historic-age
<b>ALTERATIONS</b> Some non-original windows; non-original entry door; porch has likely been altered.
NOTES
ENDANGERED No Yes

View E | West (primary) elevation

View SE | North and west (primary elevations)

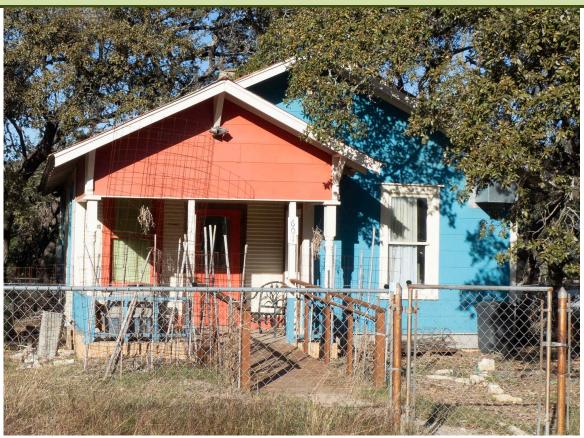
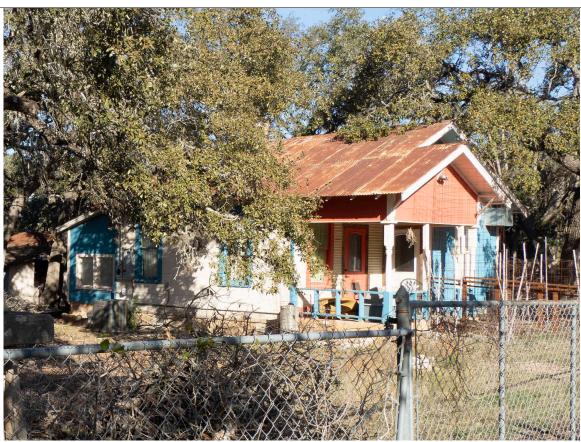
PRIORITY ASSESSMENT
PRIORITY High Medium Low
INTEGRITY
<b>ALTERATIONS</b> Non-original siding; non-original entry door. Historic wood clapboards extant at porch; historic clapboards may be extant
under non-original asbestos siding.
NOTES
ENDANGERED No Yes

View W | East (front) elevation

View NW | East (front) and south elevations

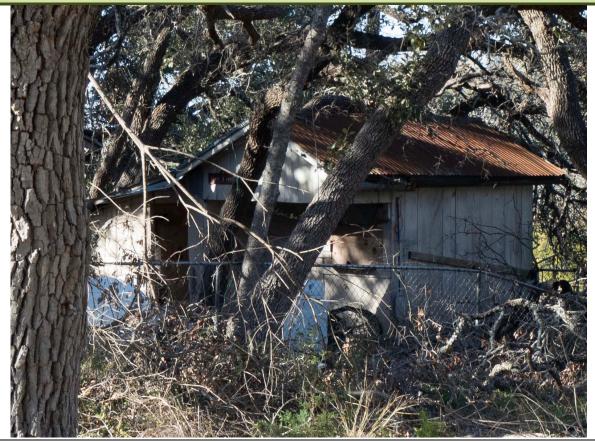
ANCILLARY STRUCTURE #11B	
CATEGORY ⊠Building ☐Site ☐Structure ☐Object	CONSTRUCTION DATE c. 1930
CURRENT USE Shed	HISTORIC USE Shed
NO. OF STORIES 1	EXTERIOR WALL CLADDING Wood plank
ROOF TYPE Gable, shed	ROOF MATERIAL Corrugated metal
NOTES

PRIORITY ASSESSMENT
PRIORITY High Medium Low
INTEGRITY   ☐ Location ☐ Setting ☐ Design ☐ Materials ☐ Workmanship ☐ Feeling ☐ Association ☐ Not historic-age
<b>ALTERATIONS</b> Does not appear to have any substantial alterations, although siding and roof material may have been updated over time.
NOTES
ENDANGERED No Yes

View SW | East and north elevations

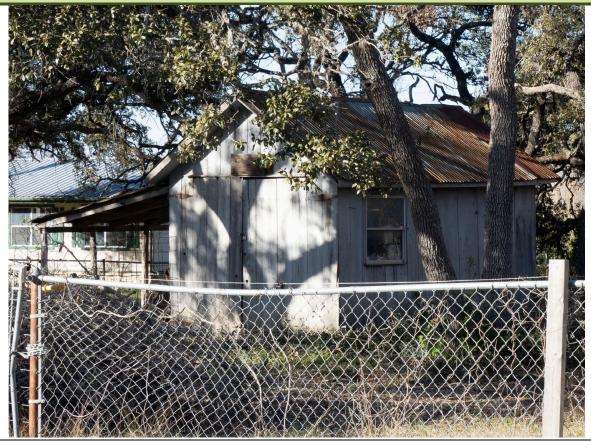
ANCILLARY STRUCTURE #11C		
CATEGORY Building Site Structure Object	CONSTRUCTION DATE c. 1930	
CURRENT USE Shed	HISTORIC USE Shed	
NO. OF STORIES 1	EXTERIOR WALL CLADDING Wood plank	
ROOF TYPE Gable, shed ROOF MATERIAL Corrugated metal		
<b>NOTES</b> This gable outbuilding with partially unenclosed side room appears to be one of the few remaining domestic or agricultural outbuildings dating to the early twentieth century.

PRIORITY ASSESSMENT
PRIORITY High Medium Low
INTEGRITY   ☐ Location ☐ Setting ☐ Design ☐ Materials ☐ Workmanship ☐ Feeling ☐ Association ☐ Not historic-age
<b>ALTERATIONS</b> Does not appear to have any substantial alterations, although siding and roof material may have been updated over time.
NOTES
ENDANGERED No Yes

View SW | East and north elevations

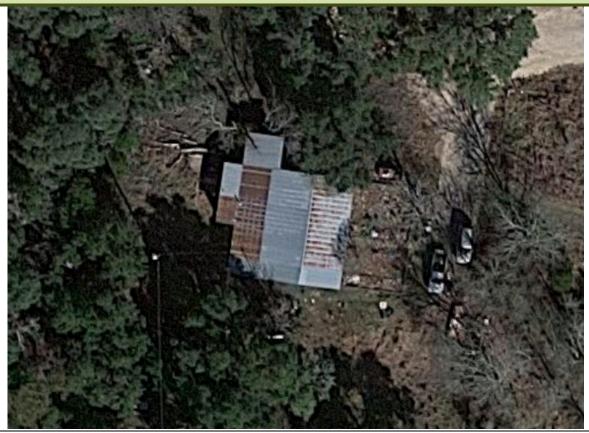
· · ·
PRIORITY ASSESSMENT
PRIORITY High Medium Low
INTEGRITY   ☐ Location ☐ Setting ☐ Design ☐ Materials ☐ Workmanship ☐ Feeling ☐ Association ☐ Not historic-age
ALTERATIONS Unknown, not visible from public ROW. Historic aerial photographs indicate a likely addition on the east elevation.
NOTES
ENDANGERED No Yes
LINDANGERED MINO MICS

View Google Earth 2024 Aerial | Roof

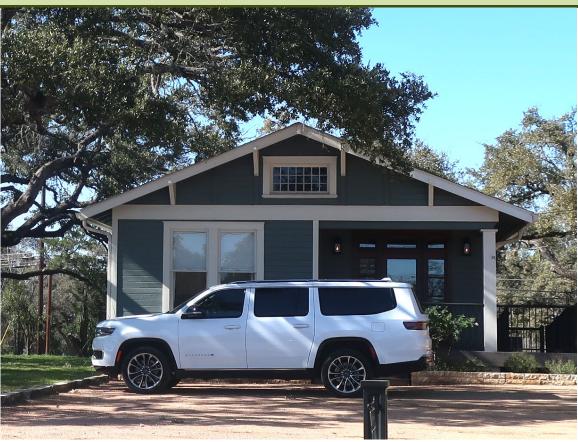
View W | East (primary) elevation

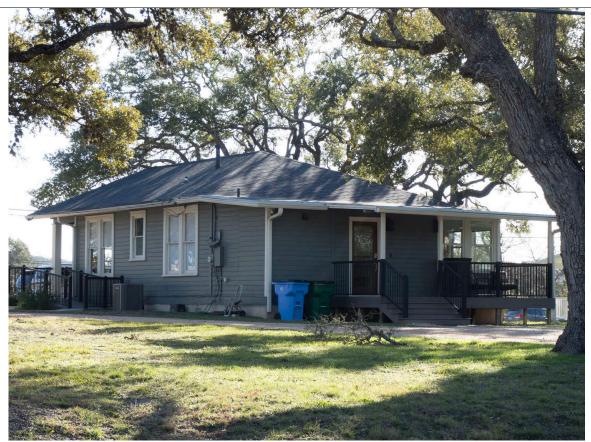
View SE | North and west (rear) elevations

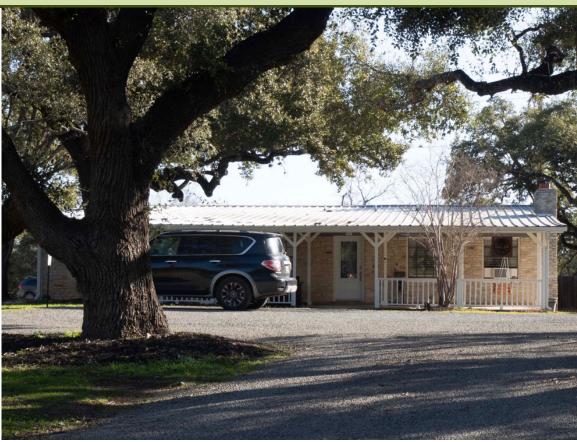
View E | West elevation

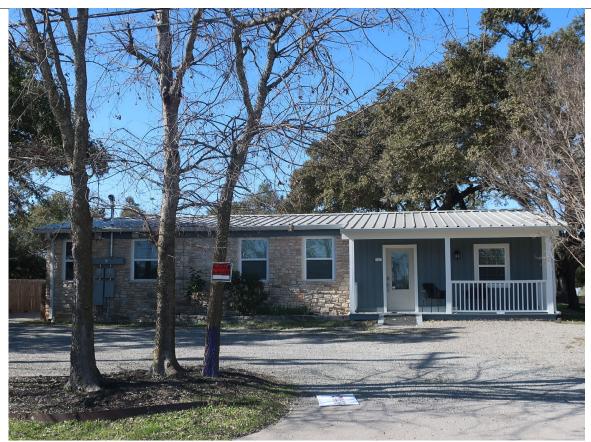
View W | East elevation

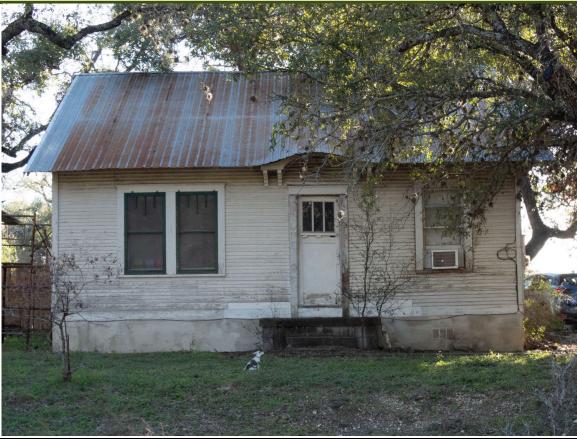
PRIORITY ASSESSMENT
PRIORITY High Medium Low
INTEGRITY
ALTERATIONS Non-original foundation.
NOTES It is unknown if the building was moved within the period of significance.
ENDANGERED No Yes

View E | West (primary) elevation

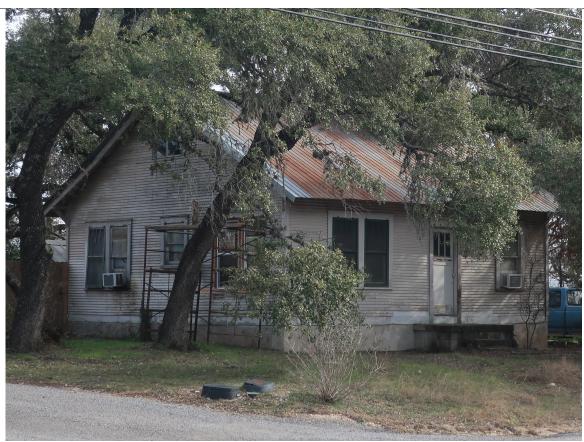
View SE | North and west (primary) elevations

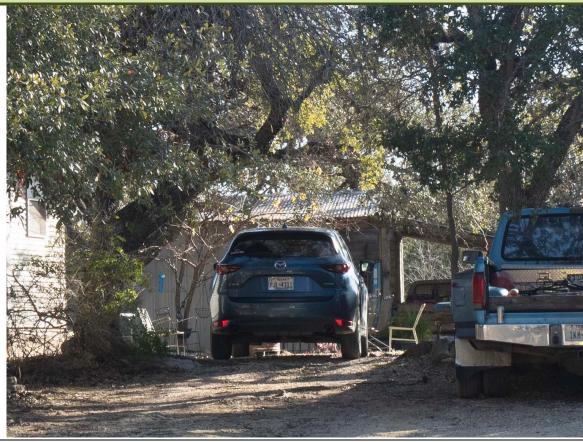
ANCILLARY STRUCTURE #16B	
CATEGORY ⊠Building □Site □Structure □Object	CONSTRUCTION DATE Unknown
CURRENT USE Shed	HISTORIC USE Unknown
NO. OF STORIES 1	EXTERIOR WALL CLADDING Wood clapboard, corrugated metal
ROOF TYPE Gable, shed	ROOF MATERIAL Corrugated metal
NOTES	·

PRIORITY ASSESSMENT
PRIORITY High Medium Low
INTEGRITY
ALTERATIONS Non-original siding.
NOTES It is unknown if the building was constructed within the period of significance. It does not appear on the 1962 aerial but does appear
on the 1983 aerial.
ENDANGERED ⊠No ☐Yes

View E | West elevation

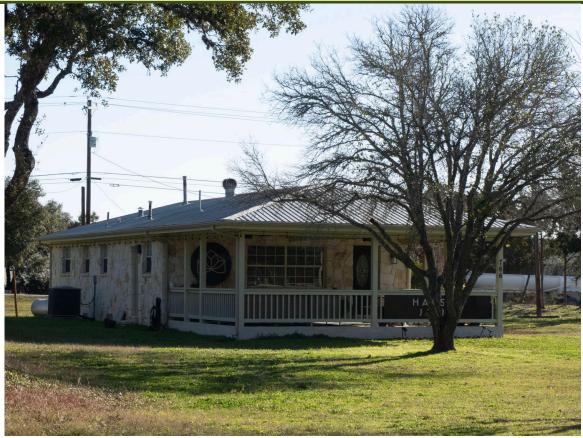
View E | North and west (primary) elevations

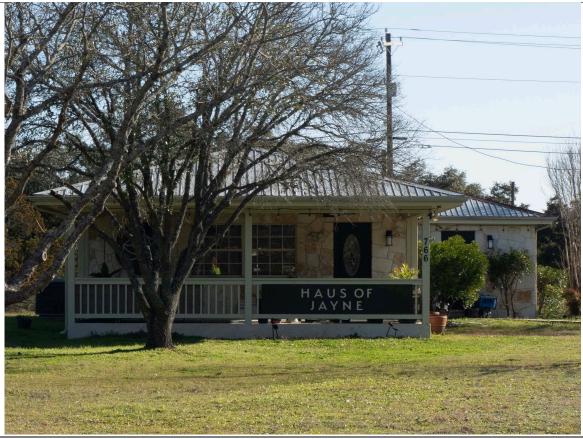
View E | West (primary) elevation

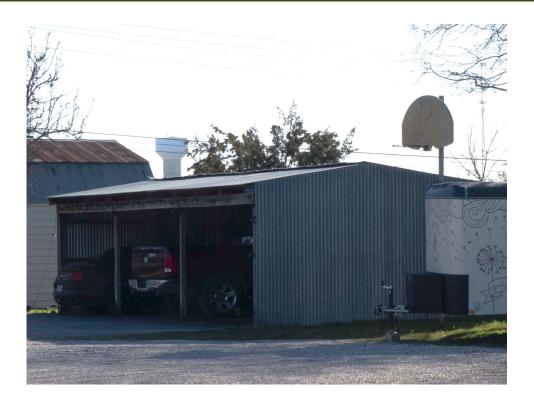
View SE | North and west elevations

ANCILLARY STRUCTURE #17C		
CATEGORY ⊠Building ☐Site ☐Structure ☐Object	CONSTRUCTION DATE 1992	
CURRENT USE Storage shed	HISTORIC USE n/a, not historic age	
NO. OF STORIES 1	EXTERIOR WALL CLADDING Aluminum lap siding	
ROOF TYPE Gambrel	ROOF MATERIAL Corrugated metal	
NOTES

PRIORITY ASSESSMENT
PRIORITY High Medium Low
INTEGRITY  Location  Setting  Design  Materials  Workmanship  Feeling  Association  Not historic-age
ALTERATIONS Not historic-age; no alterations noted.
NOTES
ENDANGERED No Yes

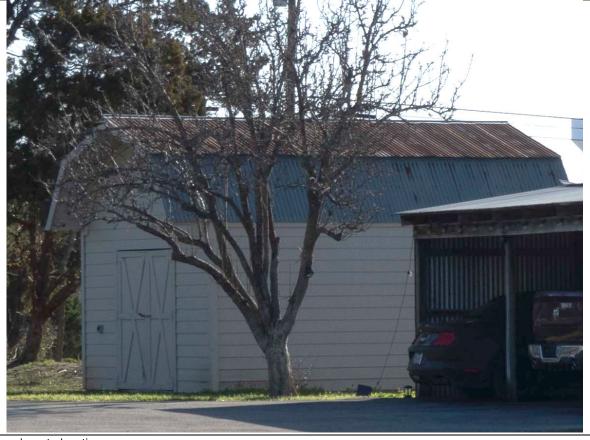
View SE | North and west elevations

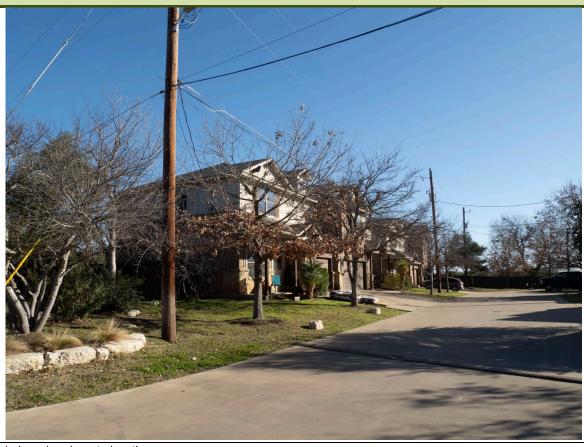
View NE | South (primary) and west elevations

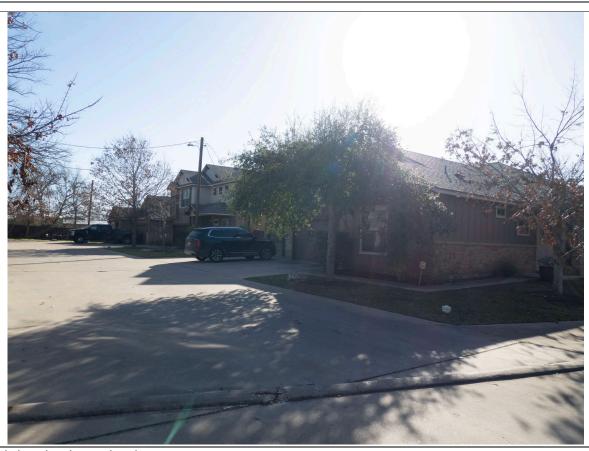
View SE | North (primary) and west elevations

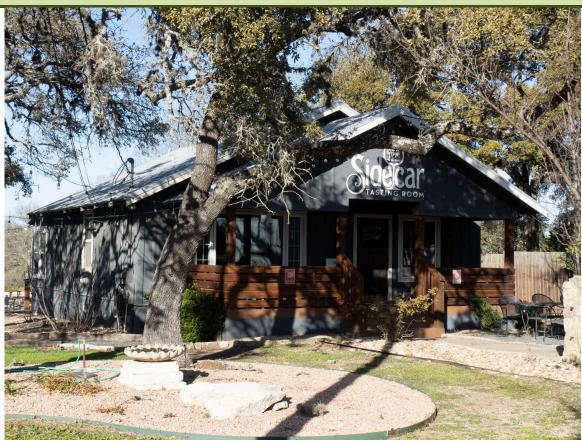
PRIORITY ASSESSMENT
PRIORITY High Medium Low
INTEGRITY   ☐ Location ☐ Setting ☐ Design ☐ Materials ☐ Workmanship ☐ Feeling ☐ Association ☐ Not historic-age
<b>ALTERATIONS</b> Non-historic roof; non-historic windows; non-historic siding; altered front porch gable; non-historic front porch posts/railings.
NOTES Gravel landscaping and parking lots, which cover a significant portion of the parcel, detract from the feeling/assocation of a rural
landscape.
ENDANGERED No Yes

View NW | East (primary) and south elevations

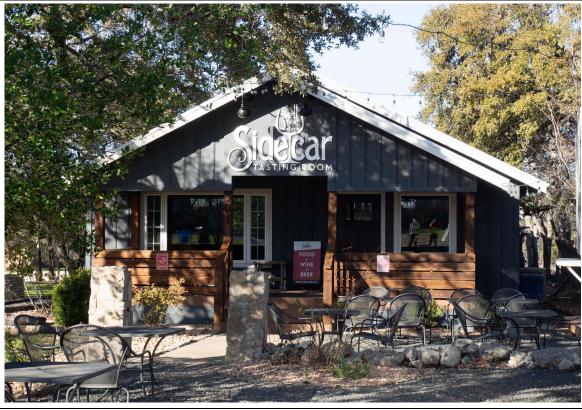
View W | East elevation

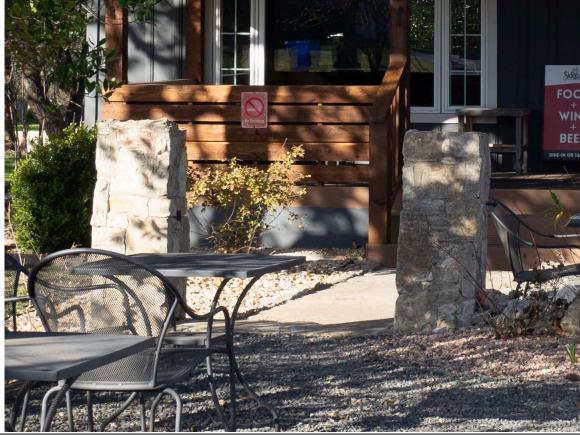
View W | Masonry posts

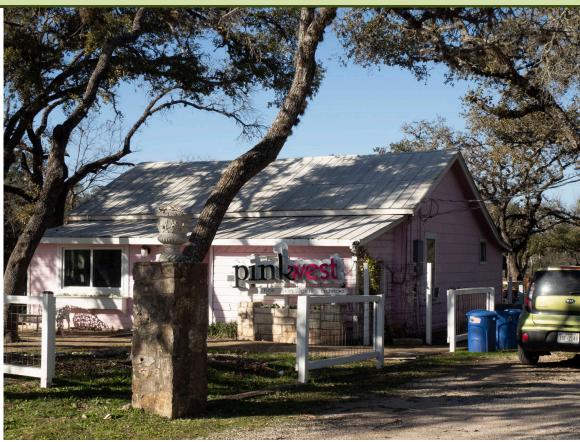
PRIORITY ASSESSMENT
PRIORITY High Medium Low
INTEGRITY  \( \text{Location} \)  \( \text{Setting} \)  \( \text{Design} \)  \( \text{Materials} \)  \( \text{Workmanship} \)  \( \text{Feeling} \)  \( \text{Association} \)  \( \text{Not historic-age} \)
<b>ALTERATIONS</b> Non-historic siding; non-historic windows; enclosed porch (north side pre-2008, south side c. 2015); 2021 west deck addition.
NOTES
ENDANGERED No Yes

View SW | East (primary) and north elevations

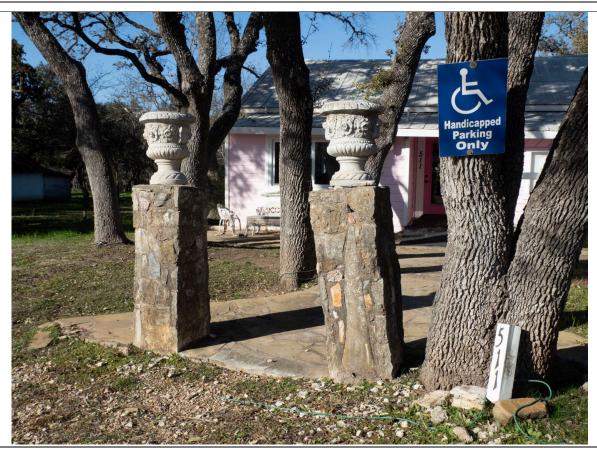
View SW | Masonry posts

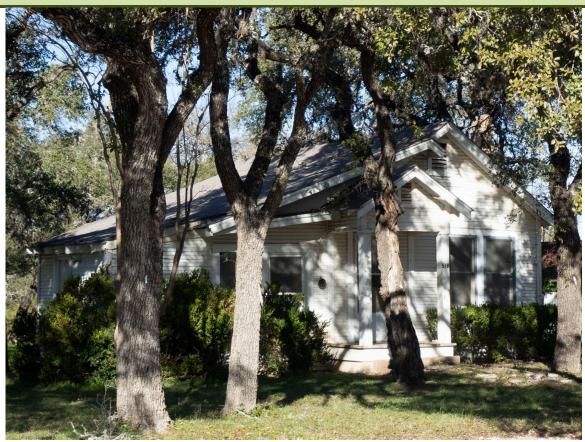
View NW | East (primary) and south elevations

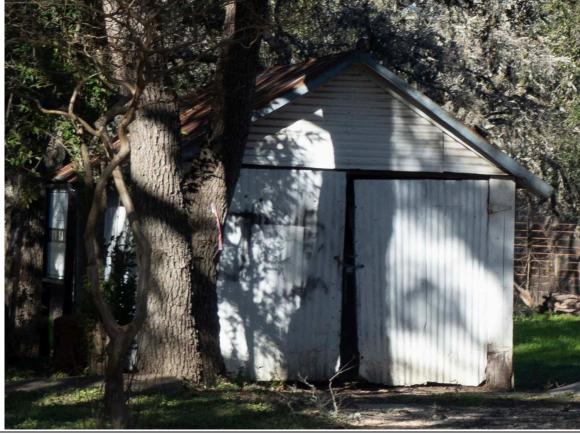
ANCILLARY STRUCTURE #21B	
CATEGORY ⊠Building ☐Site ☐Structure ☐Object	CONSTRUCTION DATE c. 1936
CURRENT USE Garage/shed	HISTORIC USE Garage
NO. OF STORIES 1	EXTERIOR WALL CLADDING Corrugated metal
ROOF TYPE Front gable	ROOF MATERIAL Corrugated metal
<b>NOTES</b> Likely constructed at the same time as the main building.

PRIORITY ASSESSMENT
PRIORITY High Medium Low
INTEGRITY   ☐ Location ☐ Setting ☐ Design ☐ Materials ☐ Workmanship ☐ Feeling ☐ Association ☐ Not historic-age
<b>ALTERATIONS</b> Non-original roof; non-original siding; non-original doors.
NOTES Despite replacement materials, the structure retains importance as one of the few early historic-age automobile-related ancillary
structures to remain extant in the district.
ENDANGERED No Yes

View W | East (primary) elevation

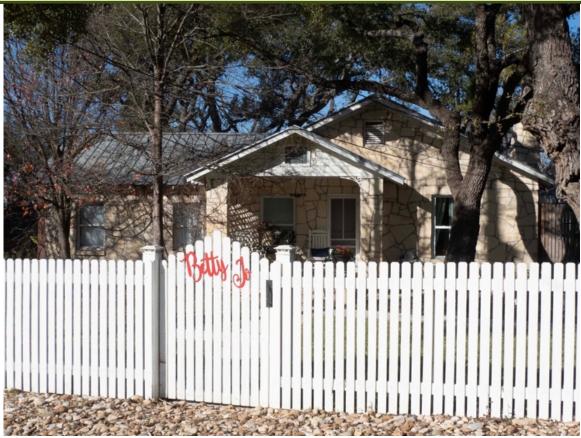
View W | East (primary) elevation

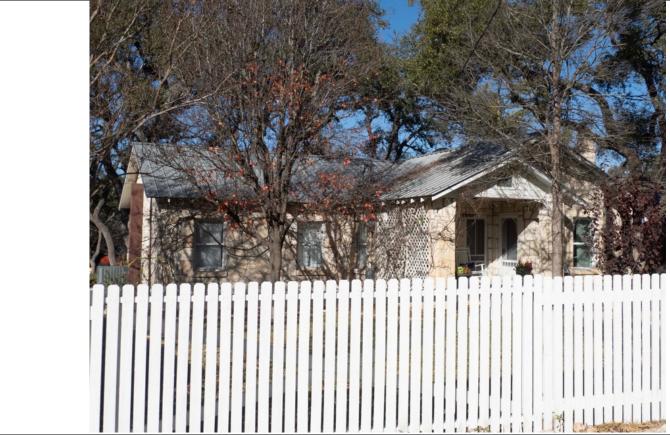
View NW | East (primary) and south elevations

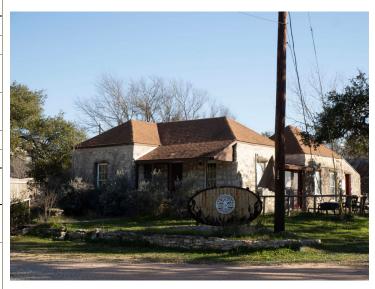
ADDRESS 400 Old Fitzhugh Road	I	
CITY/TOWN Dripping Springs		
COUNTY Hays		STATE TX
HISTORIC NAME John T. Spaw H	louse	
CURRENT NAME n/a		
<b>LAT</b> 30.196538	LONG -98.088	3399
PARCEL# R17925		
<b>LEGAL DESCRIPTION</b> ABS 0415	9-2316-01-17 P A	SMITH SURVEY
0.850 AC GEO#90401234		
OWNER NAME Austin, Bart & Thu	ıanh, T Ho	
OWNER ADDRESS 8517 Steamlin	ne Cir	
Austin, TX 78	745	
HISTORIC USE Domestic / Single	Dwelling	
<b>CURRENT USE</b> Domestic / Single	Dwelling

**ARCHITECTURAL INFORMATION CATEGORY** ⊠Building ☐Site ☐Structure ☐Object ACREAGE 0.850 ARCHITECTURAL STYLE(S) National Folk - Pyramidal Family NO. OF STORIES 1 **PLAN** Compound **ROOF TYPE** Hipped **ROOF MATERIAL** Asphalt shingle WALL CLADDING Coursed square rubble limestone **WINDOWS** ☐ Historic ☐ Replacement WINDOW MATERIAL/CONFIGURATION Vinyl frame, double-hung, 6/6 FRONT PORCH TYPE/PLACEMENT Extends across south half of the west (primary) elevation with a shed roof and wood posts CHARACTER-DEFINING FEATURES Pyramidal roof with little to no eave overhang, coursed square rubble limestone exterior walls LANDSCAPE FEATURES The building sits near the northwest corner of the parcel. A gravel lot covers the southwest corner of the parcel. A low limestone wall separates the building from the gravel lot. A wire metal fence with wood posts encloses a small area along the south elevation of the house. Grass, trees, and shrubs cover the remainder of the parcel. **NOTES** ANCILLARY STRUCTURES No Syes Shed to the east (rear) of the main building, shed to the south of the main building

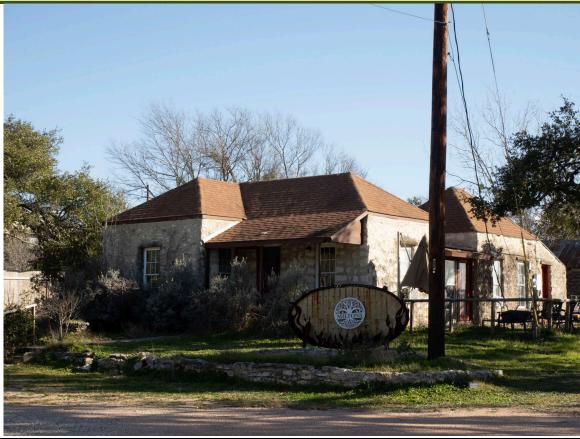
View NE | West (primary) and south elevations

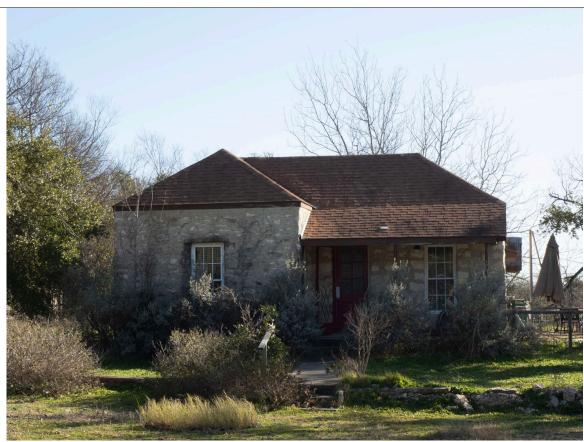
View E | West (primary) elevation

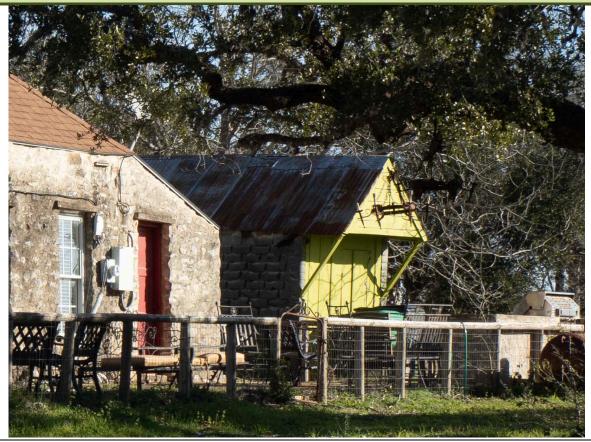
ANCILLARY STRUCTURE #22B		
CATEGORY ⊠Building □Site □Structure □Object	CONSTRUCTION DATE c. 1915	
CURRENT USE Shed	HISTORIC USE Agriculture / Smokehouse	
NO. OF STORIES 1	EXTERIOR WALL CLADDING Asphalt shingle	
ROOF TYPE Gable	ROOF MATERIAL Corrugated metal	
NOTES According to the 2014 Roark survey, this is the last remaining smokehouse located within the survey area. Roark did not assign the		
resource a survey number.

PRIORITY ASSESSMENT
PRIORITY High Medium Low
INTEGRITY   ☐ Location ☐ Setting ☐ Design ☐ Materials ☐ Workmanship ☐ Feeling ☐ Association ☐ Not historic-age
<b>ALTERATIONS</b> It appears the resource may have some replacement siding, but it was difficult to view from the public ROW.
NOTES
ENDANGERED No Yes

View NE | South (primary) and west elevations

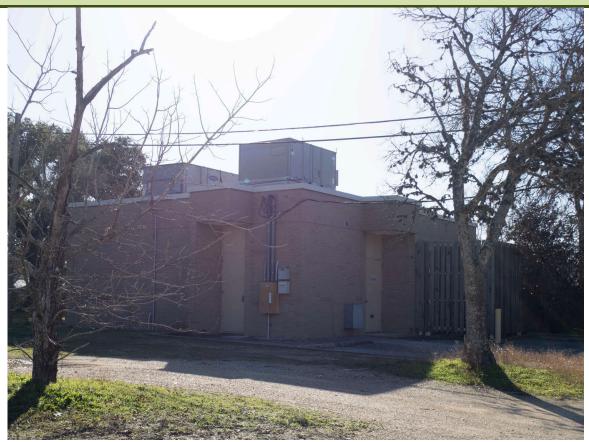
View SE | North and west elevations

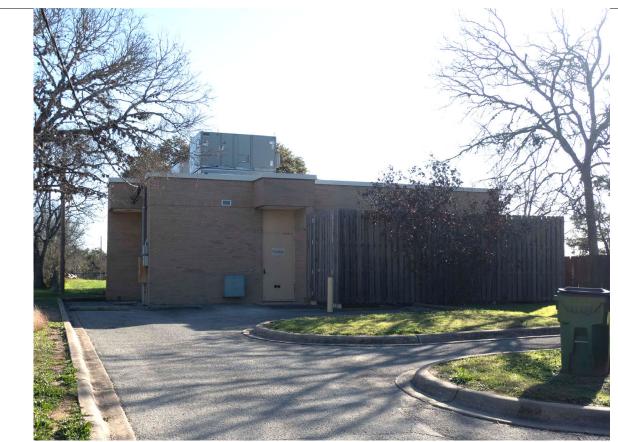
View E | West elevation

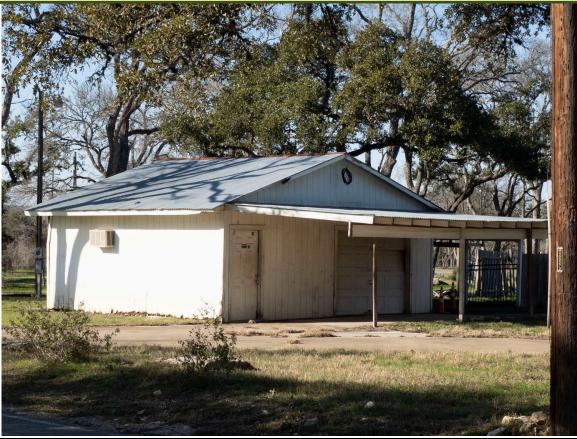
View SW | North and east elevations

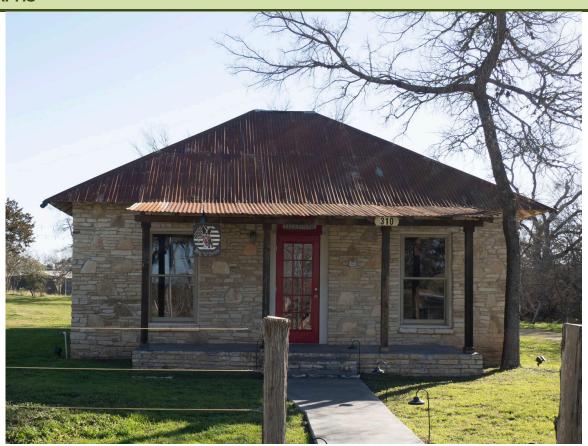
PRIORITY ASSESSMENT
PRIORITY High Medium Low
INTEGRITY ☐ Location ☐ Setting ☐ Design ☐ Materials ☐ Workmanship ☐ Feeling ☐ Association ☐ Not historic-age
<b>ALTERATIONS</b> C. 1962, exterior stone veneer installed; c. 2019, rehabilitated and converted to commercial use.
<b>NOTES</b> The gravel drives and parking lot, which cover a significant portion of the parcel, somewhat detract from the integrity of setting and
the feeling/association of a rural landscape. Potentially eligible for listing on the NRHP due to its association with the early twentieth century
development of telecommunications in Dripping Springs.
ENDANGERED No Yes

View E | West (primary) elevation

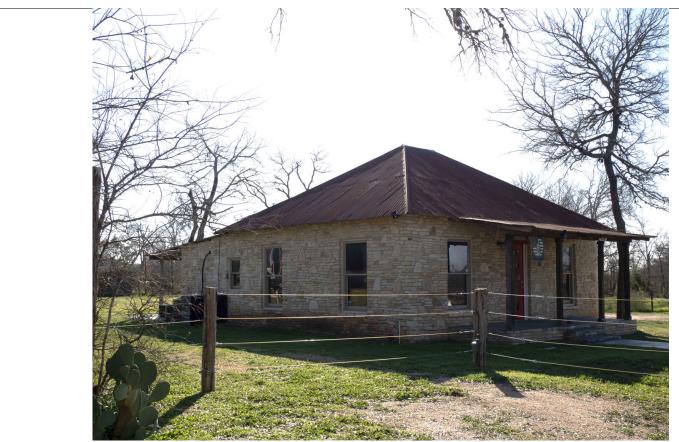
View SE | West (primary) and north elevations

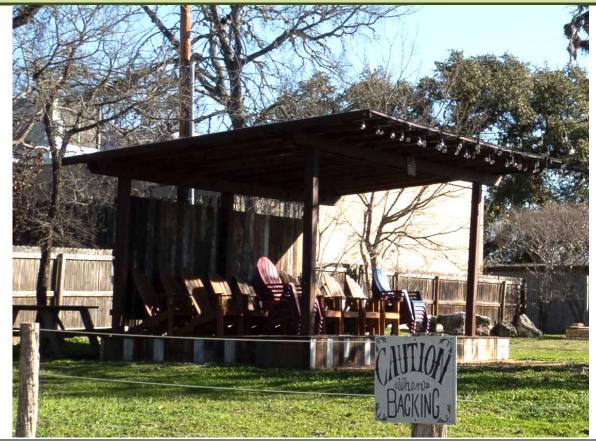
ANCILLARY STRUCTURE #27B	
CATEGORY ☐ Building ☐ Site ☐ Structure ☐ Object	CONSTRUCTION DATE c. 2019
CURRENT USE Recreation	HISTORIC USE n/a, not historic age
NO. OF STORIES 1	EXTERIOR WALL CLADDING Corrugated metal
ROOF TYPE Shed	ROOF MATERIAL Corrugated metal
NOTES	•

View NE | West and south elevations

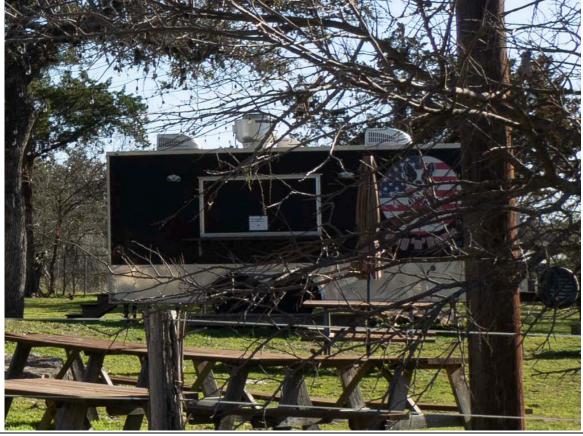
ANCILLARY STRUCTURE #27C	
CATEGORY ☐ Building ☐ Site ☐ Structure ☐ Object	CONSTRUCTION DATE c. 2019
CURRENT USE Commerce / Restaurant (food truck)	HISTORIC USE n/a; not historic-age
NO. OF STORIES 1	EXTERIOR WALL CLADDING Aluminum
ROOF TYPE Flat	ROOF MATERIAL Aluminum
NOTES

View E | West elevation

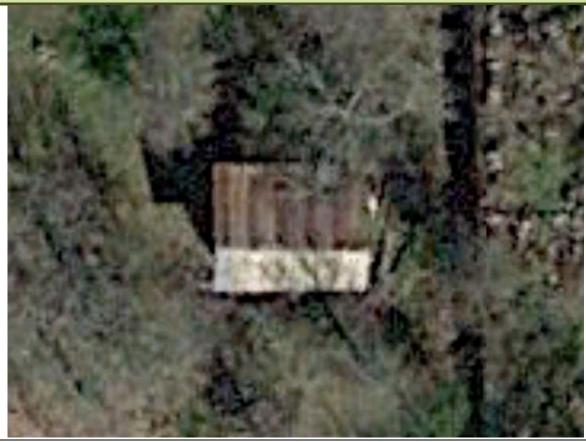
ANCILLARY STRUCTURE #31B	
CATEGORY Building Site Structure Object	CONSTRUCTION DATE Unknown, historic-age
CURRENT USE Outbuilding	HISTORIC USE Outbuilding
NO. OF STORIES 1	EXTERIOR WALL CLADDING Unknown, not visible from ROW
ROOF TYPE Gable	ROOF MATERIAL Corrugated metal
NOTES Along the east (rear) side of the parcel, surrounded by trees, g	rass, and shrubs; limited visibility from OFR.

PRIORITY ASSESSMENT
PRIORITY High Medium Low
INTEGRITY   ☐ Location ☐ Setting ☐ Design ☐ Materials ☐ Workmanship ☐ Feeling ☐ Association ☐ Not historic-age
ALTERATIONS Unknown - not visible from public ROW.
NOTES Building appears on 1962 historic aerial photograph.
ENDANGERED No Yes

Google Earth 2017 Aerial | Roof

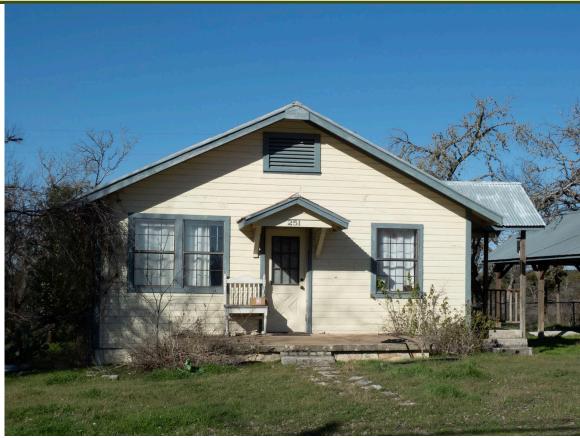
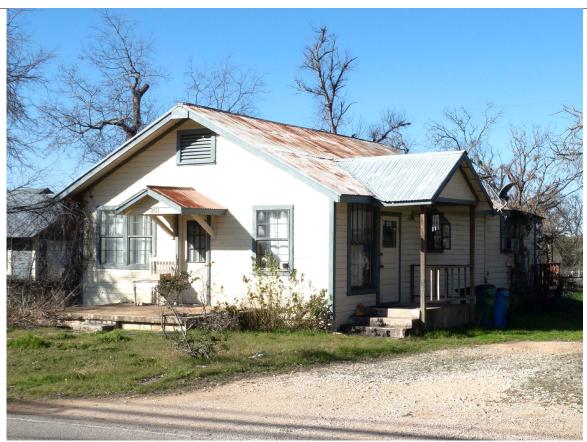
PRIORITY ASSESSMENT
PRIORITY High Medium Low
INTEGRITY ☐ Location ☐ Setting ☐ Design ☐ Materials ☐ Workmanship ☐ Feeling ☐ Association ☐ Not historic-age
<b>ALTERATIONS</b> Non-original windows; non-original front door; possible historic-age rear addition and side porch on north elevation.
NOTES
ENDANGERED No Yes

View W | East (primary) elevation

View SW | East (primary) and north elevations

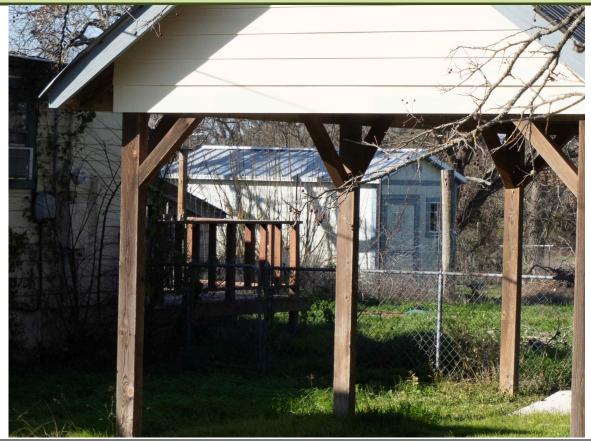
ANCILLARY STRUCTURE #32C	
CATEGORY ⊠Building □Site □Structure □Object	CONSTRUCTION DATE c. 2000
CURRENT USE Shed	HISTORIC USE n/a; not historic-age
NO. OF STORIES 1	EXTERIOR WALL CLADDING Vertical wood plank
ROOF TYPE Gable	ROOF MATERIAL Corrugated metal
NOTES

View SW | East and north elevations

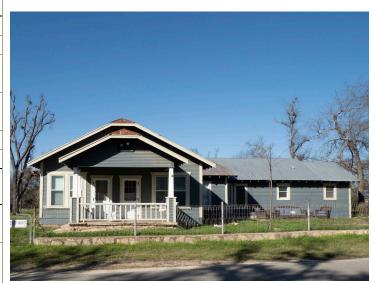
ADDRESS 215 Old Fitzhugh Road		
CITY/TOWN Dripping Springs		
COUNTY Hays		STATE TX
HISTORIC NAME K. M. Davis Hou	ise	
CURRENT NAME n/a		
<b>LAT</b> 30.194724	LONG -98.089	9560
PARCEL# R17921		
<b>LEGAL DESCRIPTION</b> ABS 415 9	-2316-02-19 P A S	SMITH SURVEY
1.789 AC GEO#90401229		
OWNER NAME 215 Old Fitzhugh	Limited Partnersh	ip
<b>OWNER ADDRESS</b> 350 Dripping	Springs Ranch RI	D
Dripping Spri	ngs, TX 78620	
<b>HISTORIC USE</b> Domestic / Single	Dwelling	
<b>CURRENT USE</b> Domestic / Single	Dwelling

**ARCHITECTURAL INFORMATION** CATEGORY Building Site Structure Object **ACREAGE** 1.789 ARCHITECTURAL STYLE(S) Craftsman NO. OF STORIES 1 **PLAN** L-plan **ROOF TYPE** Cross gable **ROOF MATERIAL** Corrugated metal WALL CLADDING Wood clapboard, limestone veneer on **WINDOWS** ⊠Historic ☐Replacement addition west (rear) elevation WINDOW MATERIAL/CONFIGURATION Wood frame, double hung, 1/1 with non-historic exterior aluminum frame storm windows FRONT PORCH TYPE/PLACEMENT Centered on the historic east (primary) elevation with a clipped front gable roof, tapered wood posts, non-original wood railings, and a concrete deck with limestone apron. CHARACTER-DEFINING FEATURES Exposed rafter tails, tapered porch posts, clipped roof gables, projecting front porch LANDSCAPE FEATURES The building sits near the northeast corner of the parcel. A wire fence atop a low limestone wall extends along the east side of the parcel between the house and OFR. A gravel drive extends from OFR to the south of the building. A stone sidewalk leads from the drive to the west (rear) elevation entrance. Grass covers the remainder of the parcel with some scattered trees. **NOTES** The house has two side-by-side primary entrances on the east elevation. Both doors are replacements. ANCILLARY STRUCTURES No Syes I. V. Davis, Jr. House Addition near the southeast corner of the parcel, shed to the west of the main building

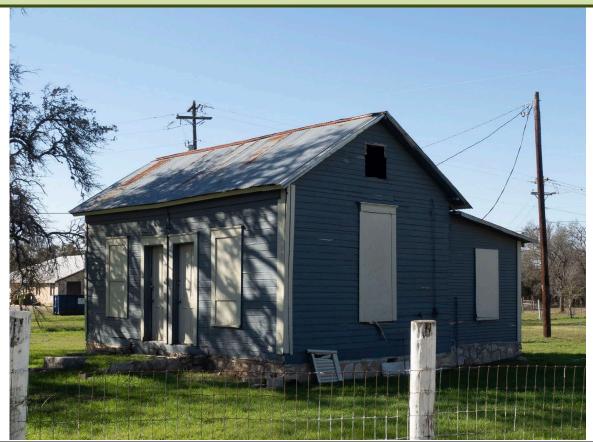
PRIORITY ASSESSMENT
PRIORITY Medium Low
INTEGRITY   ☐ Location ☐ Setting ☐ Design ☐ Materials ☐ Workmanship ☐ Feeling ☐ Association ☐ Not historic-age
<b>ALTERATIONS</b> Loss of the main portion of the house occurred during the period of significance. Additional alterations include replacement
front doors and concealed windows.
NOTES This building is one of the oldest remaining dwellings in the area, and retains its limestone foundation and most of its original
clapboard siding.
ENDANGERED No Yes

View SW | East (primary) and north elevations

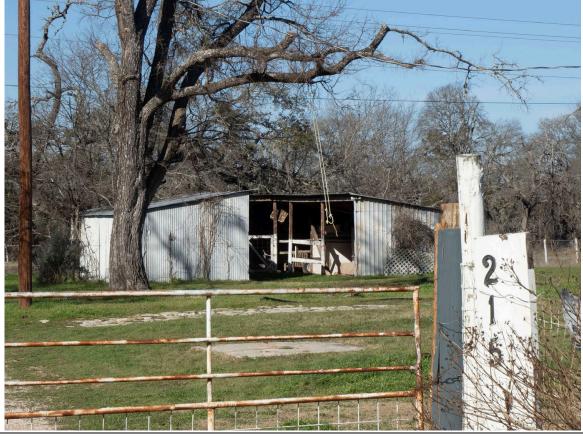
ANCILLARY STRUCTURE #33C				
CATEGORY ⊠Building □Site □Structure □Object	CONSTRUCTION DATE c. 1970			
CURRENT USE Shed	HISTORIC USE Agriculture / Shed			
NO. OF STORIES 1	EXTERIOR WALL CLADDING Corrugated metal			
ROOF TYPE Shed	ROOF MATERIAL Corrugated metal			
NOTES Although one of the few remaining agricultural outbuildings in the study area, this structure was constructed ca. 1970 and does not				
have associations with the early development of the property.

View W | East elevation

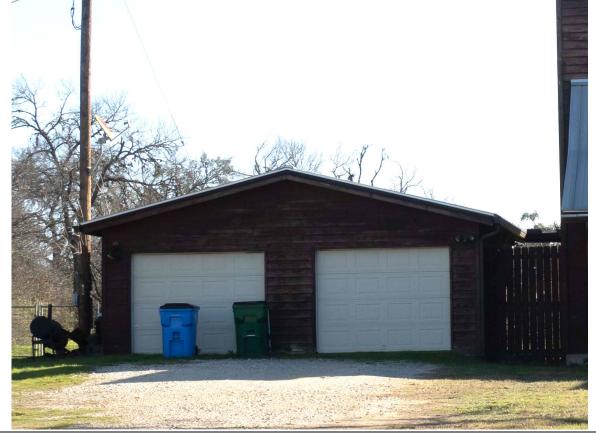
ANCILLARY STRUCTURE #34B	
CATEGORY ⊠Building ☐Site ☐Structure ☐Object	CONSTRUCTION DATE 2003
CURRENT USE Garage	HISTORIC USE n/a, not historic age
NO. OF STORIES 1	EXTERIOR WALL CLADDING Wood clapboard
ROOF TYPE Front gable	ROOF MATERIAL Corrugated metal
NOTES

View E | West (primary) elevation

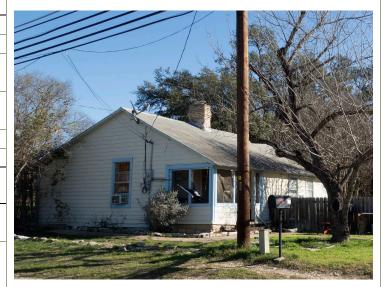
ADDRESS 150 Old Fitzhugh Road			
CITY/TOWN Dripping Springs			
COUNTY Hays	STATE TX		
HISTORIC NAME I.C.P/ McLendon House	e		
CURRENT NAME n/a			
<b>LAT</b> 30.194211 <b>LON</b>	<b>G</b> -98.089213		
PARCEL# R23576			
LEGAL DESCRIPTION WIT CHAPMAN #	#2 BLK N PT 6 ABS 415 PA		
SMITH AC 0.28 9-2210-03-02 GEO#9040	3766		
OWNER NAME Scott, John Jr			
OWNER ADDRESS PO Box 115			
Dripping Springs, TX	( 78620		
HISTORIC USE Domestic / Single Dwellin	ng; Industry / Communications		
CURRENT USE Domestic / Single Dwelling

ARCHITECTURAL INFORMATION			
CATEGORY Building Site Structure Object	ACREAGE 0.28		
ARCHITECTURAL STYLE(S) National Folk - Massed-Plan			
NO. OF STORIES 1	PLAN Rectangular		
ROOF TYPE Gable	ROOF MATERIAL Corrugated Metal		
WALL CLADDING Aluminum lap siding	WINDOWS ⊠Historic □Replacement		
WINDOW MATERIAL/CONFIGURATION Wood frame, double https://doi.org/10.1001/journal.com/state/10.10	ung, 2/2. Non-historic metal storms cover all windows.		
FRONT PORCH TYPE/PLACEMENT Recessed into the southwest	st corner of the building. Infilled since the 1988 HHM survey.		
CHARACTER-DEFINING FEATURES Pitched gable roof, central limestone chimney, minimal detailing			
LANDSCAPE FEATURES The building sits at the northwest corner of the parcel. A gravel drive leads from OFR to the garage. A wood			
privacy fence surrounds the yard to the south and east of the main building. Grass covers the remainder of the parcel with trees along the

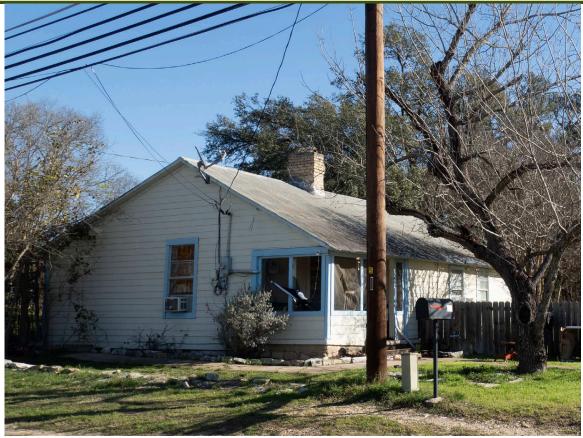
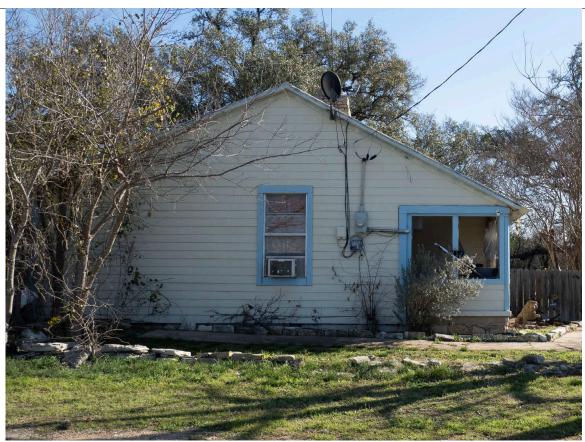
PRIORITI ASSESSMENT
PRIORITY High Medium Low
INTEGRITY
<b>ALTERATIONS</b> Post-1988, infilled front porch; non-original aluminum lap siding; non-original window and door surrounds.
<b>NOTES</b> Despite alterations to the porch and materials, the property retains high priority as one of the oldest extant dwellings in the district
and for its association with the early development of telecommunications in Dripping Springs.
ENDANGERED ☐ No ☐ Yes Building is leaning/sinking

View NE | West and south elevations

View E | West elevation
