#### **Historic Preservation Commission Regular Meeting - Amended**

City of Dripping Springs Council Chambers
511 Mercer Street – Dripping Springs, Texas
Thursday, May 02, 2024, at 4:00 PM

# Old Fitzhugh Road Local Historic District Resurvey Historic Resources Survey Report

Project Limits: Old Fitzhugh Road Historic District

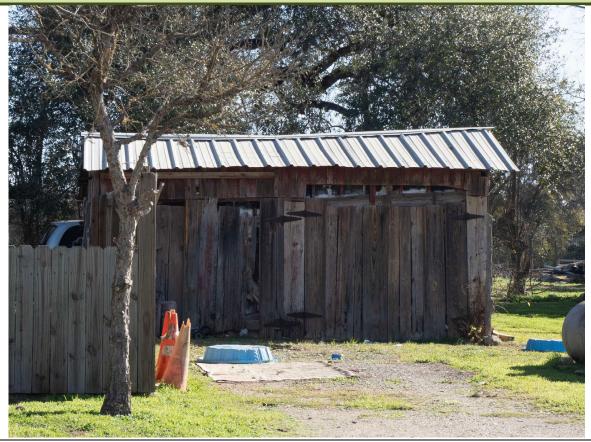
PRIORITY ASSESSMENT
PRIORITY High Medium Low
INTEGRITY   ☐ Location ☐ Setting ☐ Design ☐ Materials ☐ Workmanship ☐ Feeling ☐ Association ☐ Not historic-age
<b>ALTERATIONS</b> Replacement roof; non-original wood plank doors cover what appear to be historic wood doors with glazing.
NOTES
ENDANGERED No Yes

View E | West elevation

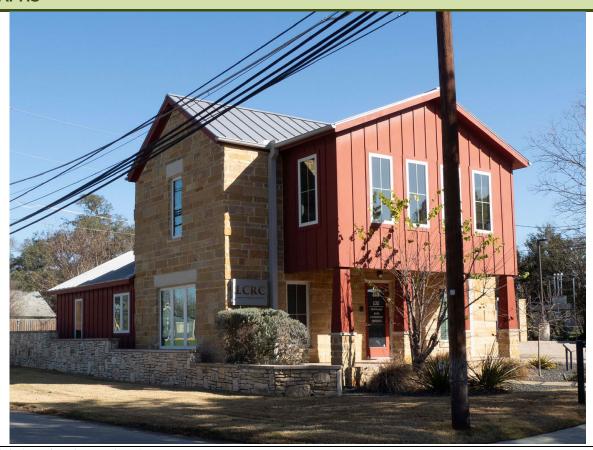
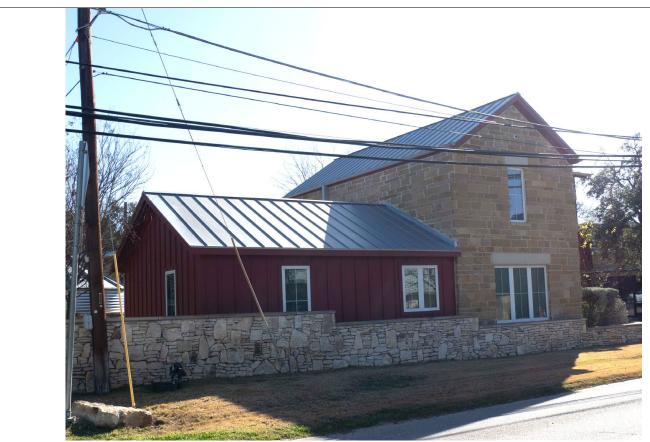
PRIORITY ASSESSMENT
PRIORITY ☐ High ☐ Medium ☐ Low
INTEGRITY \( \subseteq \text{Location} \subseteq \text{Setting } \subseteq \text{Design } \subseteq \text{Materials } \subseteq \text{Workmanship } \subseteq \text{Feeling } \subseteq \text{Association } \subseteq \text{Not historic-age}
<b>ALTERATIONS</b> Original building was remodeled and extensively altered beyond recognition c. 2016. Current structure retains similar form
and massing, but materials and proportions have been changed. Current building is unrecognizable as an historic 1881 boarding house and residence.
NOTES
ENDANGERED No Yes

View NE | South (primary) and west elevations

View SE | North and west elevations

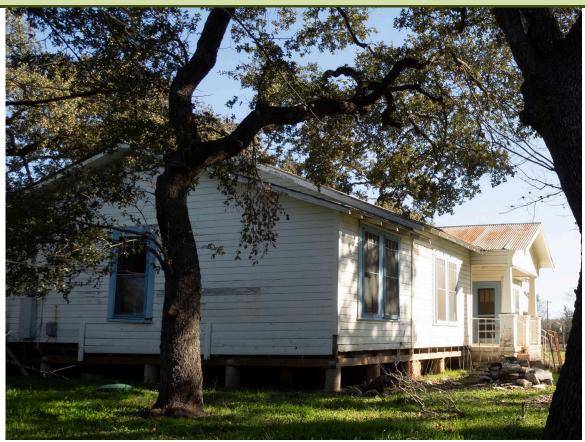
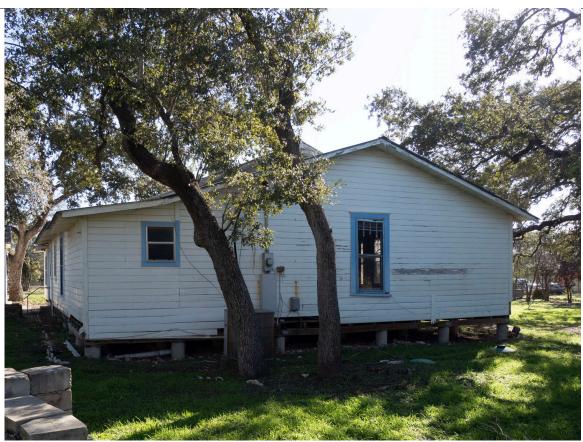
**ALTERATIONS** Possible early alterations prior to 1930; non-historic carport on north elevation; non-original porch railings; c. 2016, historic foundation removed and replaced with concrete piers

**ENDANGERED** No Yes; Structural issues appear to have been addressed c. 2016 with concrete foundation piers. However, lower clapboards have not been replaced, leaving the apron and lower walls exposed to the elements and susceptible to rot and deterioration.

View NE | South (primary) and west elevations

View SE | North and west elevations

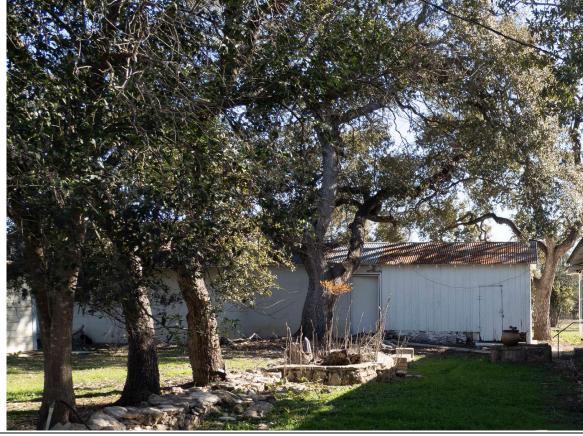
ANCILLARY STRUCTURE #38B	
CATEGORY Building Site Structure Object	CONSTRUCTION DATE c. 1925
CURRENT USE Outbuilding	HISTORIC USE Outbuilding
NO. OF STORIES 1	EXTERIOR WALL CLADDING Vertical wood plank
ROOF TYPE Gable	ROOF MATERIAL Corrugated metal
NOTES Associated with 1920s Crenshaw homestead and subsistence	farm/ranch

PRIORITY ASSESSMENT
PRIORITY High Medium Low
INTEGRITY   ☐ Location ☐ Setting ☐ Design ☐ Materials ☐ Workmanship ☐ Feeling ☐ Association ☐ Not historic-age
ALTERATIONS No significant alterations noted.
NOTES
ENDANGERED No Yes

View E | West elevation

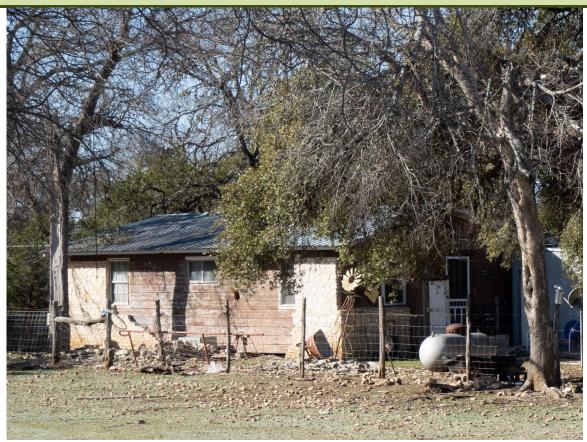
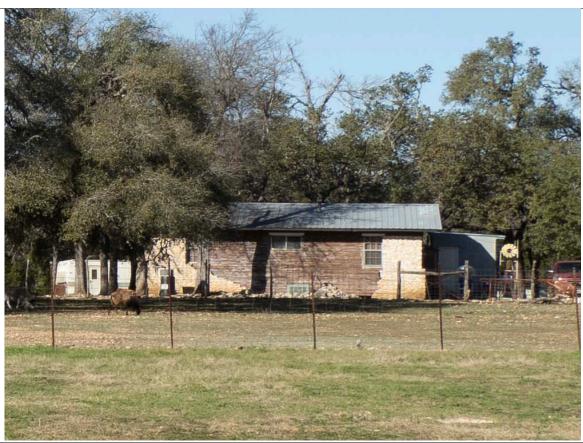
PRIORITY ASSESSMENT
PRIORITY High Medium Low
INTEGRITY   ☐ Location ☐ Setting ☐ Design ☐ Materials ☐ Workmanship ☐ Feeling ☐ Association
<b>ALTERATIONS</b> Much of the masonry veneer is in disrepair and is crumbling from the building's exterior. There appears to be a shed roof
addition on the north elevation.
<b>ENDANGERED</b> ☐No ☐Yes Deteriorated cladding has left the building structure exposed to the elements

View SW | North and east elevations

View W | East elevation

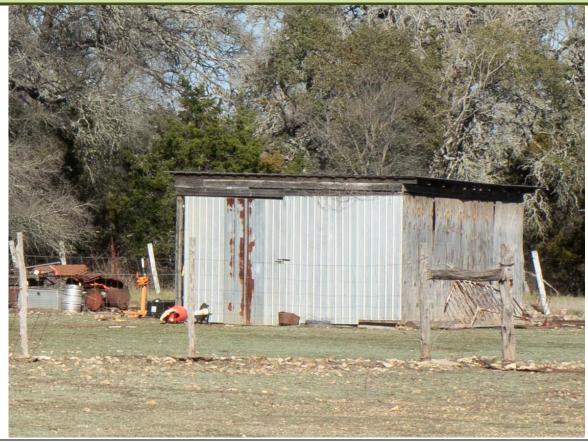
CONSTRUCTION DATE c. 1975
HISTORIC USE n/a; not historic-age
<b>EXTERIOR WALL CLADDING</b> Corrugated metal, plywood panels
ROOF MATERIAL Corrugated metal

PRIORITY ASSESSMENT
PRIORITY High Medium Low
INTEGRITY □Location □Setting □Design □Materials □Workmanship □Feeling □Association ☑Not historic-age
ALTERATIONS Not historic-age; replacement siding.
NOTES
ENDANGERED No Yes

View NW | East and south elevations

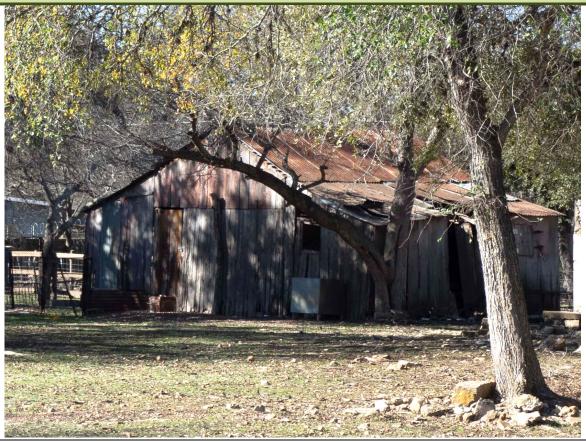
PRIORITY ASSESSMENT
PRIORITY High Medium Low
INTEGRITY   ☐ Location ☐ Setting ☐ Design ☐ Materials ☐ Workmanship ☐ Feeling ☐ Association ☐ Not historic-age
<b>ALTERATIONS</b> No significant alterations noted, some missing roof material.
NOTES
ENDANGERED No Yes

View SW | North and east elevations

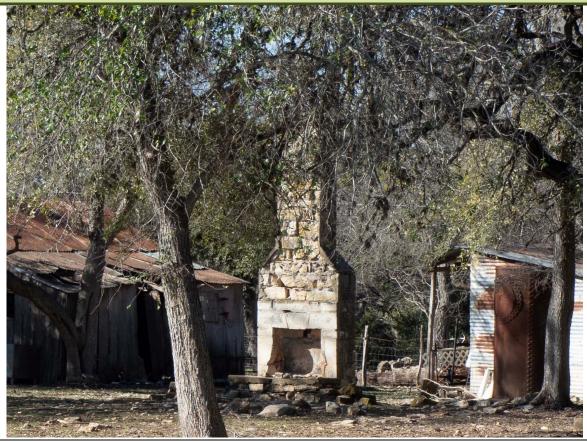
PRIORITY ASSESSMENT
PRIORITY High Medium Low
INTEGRITY   ☐ Location ☐ Setting ☐ Design ☐ Materials ☐ Workmanship ☐ Feeling ☐ Association ☐ Not historic-age
<b>ALTERATIONS</b> This limestone chimney is all that remains of a former residence.
NOTES
ENDANGERED ☐ No ☐ Yes Ruins, at risk of further deterioration/demolition.

View SW | East elevation
