Historic Preservation Commission Regular Meeting

City of Dripping Springs Council Chambers 511 Mercer Street – Dripping Springs, Texas Thursday, April 04, 2024, at 4:00 PM

- **2.** Discuss and consider possible action regarding the Historic Preservation Commission Fiscal Year 2025 Budget Recommendation.
- **<u>3.</u>** Presentation, discussion, and consideration of acceptance of the Old Fitzhugh Road Local Historic District Resurvey Historic Resources Survey Report.
- **4.** Public hearing and consideration of approval of COA2024-0002: Application for Certificate of Appropriateness for the the addition of a covered entrance and roof line alterations for the existing building located at 575 Old Fitzhugh Road in the Old Fitzhugh Road Historic District. *Applicant: McKena & Bryan Strobel*
 - a. Presentationb. Staff Reportc. Public Hearingd. COA2024-0002

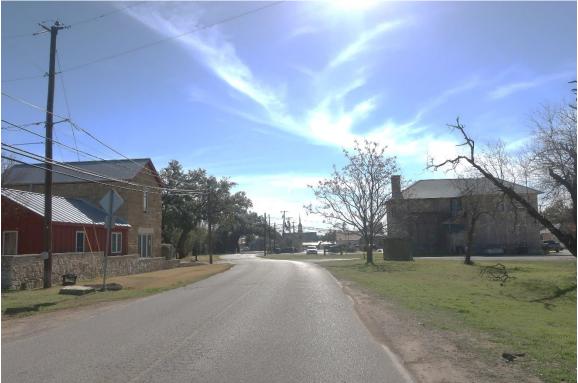
Photo 8: Streetscape along OFR at southern edge of district boundary showing Resource 37A at right, view south.

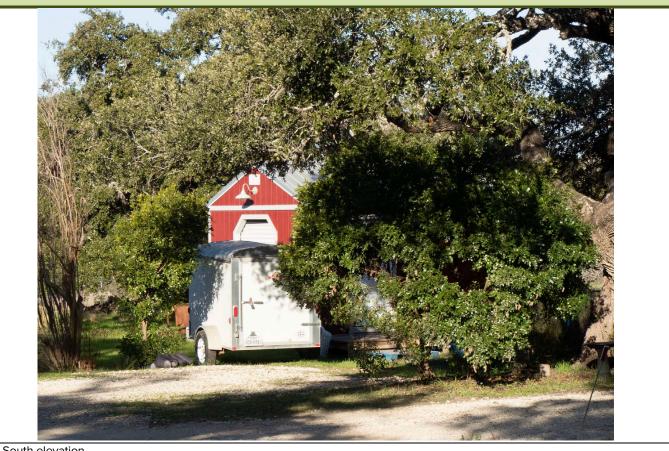
PRIORITY ASSESSMENT
PRIORITY High Medium Low
INTEGRITY Location Setting Design Materials Workmanship Feeling Association Not historic-age
ALTERATIONS Not historic-age; no alterations noted.
NOTES

View NE | South elevation

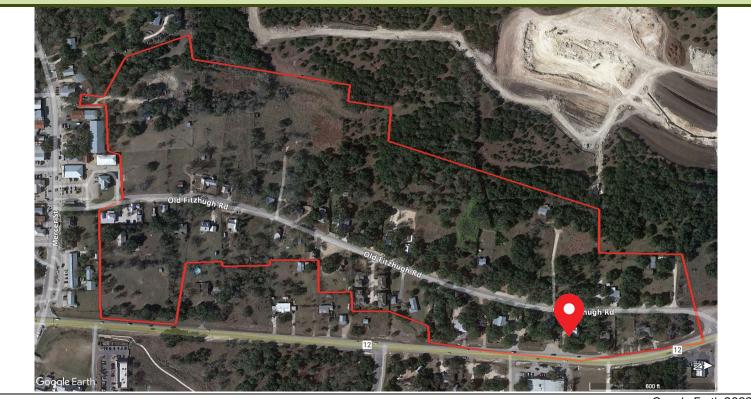
Google Earth 2023

PRIORITY High Medium Low
INTEGRITY Location Setting Design Materials Workmanship Feeling Association Not historic-age
ALTERATIONS C. 2015, moved from original location on Rainey Street in Austin; c. 2016, concrete foundation and east/west elevation
porches added.
NOTES Moved outside the period of significance.

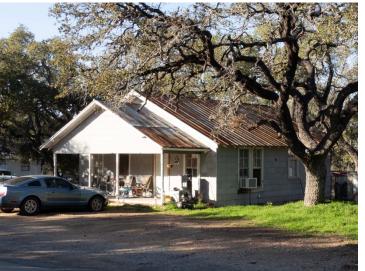
ADDRESS 730 Old Fitzhugh Road	, 801 Old Fitzhugl	n Road	Ser. 3
CITY/TOWN Dripping Springs			
COUNTY Hays STATE TX			
HISTORIC NAME William Roberts	House		
CURRENT NAME n/a			
LAT 30.199535	LONG -98.087	7931	
PARCEL# R17905, R17906		- Can	
LEGAL DESCRIPTION A0415 PH	ILIP A SMITH SU	RVEY, ACRES 1.00,	
A0415 PHILIP A SMITH SURVEY, AC	RES 0.32		
OWNER NAME Katter LLC			
OWNER ADDRESS 130 Dream Lr	1		and the second second
Concord, VT	05824-9697		
HISTORIC USE Domestic / Single	Dwelling		1

ATEGORY Building Site Structure Object	
ARCHITECTURAL STYLE(S) Vernacular Craftsman	
NO. OF STORIES 1 PLAN Rectangular	
ROOF TYPE Gable	ROOF MATERIAL Standing-seam metal, corrugated metal on porch
WALL CLADDING Asbestos shingle WINDOWS Historic Replacement	
WINDOW MATERIAL/CONFIGURATION Wood sash, doub	le-hung, 4/4
FRONT PORCH TYPE/PLACEMENT Full front porch with fro	ont gable roof, square wood columns, and concrete slab base.
CHARACTER-DEFINING FEATURES Minimal detailing, exp LANDSCAPE FEATURES The building sits near the east side located between the building and the road. A garage sits to the	osed rafter tails e of the parcel, close to Old Fitzhugh Road. A gravel-covered parking area is north of the building and a second dwelling sits to the south. A gravel drive
CHARACTER-DEFINING FEATURES Minimal detailing, exp LANDSCAPE FEATURES The building sits near the east side	osed rafter tails e of the parcel, close to Old Fitzhugh Road. A gravel-covered parking area is north of the building and a second dwelling sits to the south. A gravel drive

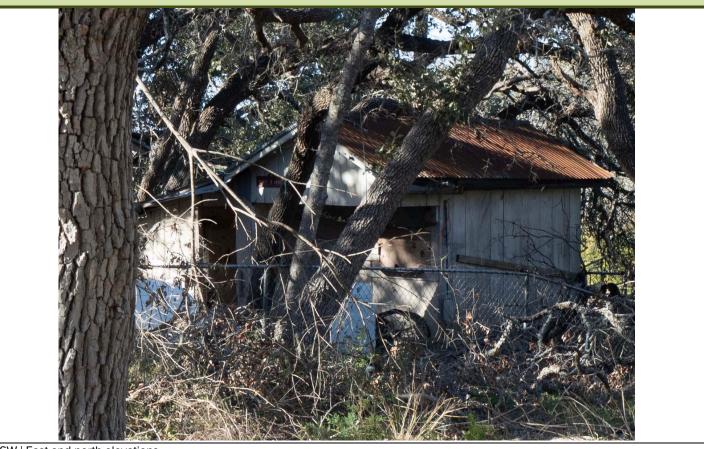
cation 🛛 Setting 🖾 Design 🖾 Materials 🖾 Workmanship 🖾 Feeling 🖾 Association 🗌 Not historic-age
ALTERATIONS	bes not appear to have any substantial alterations, although siding and roof material may have been updated over time.
NOTES	
ENDANGERED	No lyres

View SW | East and north elevations

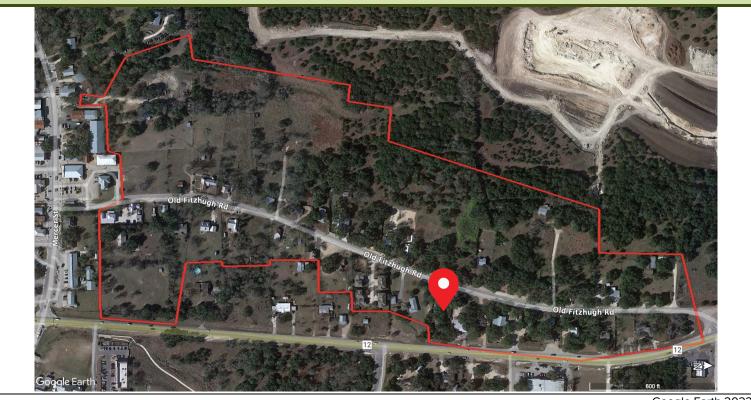
Google Earth 2023

PRIORITY High Medium Low
INTEGRITY
ALTERATIONS Non-original foundation.
NOTES It is unknown if the building was moved within the period of significance.

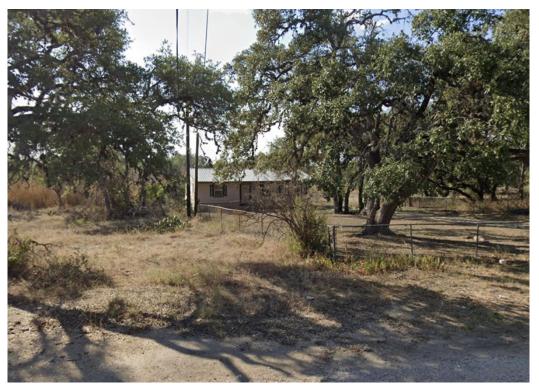
575 OFR: "Current Condition". Images from Google Maps, 2023.
