**OAK HOLLOW/SHEFFIELD VILLAGE PUBLIC
IMPROVEMENT DISTRICT BOARD MEETING
CROSSPOINT CHURCH OF CHRIST, 3020 BARDIN ROAD
THURSDAY, MAY 16, 2024 AT 6:30 PM**

TITLE: Discuss the Engineering report from Lerch Bates on the condition of the wall that runs along Magna Carta Blvd and Claremont Drive.

R01000050391
Sheffield Village Screen Wall –
Grand Prairie, Texas

PROJECT NUMBER: R0100050391
PROJECT NAME: Sheffield Village Screen Wall
PROJECT LOCATION: Grand Prairie, Texas

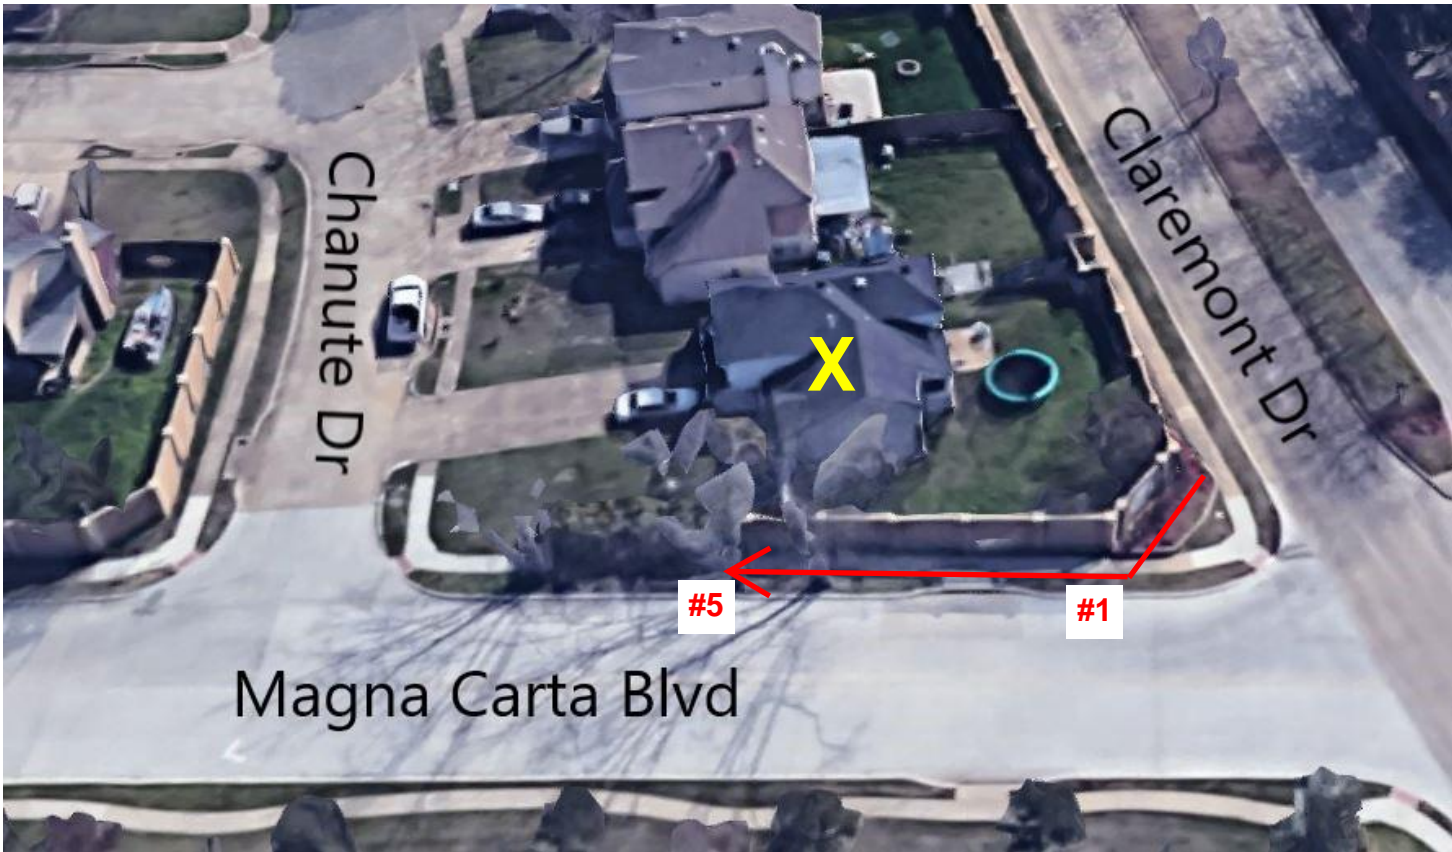
Section 1

- Eight (8) panels and nine (9) columns spanning 84 feet of Section 1, inclusive of a monument sign on the corner of Magna Carta Boulevard and Claremont Drive (**Figures 1 - 2**). Panel 1 started to the north of the monument sign, continuing north on Magna Carta Boulevard to Chanute Drive.
- Separations between the monument sign panel, adjacent columns, and adjacent panels (**Figures 3 - 4**).
- Raised landscape bed adjacent to the southwest face (street side) of the monument sign panel (**Figure 5**).
- All columns visibly leaning.
- Cracks and separations at the mow strips and column foundations. Upward displacement of the mow strips and trees were observed at these locations (**Figures 6 - 7**).

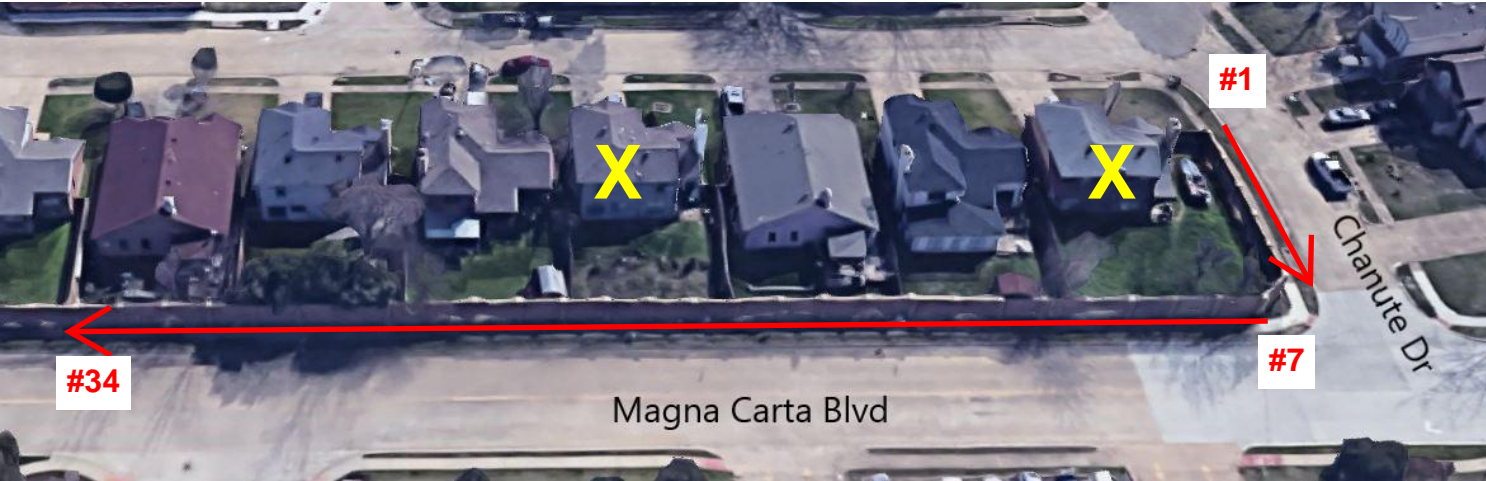
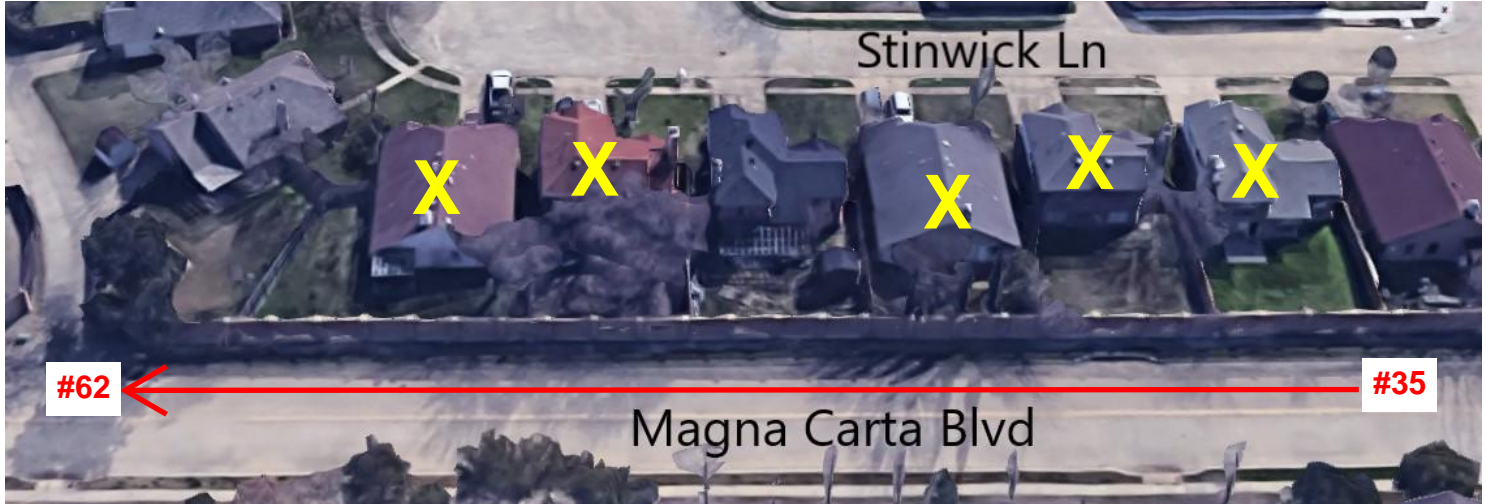
Section 2

- Consisted of 62 panels and 63 columns spanning approximately 830 feet from Chanute Drive to the south alley entrance of Spinner Lane. Panels 1 through 6 spanned east-west along Chanute Drive, and panels 7 through 62 continued north along Magna Carta Boulevard.
- Out-of-plumb columns with separations between columns and adjacent panels.
- Cracks and upward movement at the mow strip along the entire length of the wall with separations between the columns and wall panels (**Figures 11 - 14**).
- Reported previous repairs at the mow strip of 4133 Stinwick Lane to 4117 Stinwick Lane. Cracking at the mow strip and separations between the mow strip and adjacent column foundations were observed (**Figures 15 - 16**).
