## Historic Preservation Commission Regular Meeting

- 2. Public hearing and consideration of approval of COA2024-011: Application for a Certificate of Appropriateness for Phase 1 Stabilization of the home located at 100 Old Fitzhugh Rd in the Old Fitzhugh Rd Historic District. Applicant: Pamela Bosco.**
  1. Presentation
  2. Staff Report
  3. Public Hearing
  4. COA2024-0011
- 3. Presentation on Stars of Dripping Springs Public Art Project. Lisa Sullivan, People & Communications Director**
- 4. Update on Downtown Restrooms Project. Michelle Fischer, City Administrator**

100 Old Fitzhugh Road structure is a house constructed in the mid to late 1920s with later mid-century additions and minor alterations. The current condition of the home is poor after years of water and pest damage and needs to be stabilized before Phase 2, finishes.

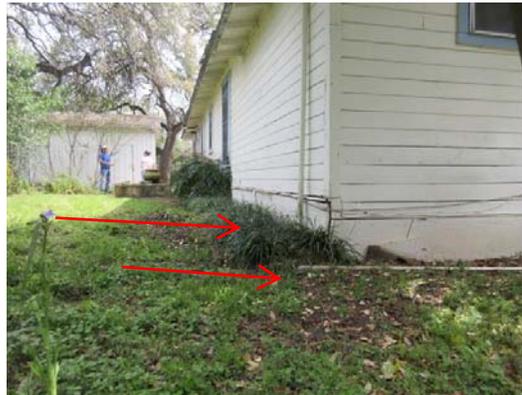
**Water pooling:** There are low areas at various locations around the foundation perimeter where water may be pooling when it rains. In some cases expansion and contraction of soils around the foundation can cause foundation issues.

**Grade higher than crawlspace:** It appears that the exterior grade is higher than the crawlspace. This may be causing water to enter the crawlspace. Water may be pooling at the footings/piers at some locations. This may contribute to uneven expansion of the soil under the piers which can cause foundation movement. Grading and/or drainage may need to be improved to prevent water from entering the crawlspace.

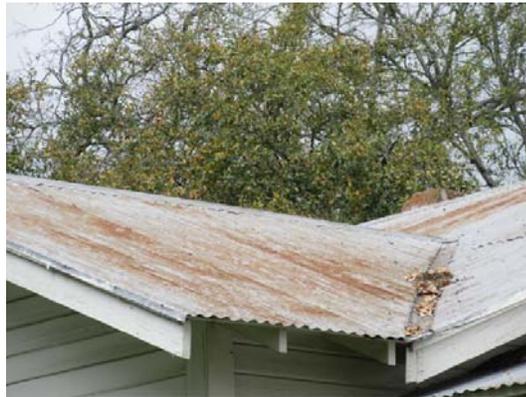
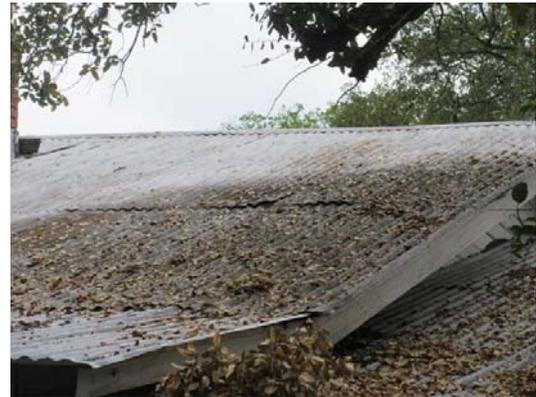
**Possible roof leak:** There appears to be evidence of a roof leak at the left back roof slope over master bathroom. Water evidence was observed at the bathroom ceiling. Recommend confirmation by a roofing contractor and repair as necessary.

**Possible roof leak at valleys:** There appears to be evidence of roof leaks at the roof valleys. Water evidence was observed in the attic at framing. Recommend confirmation by a roofing contractor and repair as necessary.

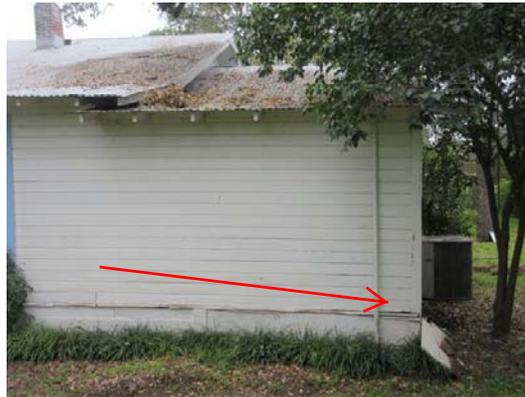
**Siding damage:** Siding shows signs of damage and is loose in one area at the left side of the house.

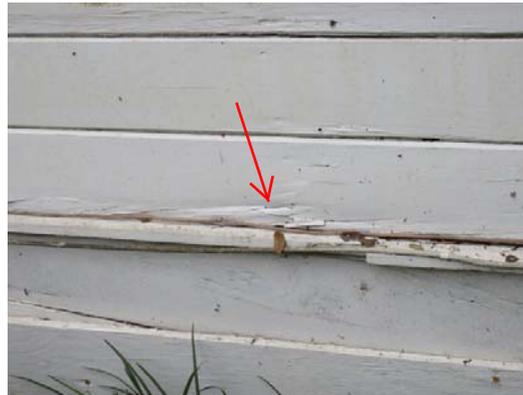
**Moisture barrier missing:** There does not appear to be a moisture barrier behind exterior siding. This is not uncommon with homes from this era.

**Insulation missing:** There doesn't appear to be any insulation in some of the walls. Any wall where insulation is missing has no thermal barrier, which can effect energy usage and comfort.

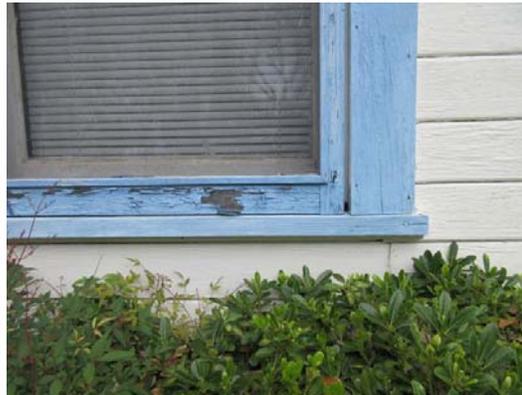
**Windows in poor condition:** The windows are older wood frame windows which appear to be in poor condition. Windows are damaged, leaky and drafty. In addition, the glass in some of the windows is loose and some wood rot was observed.

**Windows do not open:** Some windows are inoperable and do not open. Bedroom windows should be operable so they can be used as an escape in the event of an emergency.

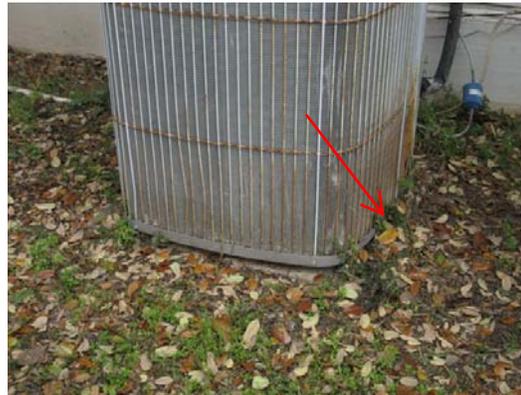
**Fins are damaged:** The AC compressor fins are bent and damaged. This does not appear to be effecting performance at this time.

**Suction line insulation:** The insulation on the suction line at the compressor is damaged and/or does not cover the suction line properly. Properly insulating this line helps with efficiency and can prevent condensation from forming on the pipe.

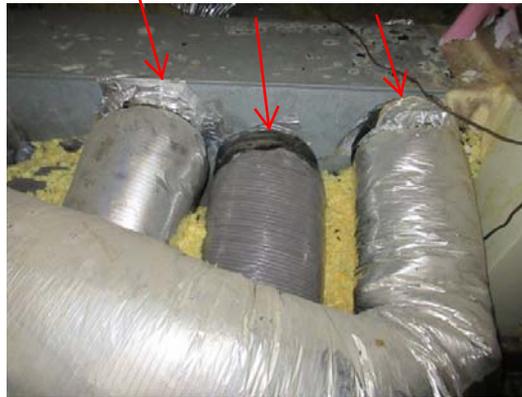
**Insulation pieces in registers:** There appears to be insulation pieces in the registers at various locations. This may be an indication of damage to ducting.

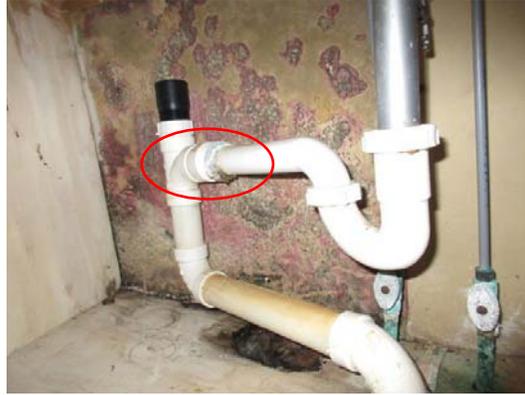
**Active plumbing leak:** There is an active leak at the drain under the master bathroom sink. Recommend immediate repair to prevent water damage.

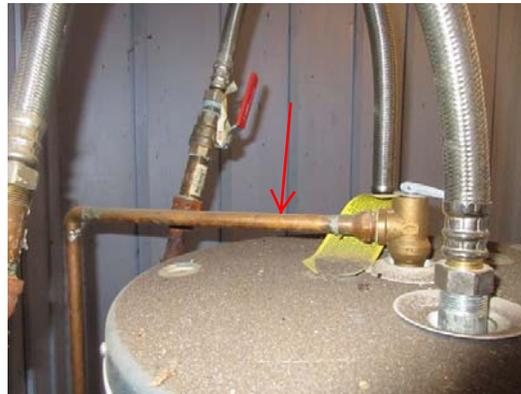
**TPRV drain line reduced:** The TPRV (temperature pressure relief valve) drain line should be 3/4 of an inch in diameter and should not be reduced.
