AGENDA
CITY OF LAKE WORTH BEACH
CITY COMMISSION WORK SESSION - BEACH COMPLEX
CITY HALL COMMISSION CHAMBER
WEDNESDAY, JANUARY 26, 2022 - 4:00 PM

LAKE WORTH BEACH COMPLEX | THE ART OF FLORIDA LIVING
NEW POOL COMPLEX CONCEPTUAL PACKAGE

Property Condition Assessment

RE: *Aquatics and Beach Complex Baseline Property Condition Assessment*
KH Job #140335001

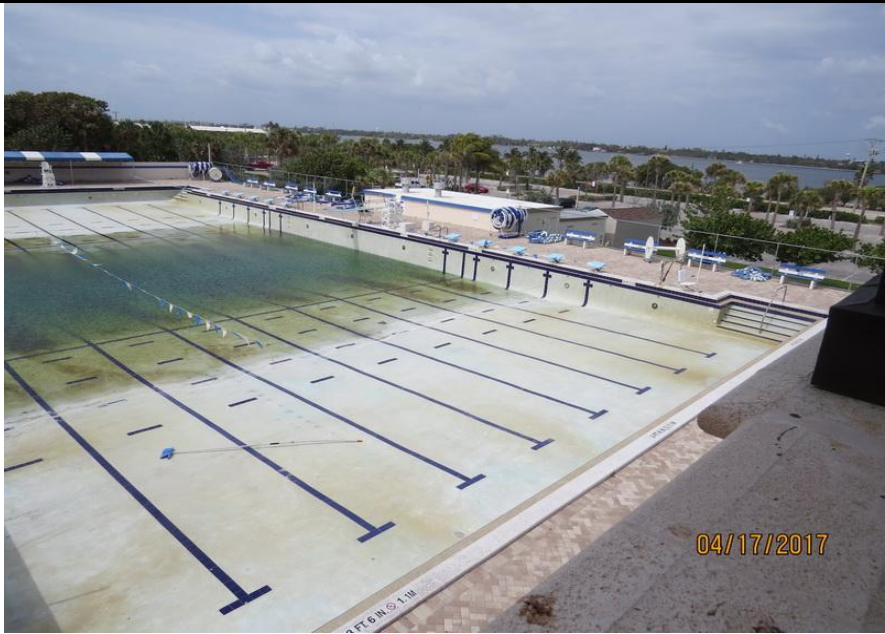
Photo No. 1

The Main Lap Pool is a 50-meter, competition style pool constructed in 1971 (Photo 1). It replaced a similar pool that was part of the original Lake Worth Casino built in 1920. The current pool was constructed with a reinforced concrete shell on compacted sand subgrade. The depth varies from approximately 3.5 ft at the north and south ends, to approximately 12 feet at the center. Lane striping facilitates lap swimming in either the 50-meter or the 23 -meter direction.

Remarks: 50-meter competition style pool constructed in 1971.

Location: Main Lap Pool

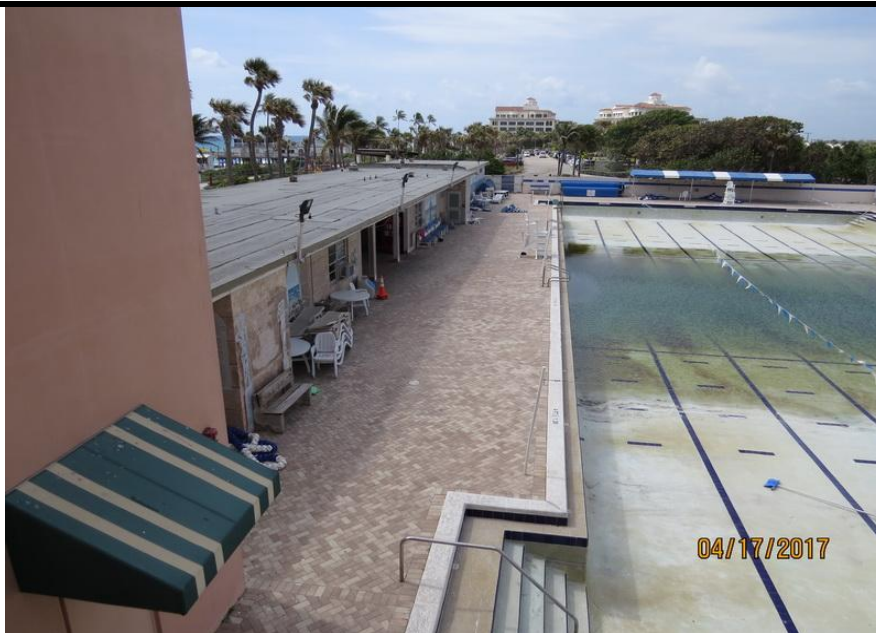
Photo No. 6

- Reportedly, the area drains on the east side of the pool are filled with hard debris and cannot be cleared (Photo 6). Lack of drainage creates a potential slipping hazard. **Recommendation: Remove the pool deck to expose the deck drainage piping. Replace the piping and verify clear flow to the storm drain. Inspect with a plumber's camera all deck drain lines for blockage, separated joints or other defects.**

Remarks: Area drains on East side of pool are filled with hard debris.

Location: Main Lap Pool

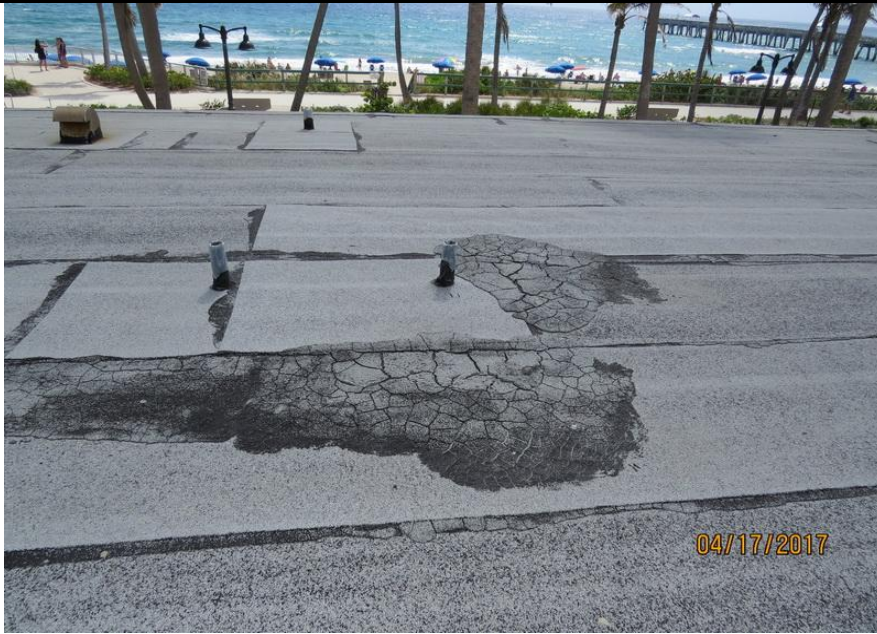
Photo No. 9

Remarks: 9ft x 12ft roof patch.

Location: Pool Restrooms

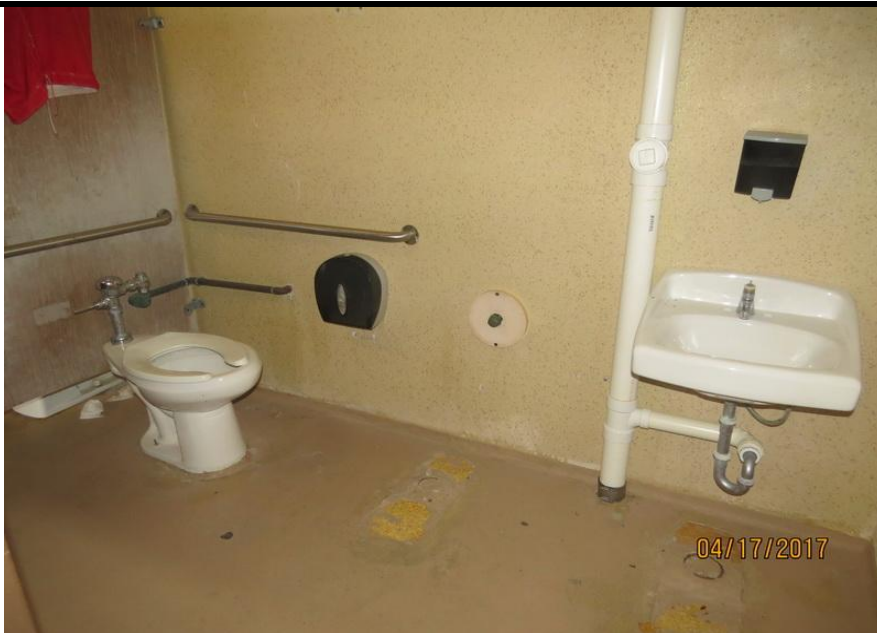
Photo No. 10

- Handicapped stalls do not comply with dimension standards of the Florida Accessibility Code, Section 604.3.1. The stall is not a minimum of 60 inches measured perpendicular from the side wall and 56 inches minimum measured perpendicular from the rear wall. The handicapped stall dimensions on both men's and women's bathroom on the Bathhouse and Offices Building that serve the pool were observed to be less than the required minimum dimensions. Lavatory drains lack insulation (Photo 10). **Recommendation: Reconstruct ADA stalls to meet FAC requirements.**

Remarks: Handicapped stall dimension are less than the required. Lavatory drains lack insulation.

Location: Pool Restrooms

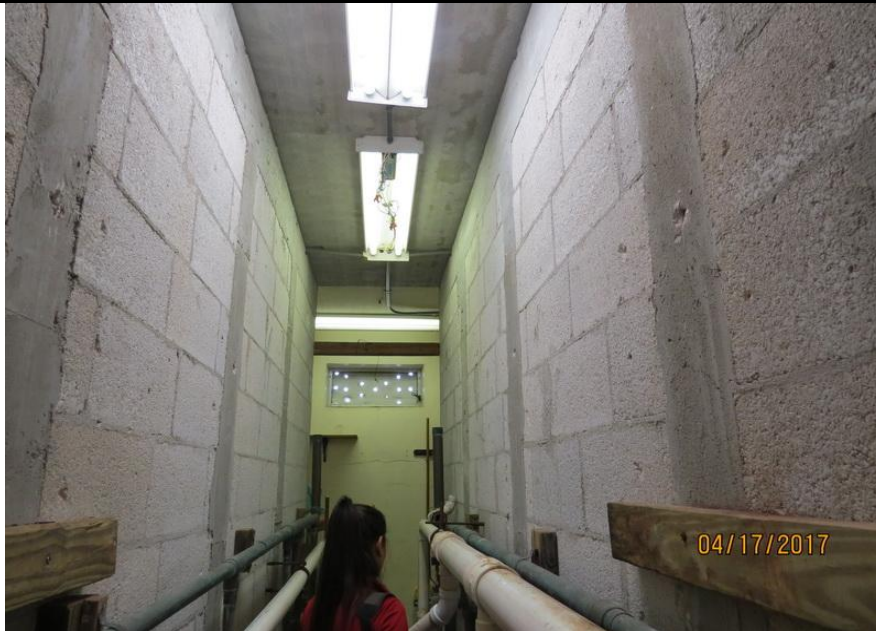
Photo No. 17

Remarks: Mechanical space between men's and women's toilets is poorly ventilated.

Location: Beach Restrooms

- The mechanical space between the men’s and women’s toilets is poorly ventilated. **Recommendation: Install mechanical ventilation (Photo 17).**
- The mechanical space floor drain has been plugged. It was reported that sanitary waste backflows out of the floor drain (Photo18). **Recommendation: Inspect sanitary drain lines and building sewer. Clear any blockage.**
- Drain, waste, land vent piping is poorly supported. Threaded rod hangers are loaded in bending instead of tension. Brackets are severely corroded (Photo 19). **Recommendation: Replace pipe supports.**
- The lavatory drain in the ADA stalls is not insulated. **Recommendation: Replace missing insulation.**
- The floor drain in the women’s restroom is too high, causing water to puddle on the floor (Photo 20). **Recommendation: Lower the floor drain.**

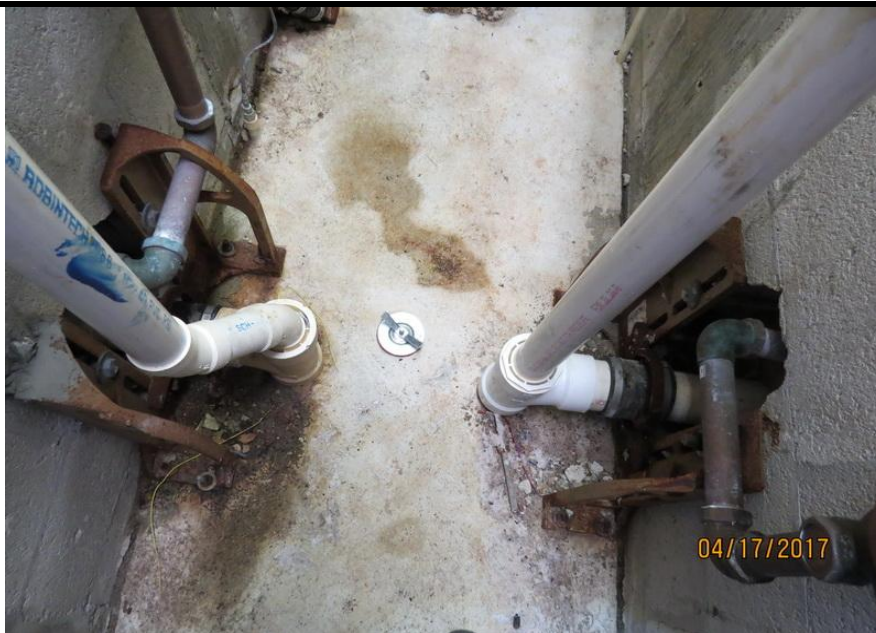
Photo No. 18

Remarks: Mechanical space floor drain has been plugged.

Location: Beach Restrooms

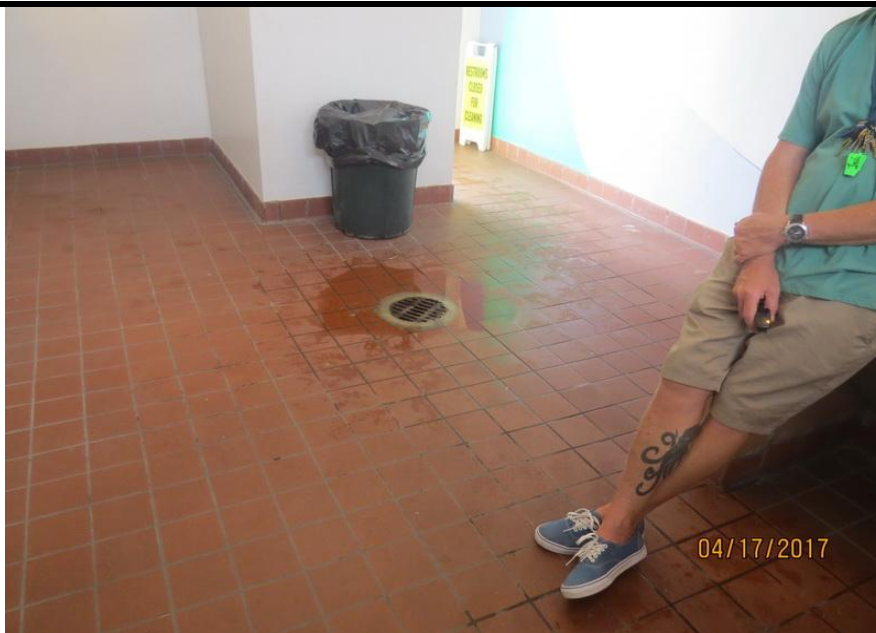
Photo No. 20

Remarks: Floor drain on women's restroom is too high causing water to puddle on the floor.

Location: Beach Restrooms

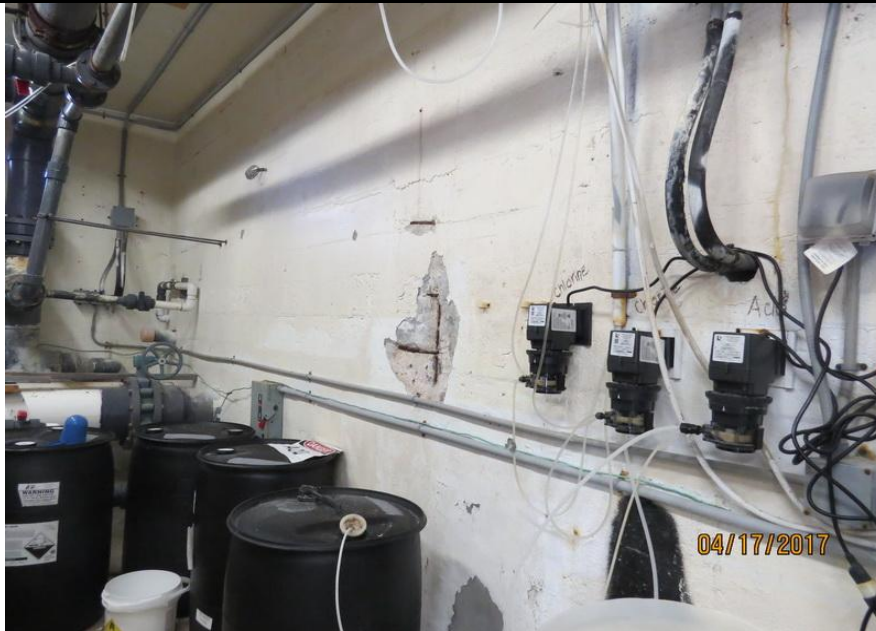
Photo No. 25

- The interior face of one tie-column in the east wall of the pump room has spalled, exposing reinforcing steel (Photo 25). **Recommendation: Clean the corroded steel and apply a patching mortar.**

Remarks: Exposed reinforcing steel at interior face of one tie-column in the east wall of the pump room.

Location: Pool Filter Equipment Building

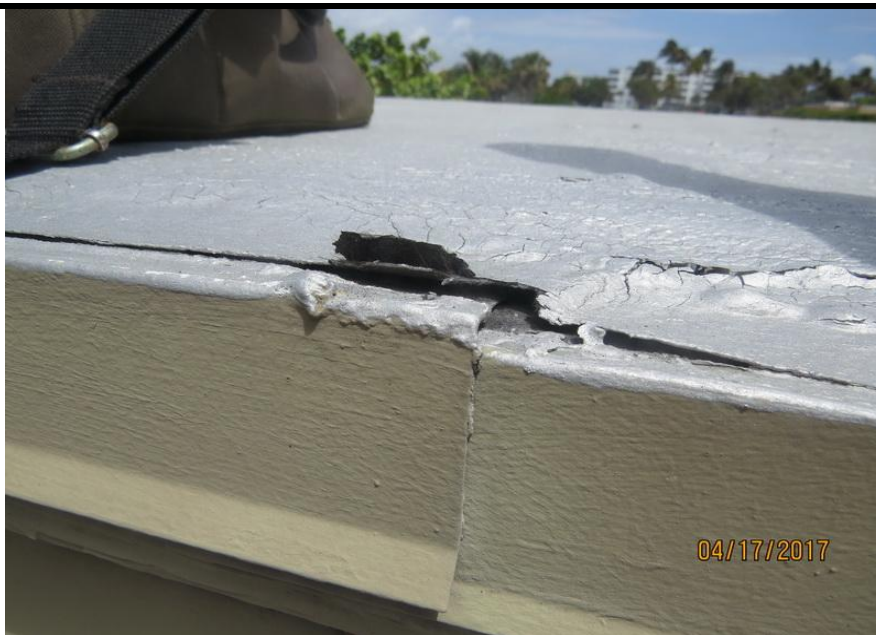
Photo No. 28

Remarks: Small blisters on waterproofing are present near the south edge of the roof.

Location: Chlorine Storage Building

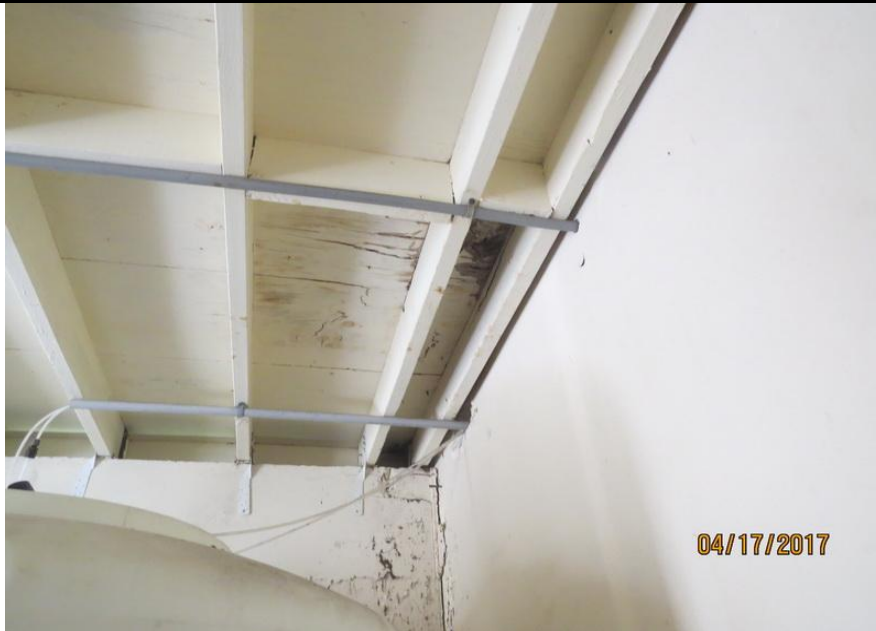
Photo No. 29

Remarks: The roof sheathing near the east edge is soft and yields under foot pressure.

Location: Chlorine Storage Building

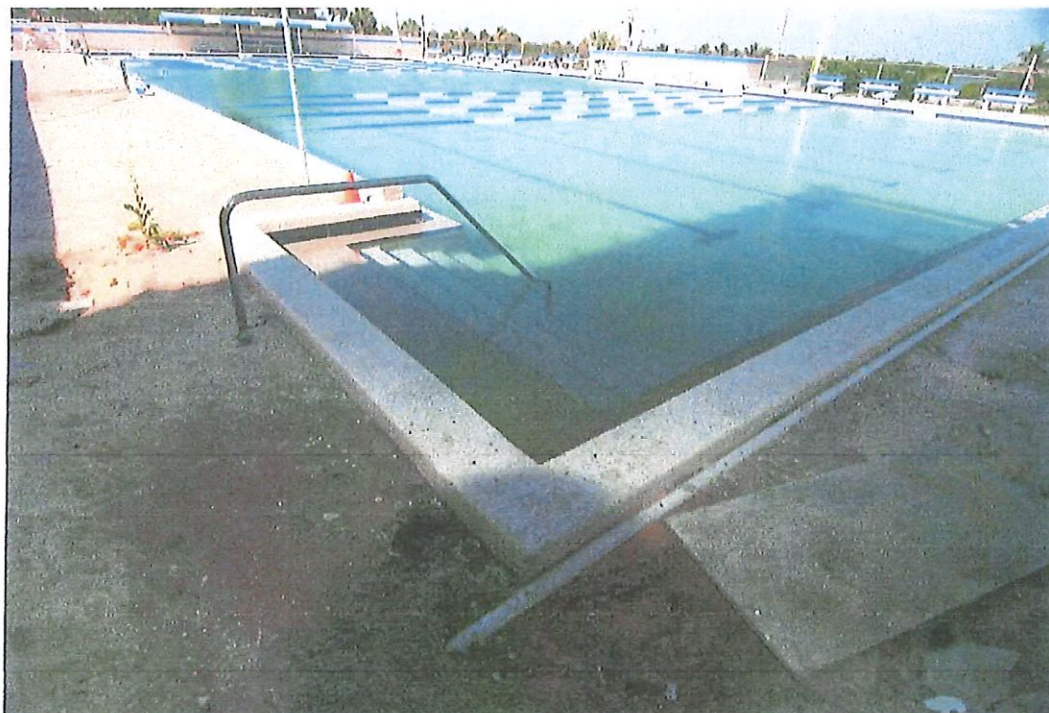
EXHIBIT 6. VIEW OF STEPS IN NORTHEAST AREA OF POOL
