AGENDA
CITY OF LAKE WORTH BEACH
SPECIAL CITY COMMISSION MEETING - ARTIFICIAL TURF & TREE PLANTING
CITY HALL COMMISSION CHAMBER
THURSDAY, MAY 09, 2024 - 5:00 PM

**Lake Worth Beach - Municipal Beach Complex
Development Professional Services**

Property Condition Assessment

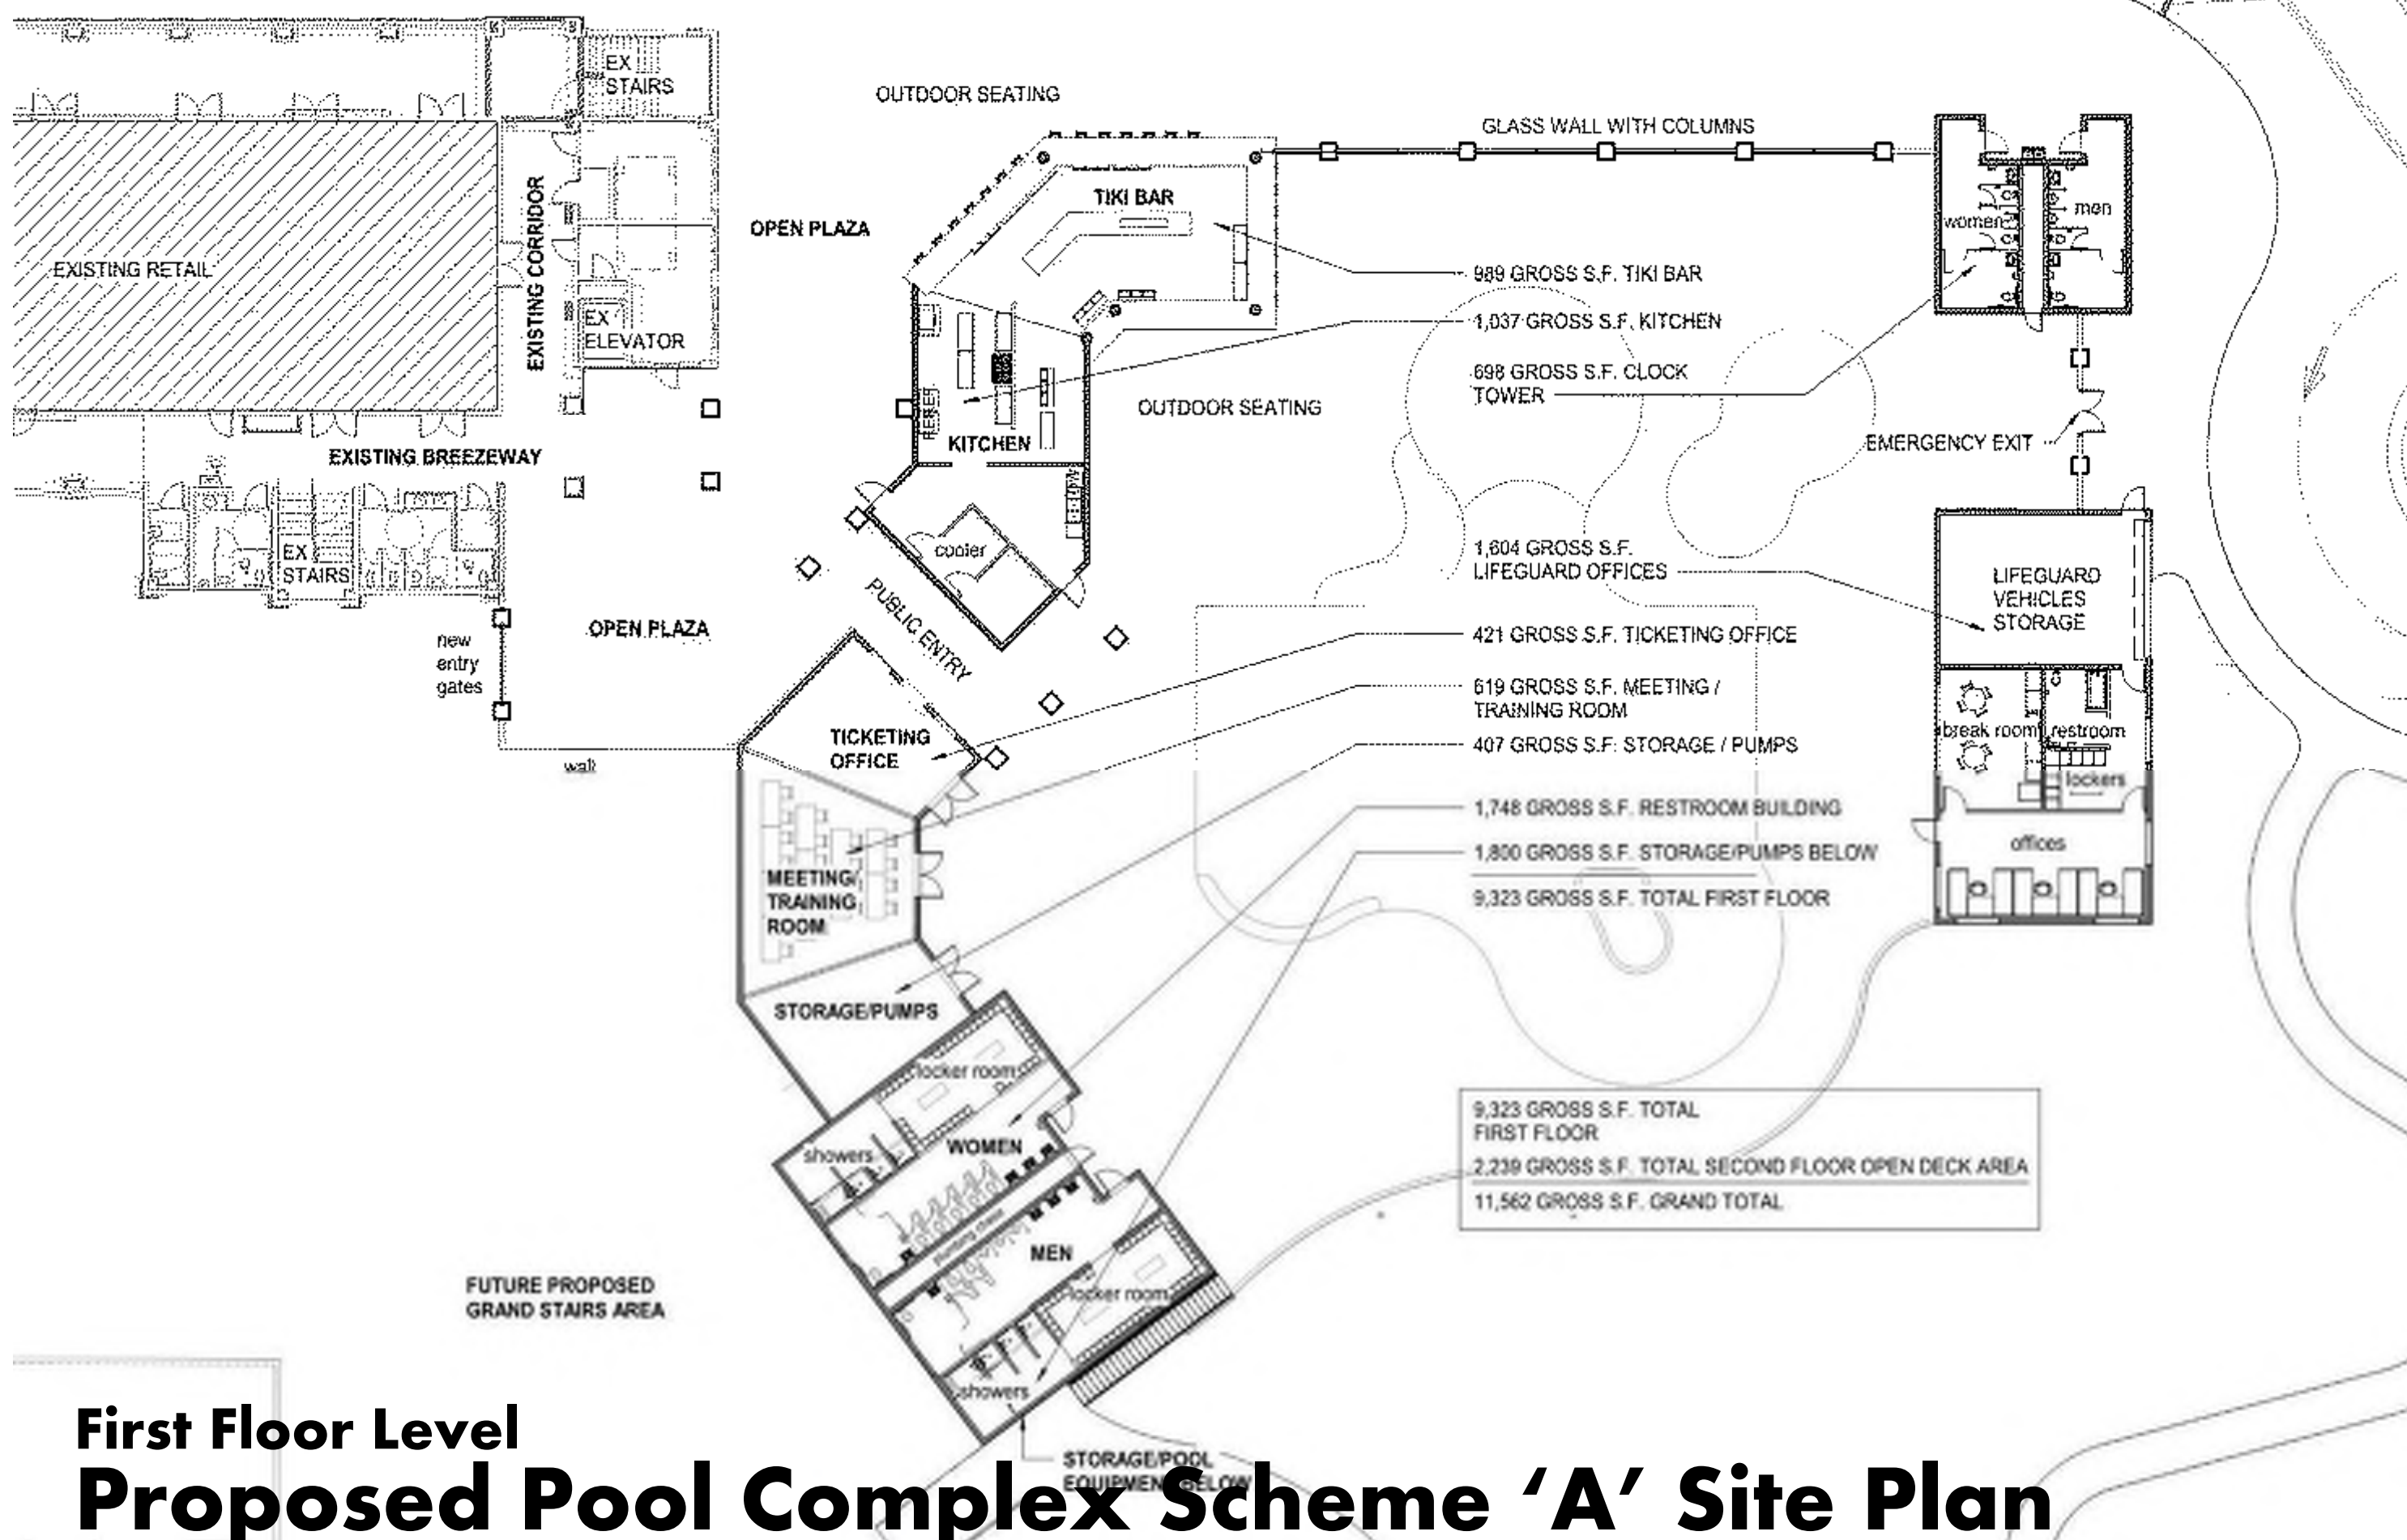
First Floor Level Proposed Pool Complex Scheme 'A' Site Plan

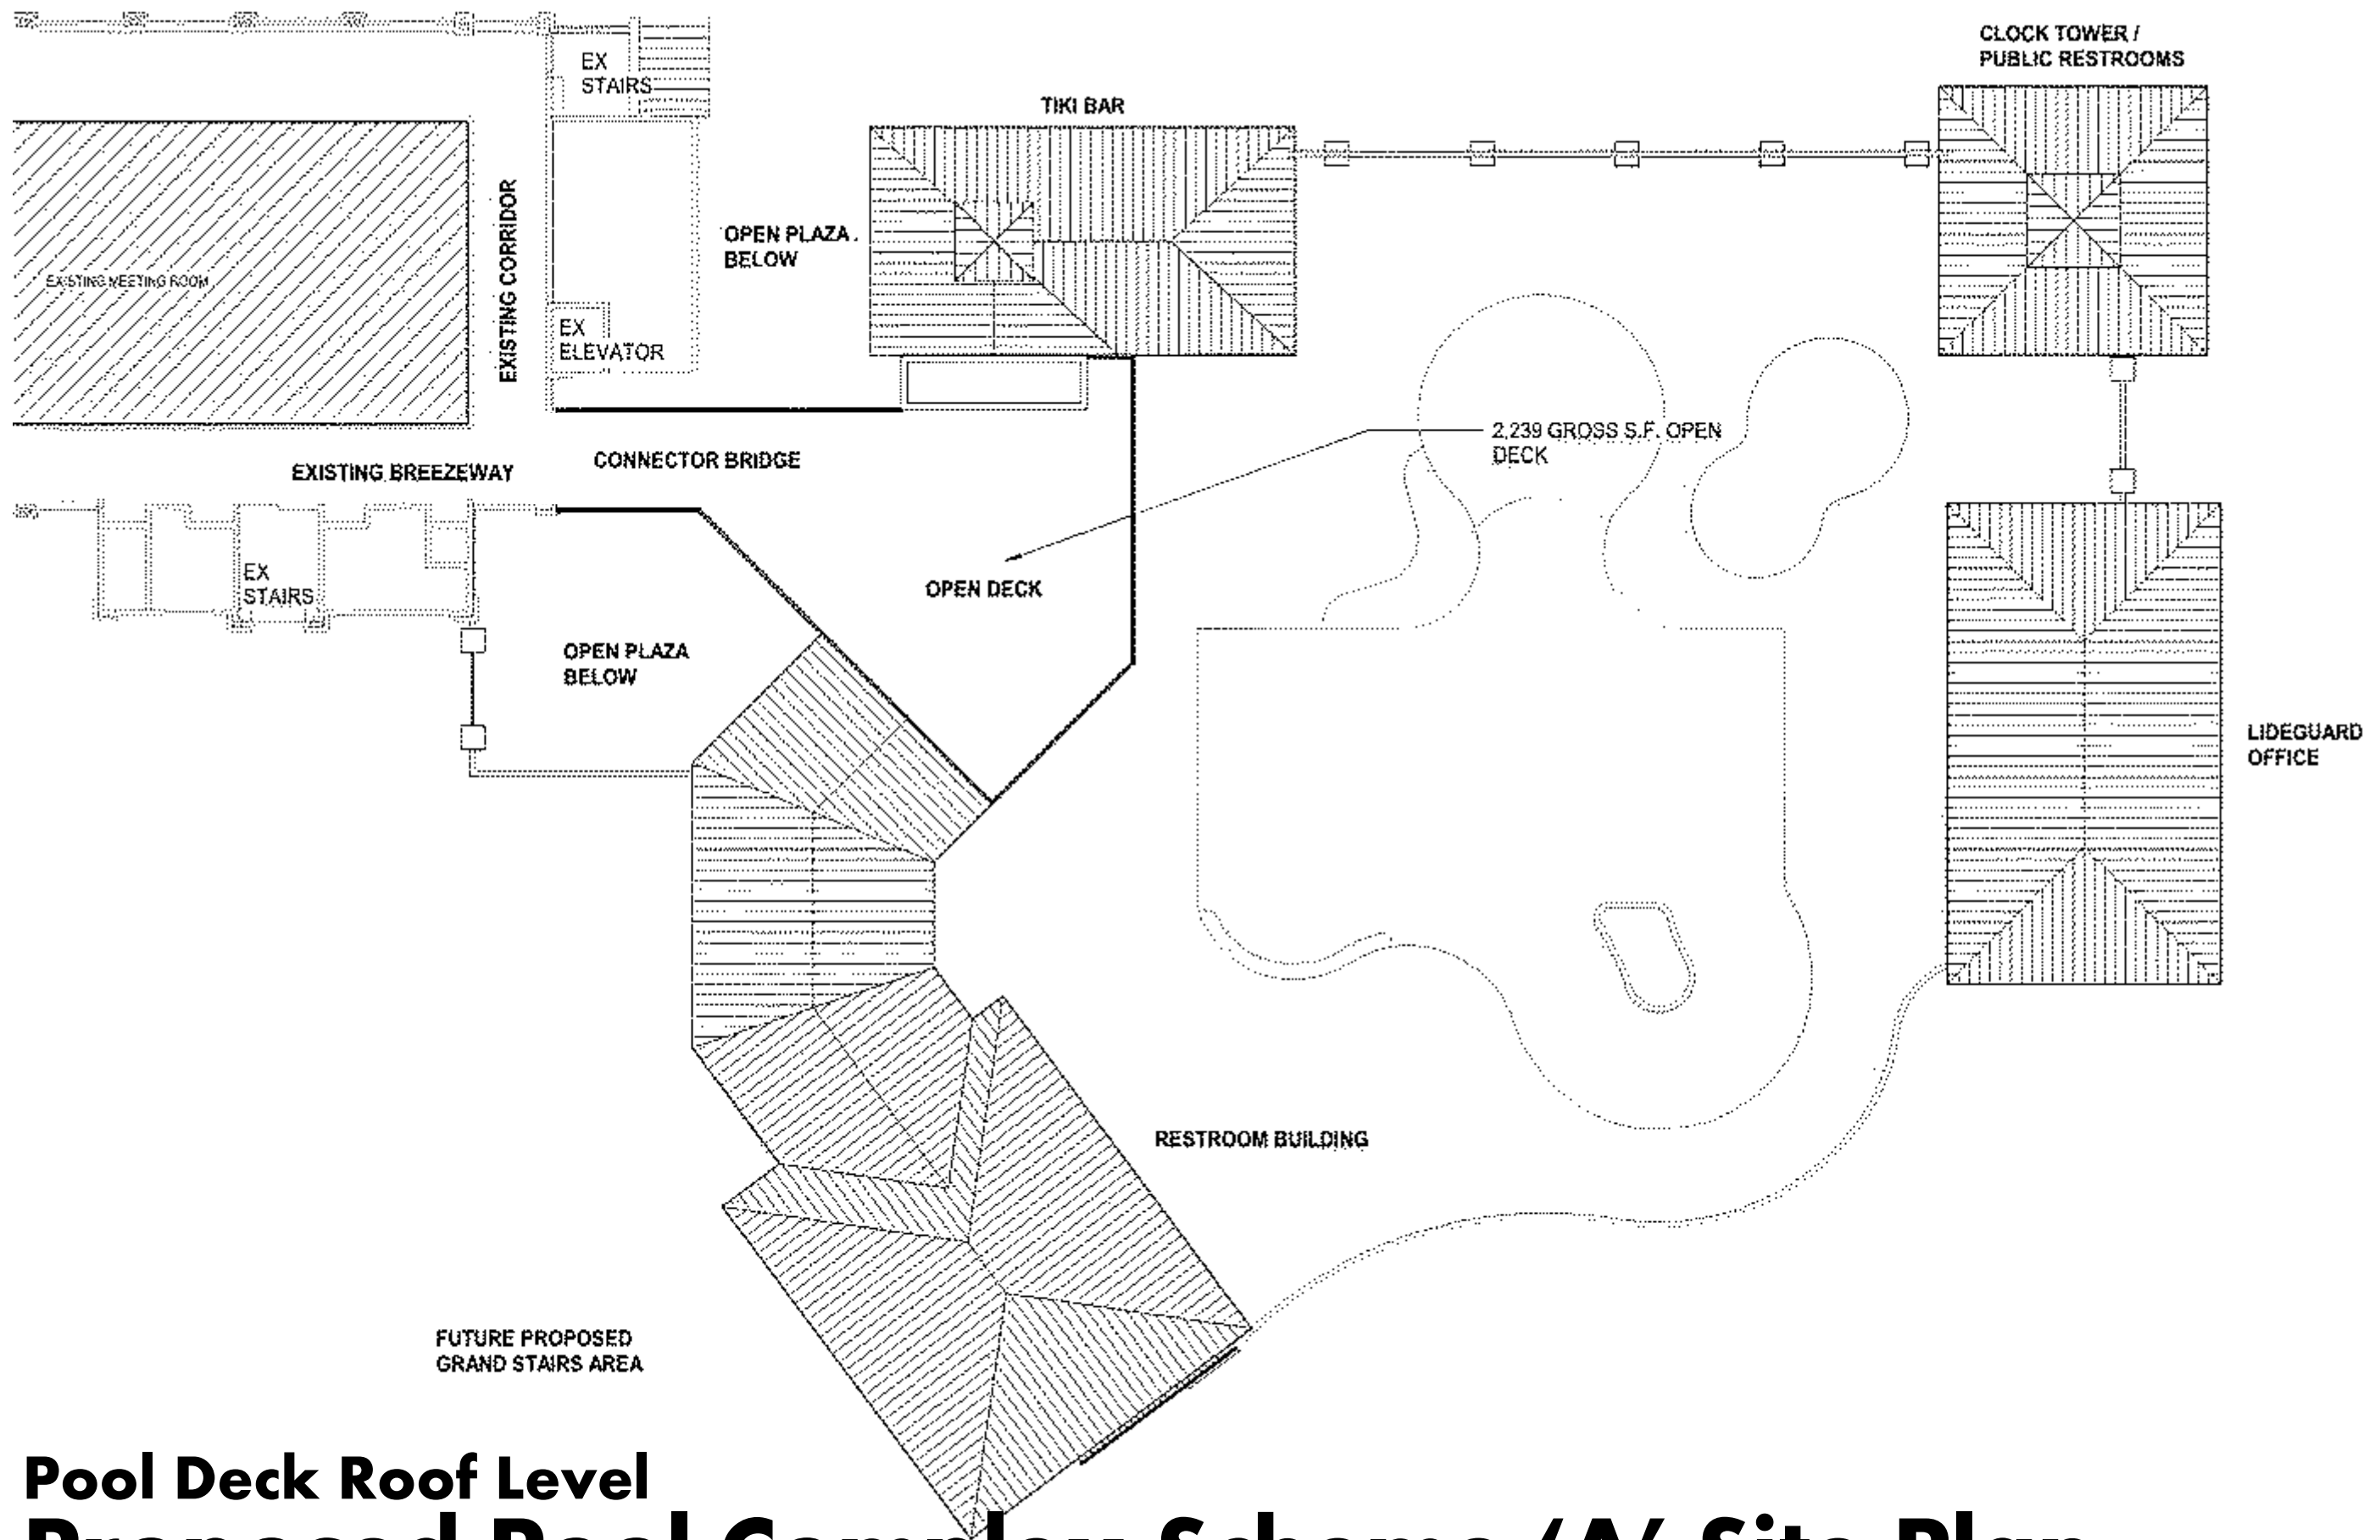
Pool Deck Roof Level Proposed Pool Complex Scheme 'A' Site Plan

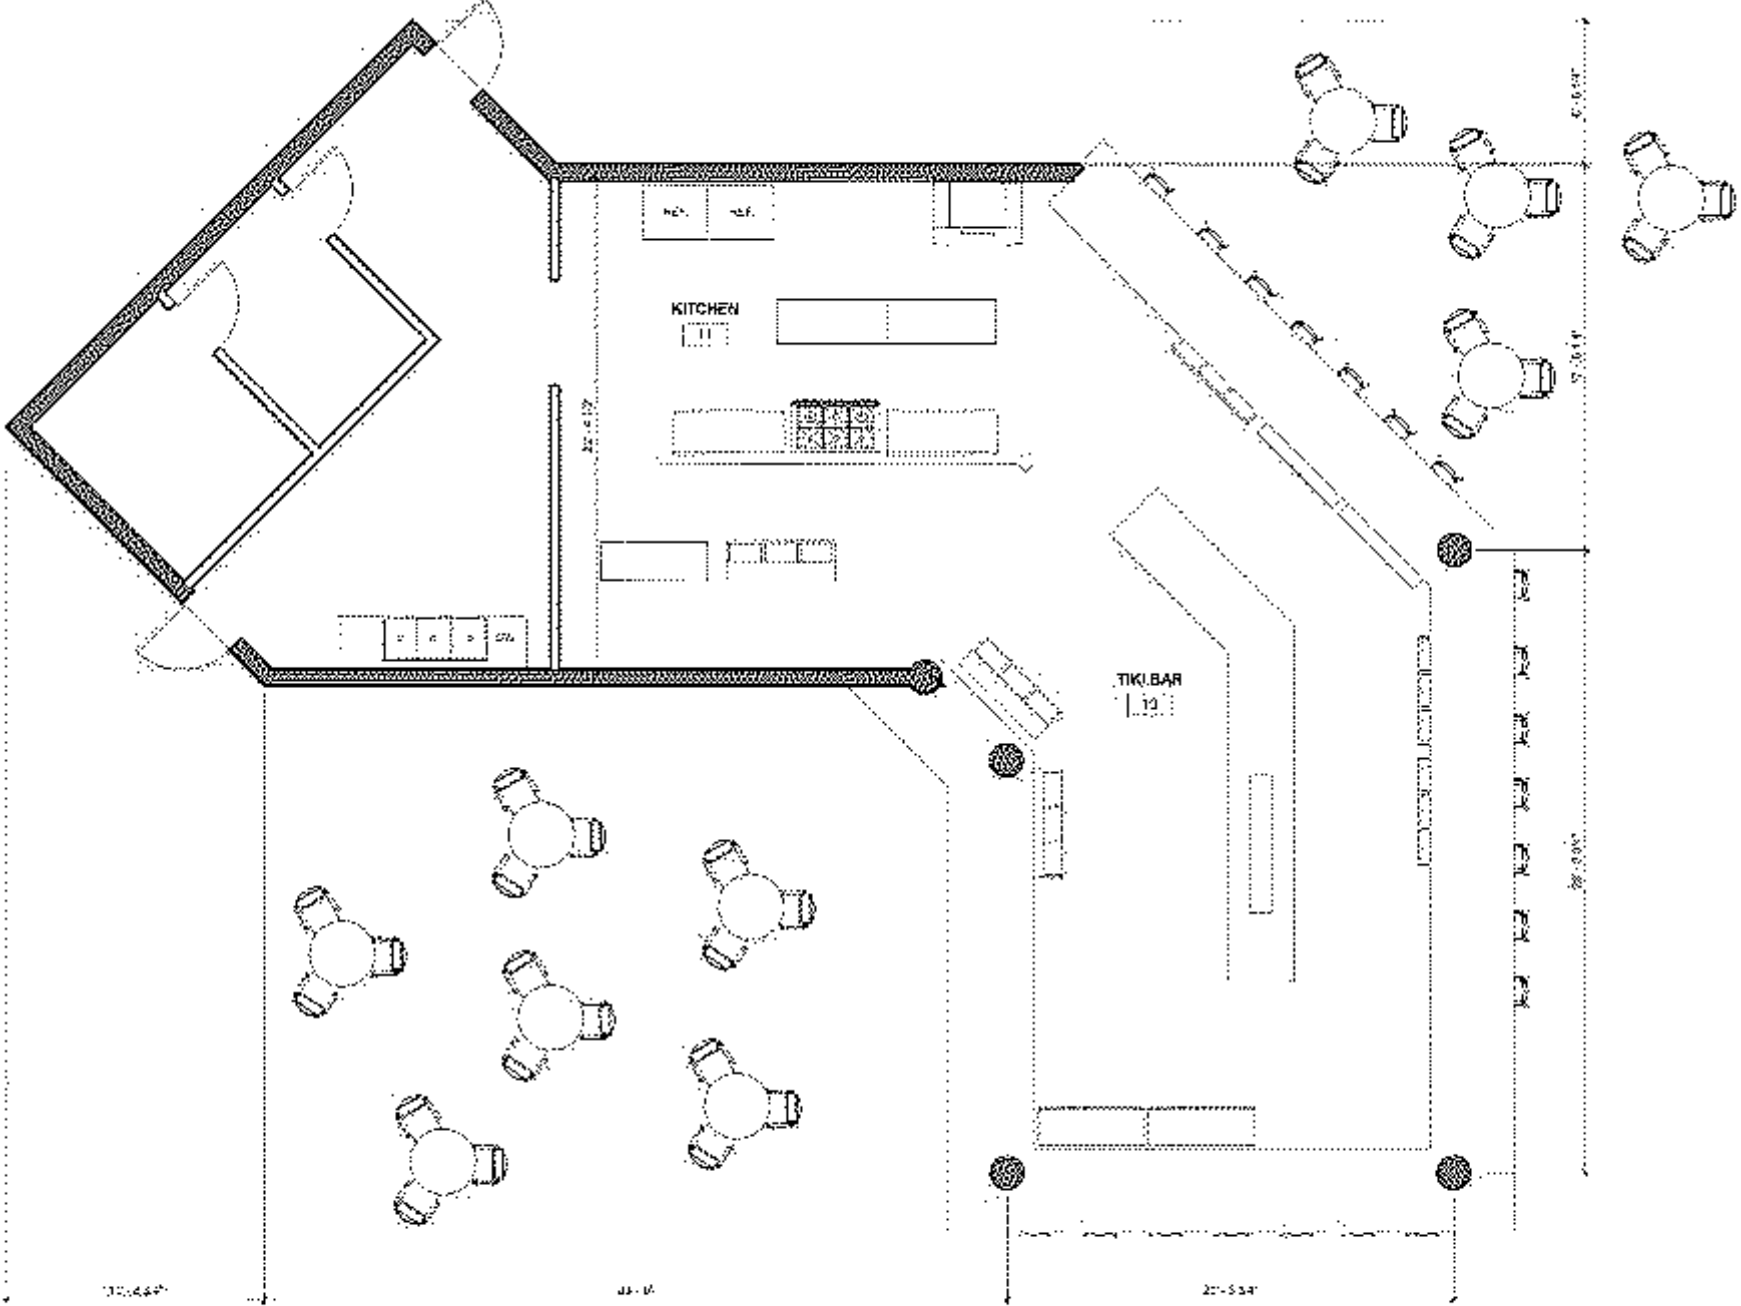
TIKI BAR BUILDING SCHEME A

Proposed Tiki Bar Building Floor Plan Scheme 'A'

989 S.F. TIKI BAR.
1037 S.F. KITCHEN

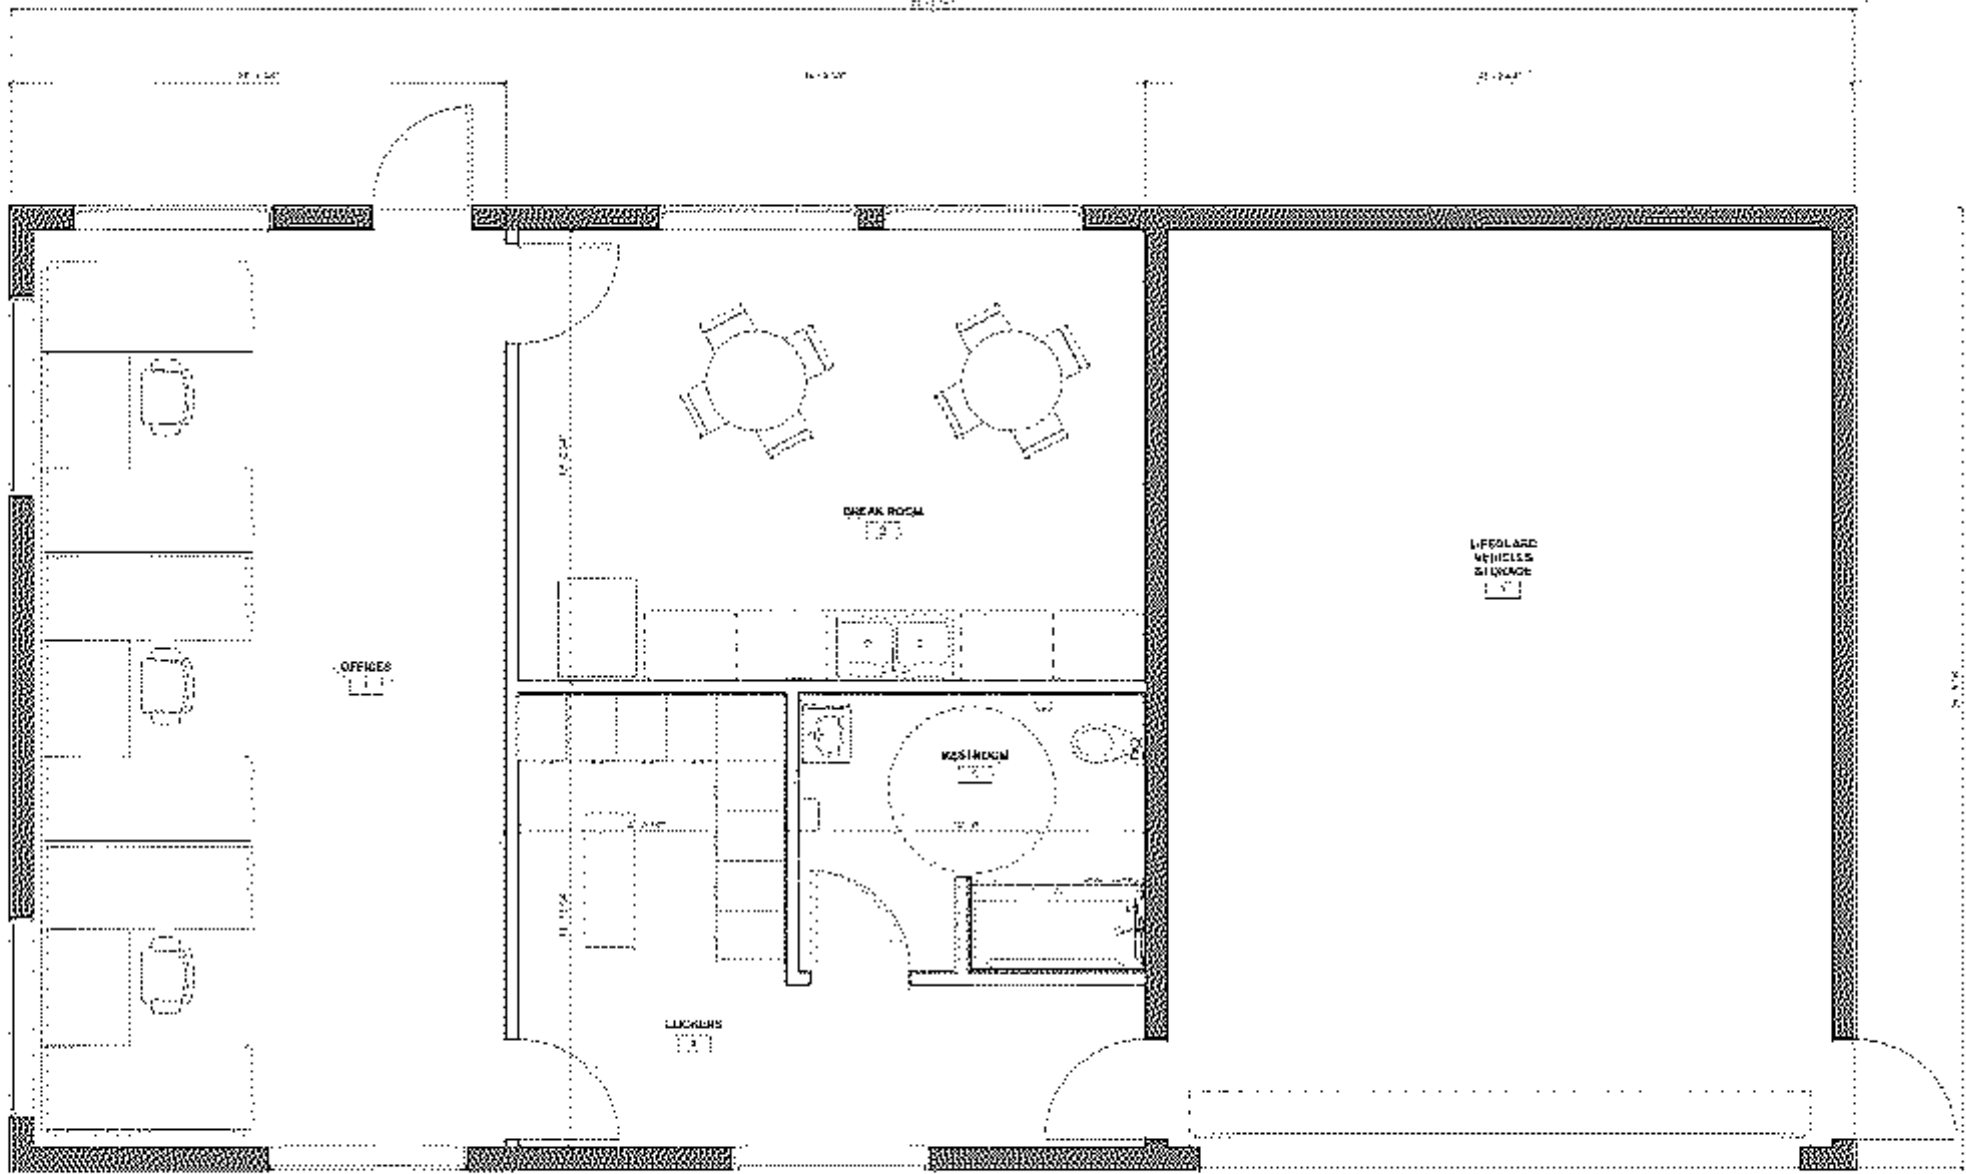
LIFEGUARD BUILDING SCHEME A.

Proposed Lifeguard Building Floor Plan Scheme 'A'

1604 S.F. LIFEGUARD BUILDING.

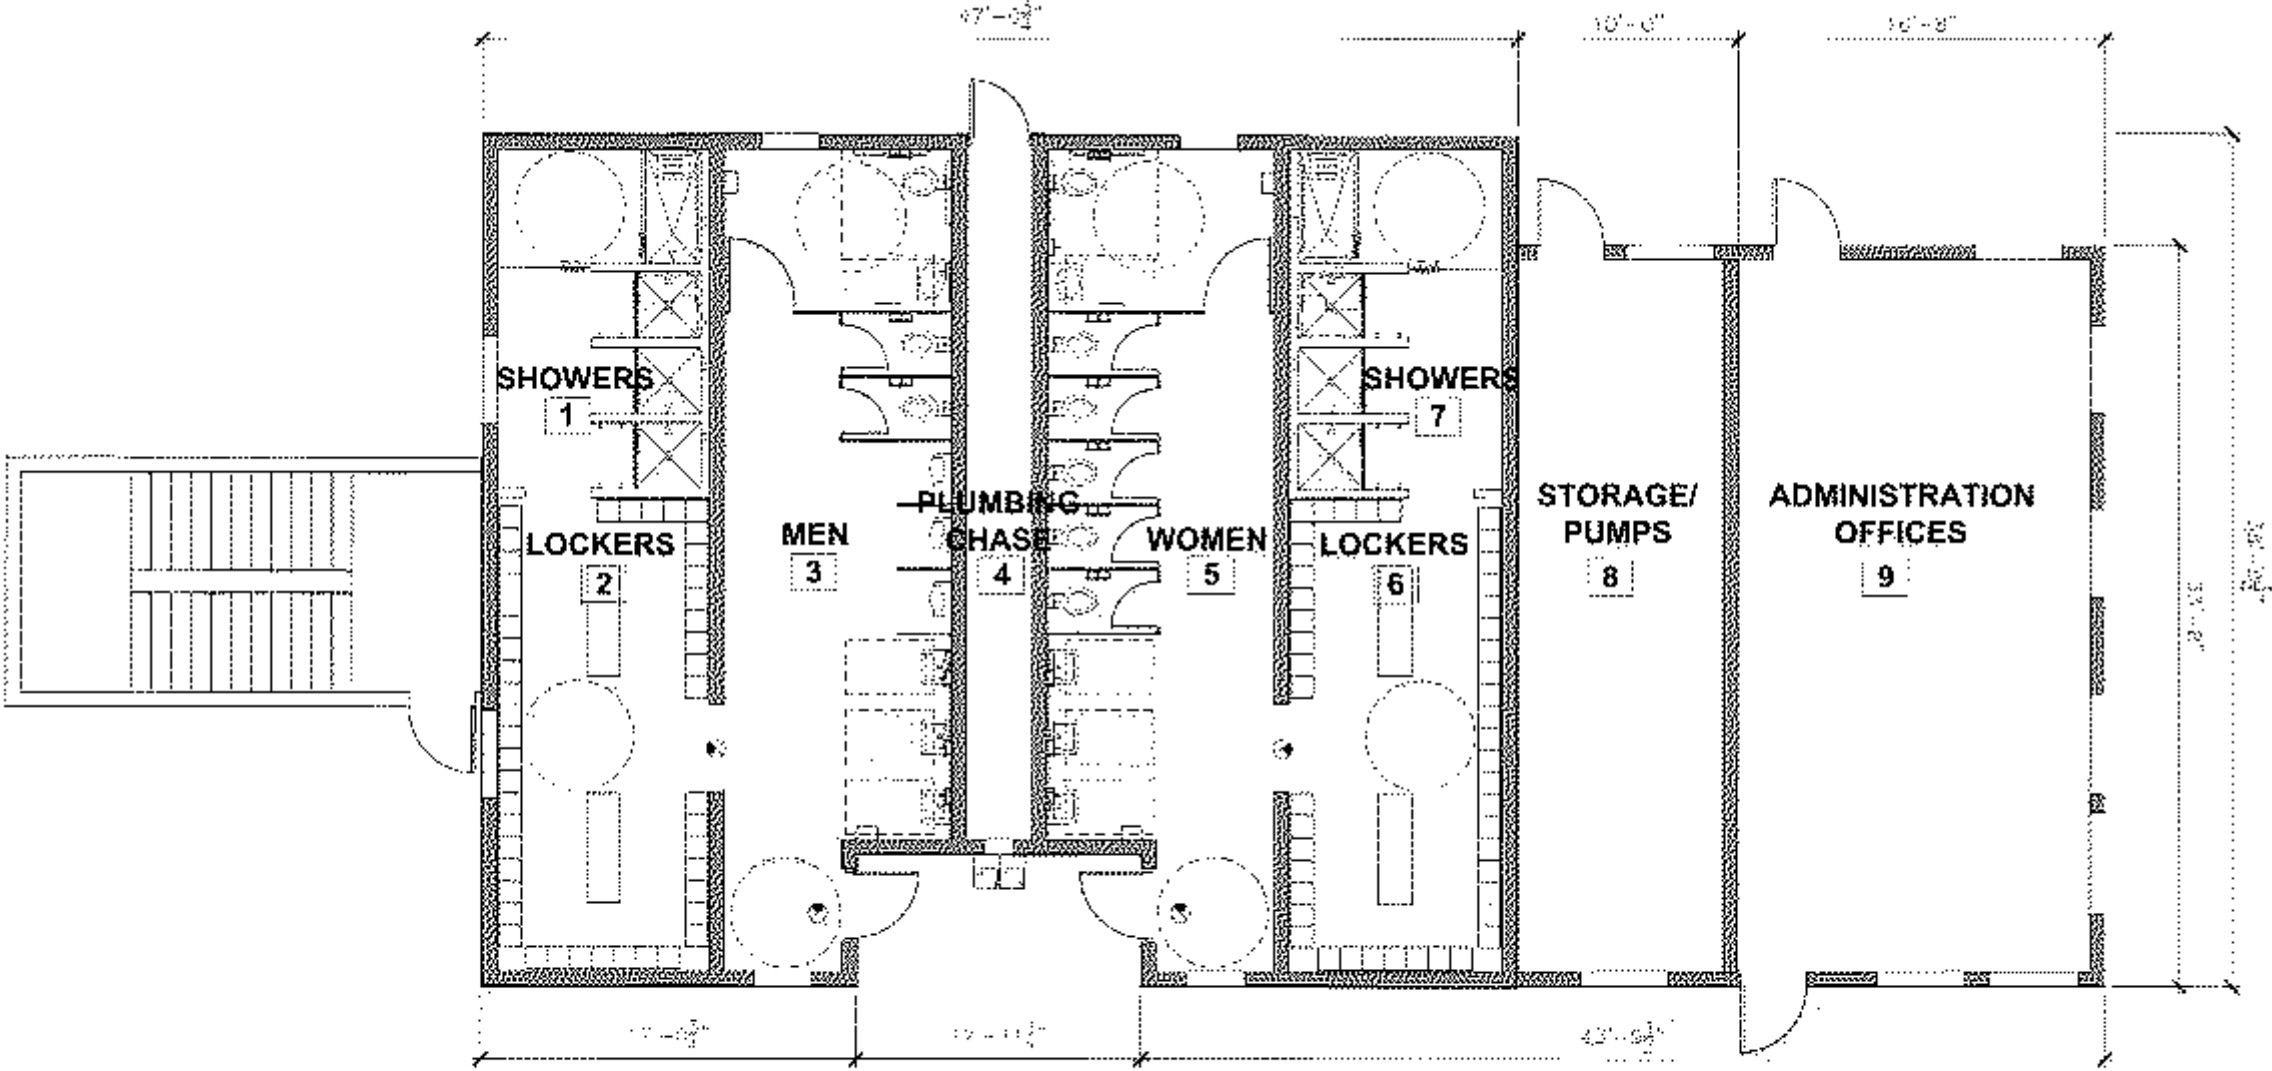
Proposed Administration / Restroom Building Floor Plan Scheme 'B'

PROPOSED POOL COMPLEX FIRST FLOOR OPTION 'B' SHOWERS/ LOCKER ROOM

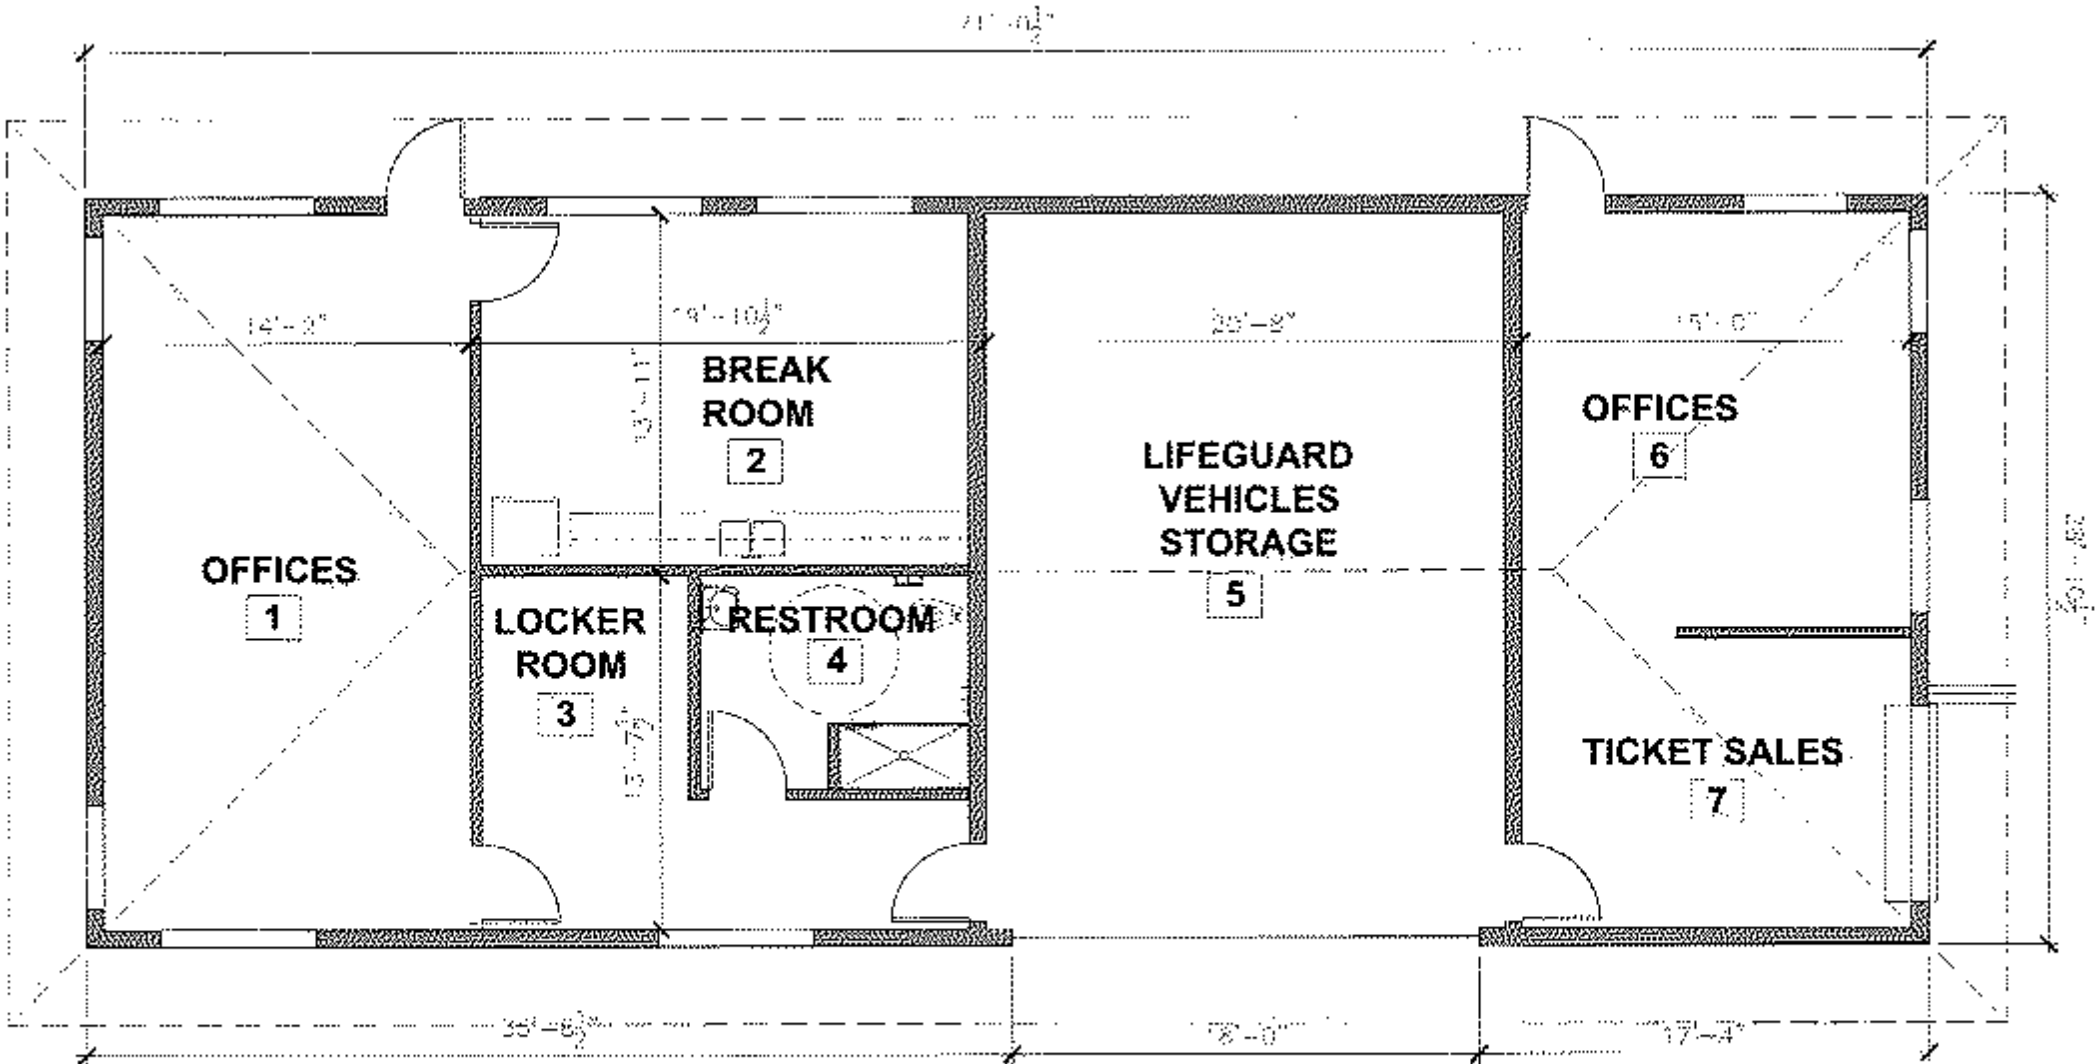
Proposed Ticketing / Lifeguard Building Floor Plan Scheme 'B'

PROPOSED POOL COMPLEX FIRST FLOOR OPTION 'B' LIFEGUARD OFFICES

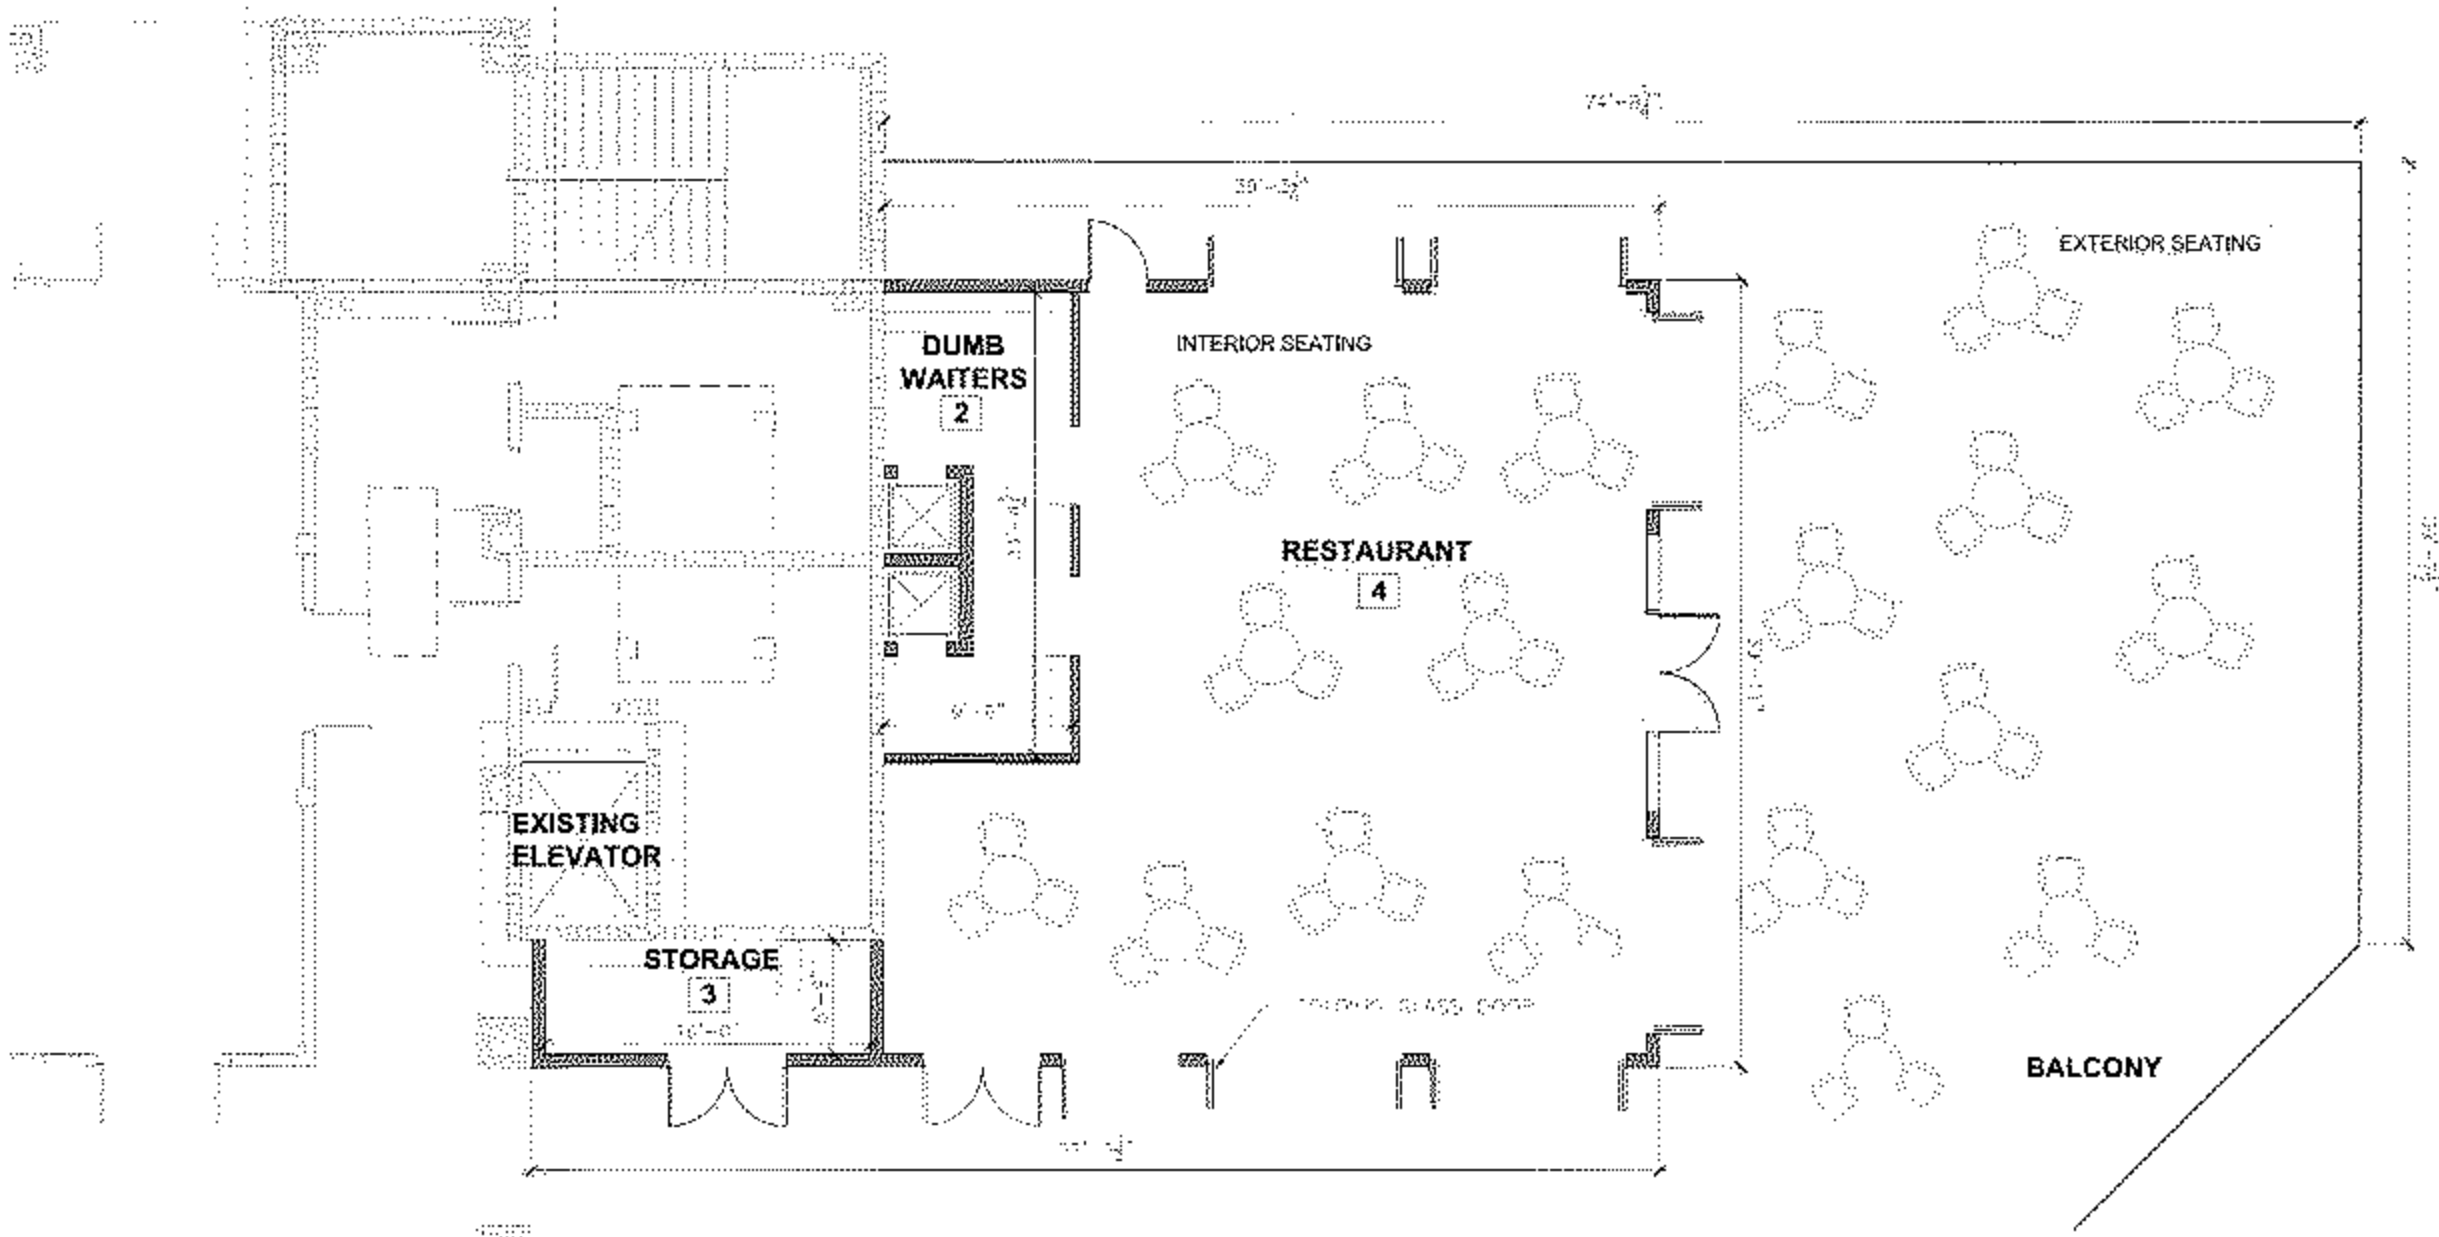
Proposed Second Floor Restaurant / Exterior Deck Plan Scheme 'B'

PROPOSED POOL COMPLEX SECOND FLOOR OPTION 'B' RESTAURANT

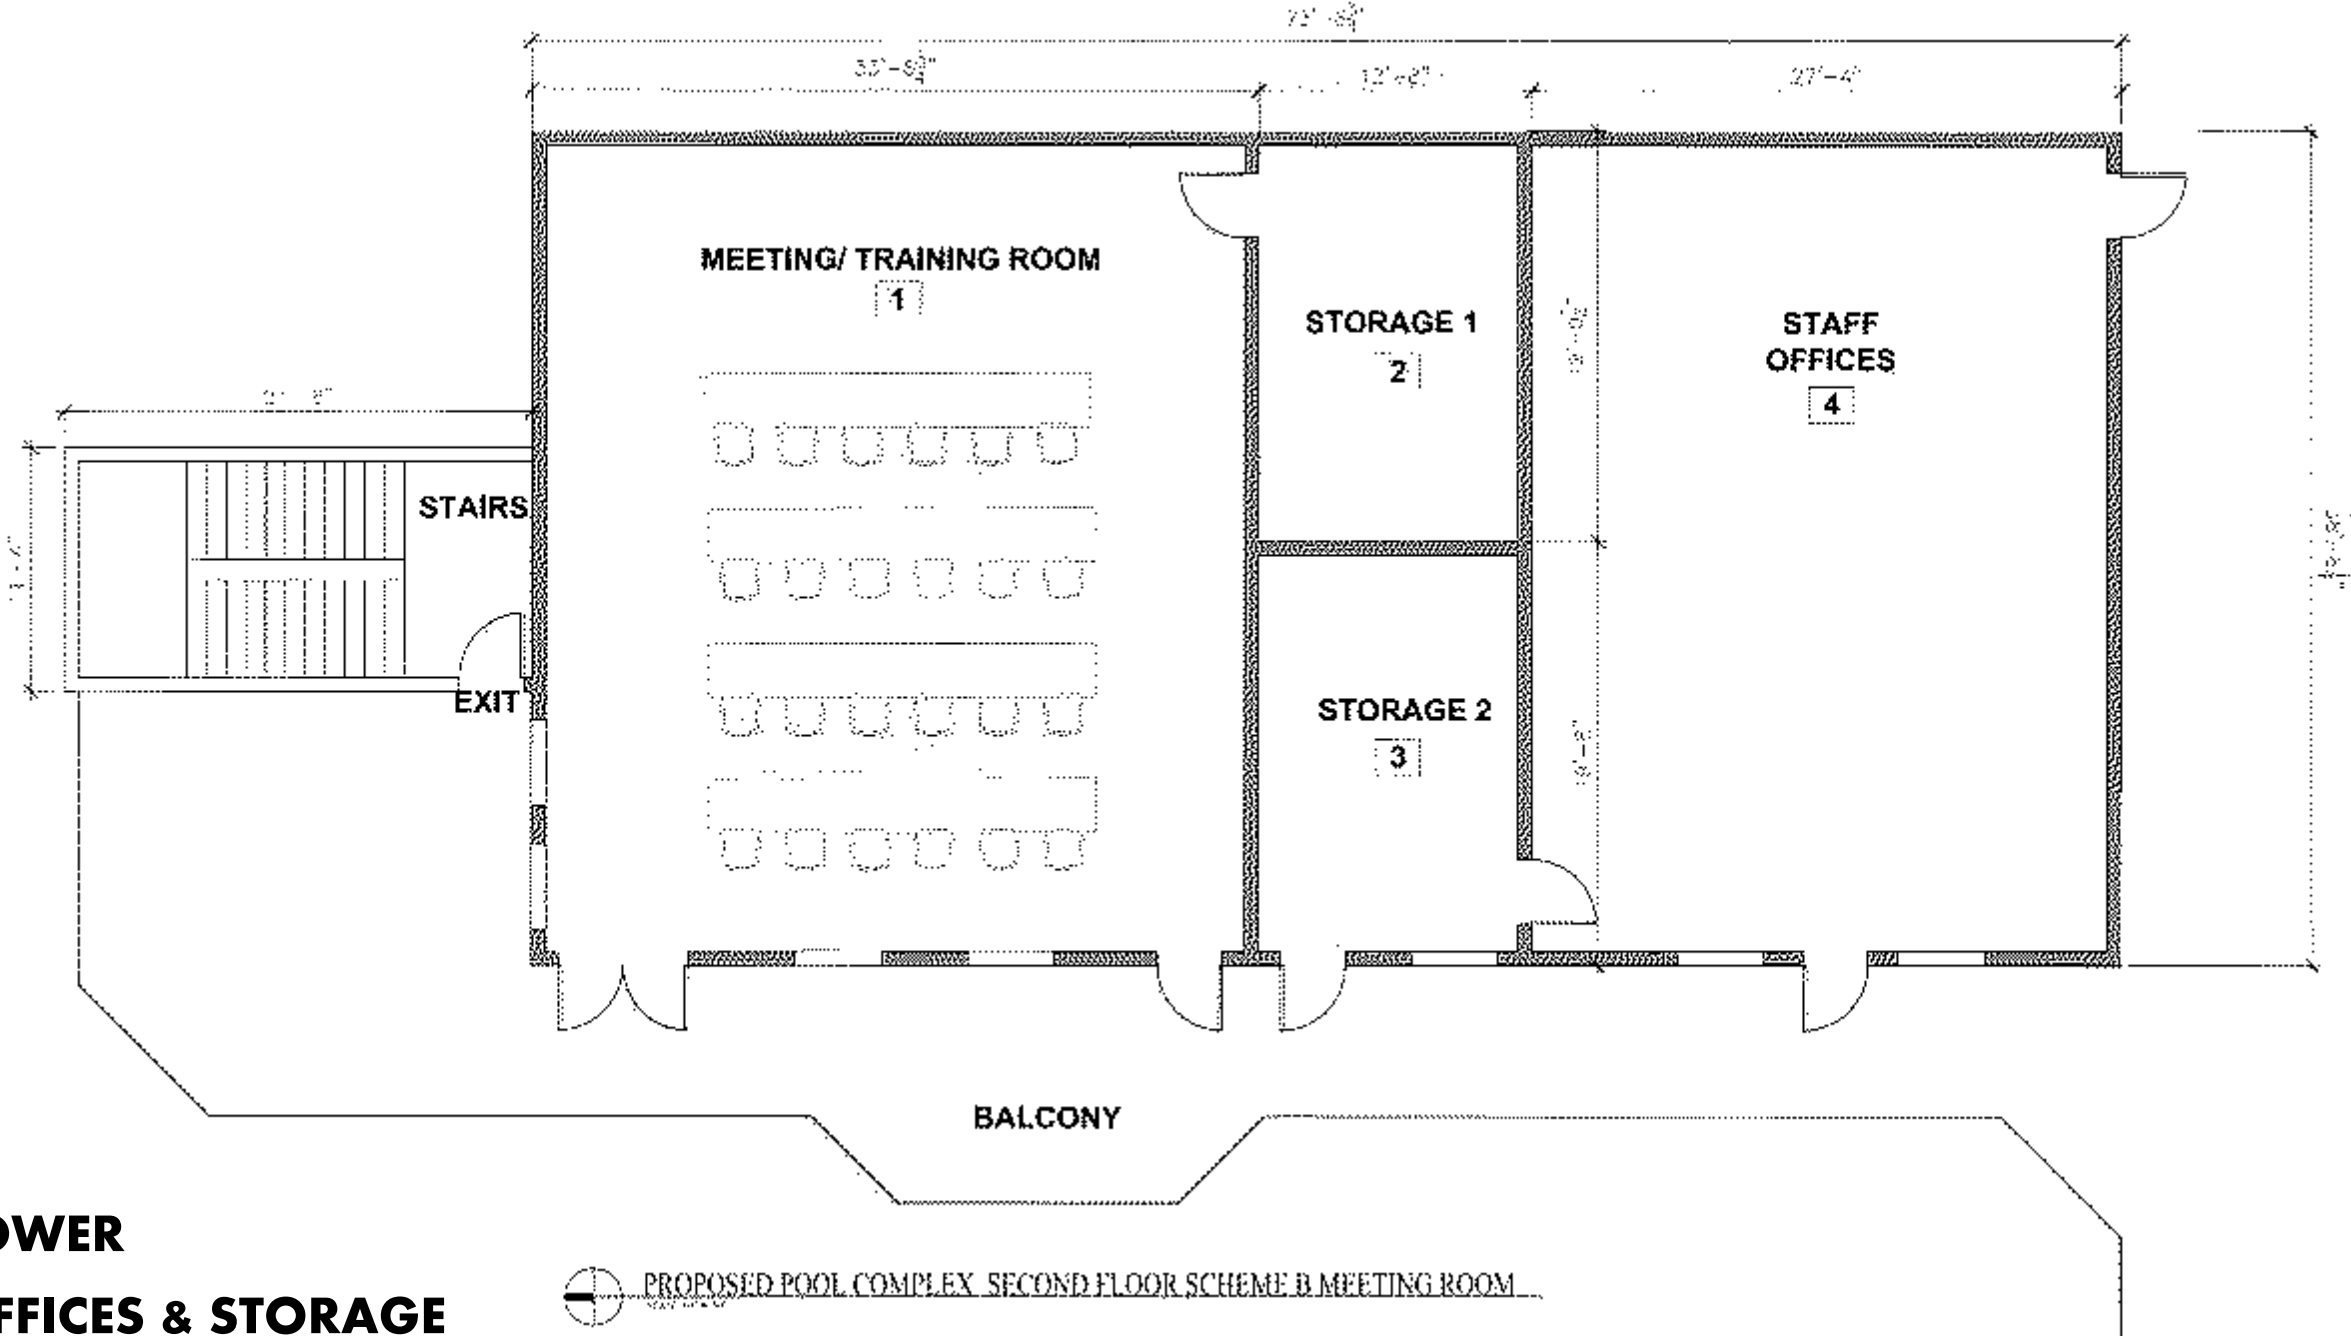
Proposed Second Floor Offices / Meeting Room & Balconies Plan Scheme 'B'

- 245 S.F.** STAIR TOWER
- 1316 S.F.** STAFF OFFICES & STORAGE
- 1536 S.F.** MEETING/ TRAINING ROOM & STORAGE

PROPOSED POOL COMPLEX SECOND FLOOR SCHEME B MEETING ROOM
