AGENDA
CITY OF LAKE WORTH BEACH
SPECIAL CITY COMMISSION MEETING - ARTIFICIAL TURF & TREE PLANTING
CITY HALL COMMISSION CHAMBER
THURSDAY, MAY 09, 2024 - 5:00 PM

**Lake Worth Beach - Municipal Beach Complex
Development Professional Services**

Property Condition Assessment

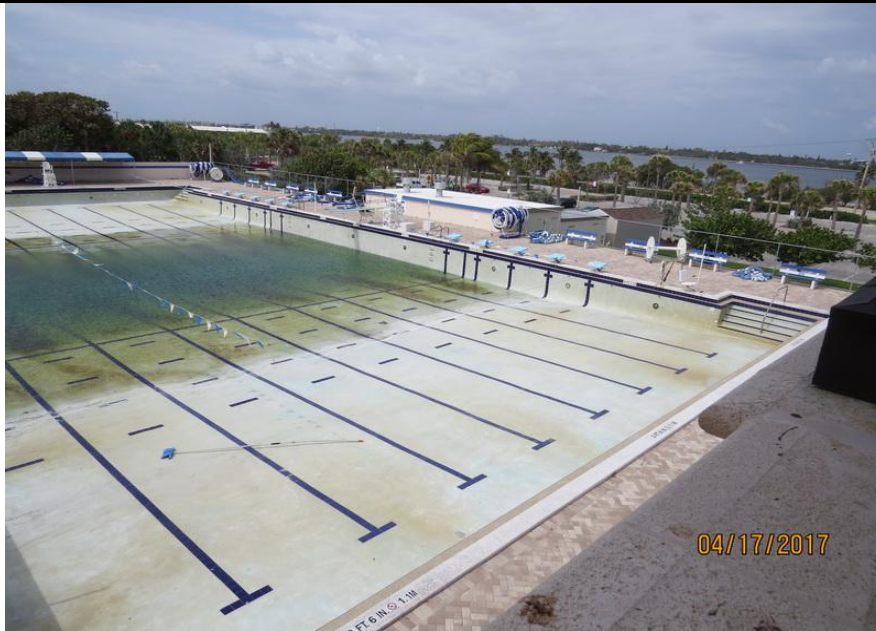
Photo No. 1

Remarks: 50-meter competition style pool constructed in 1971.

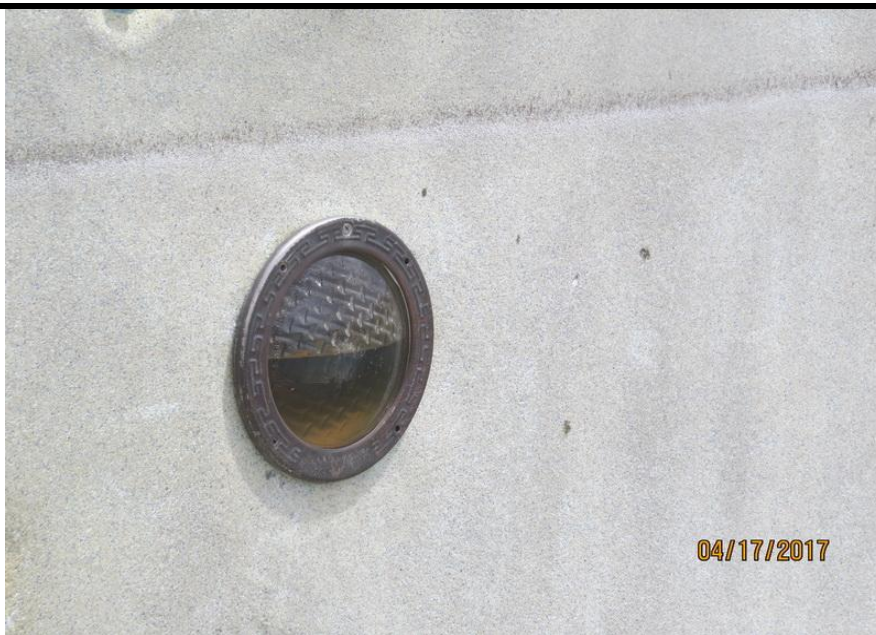
Photo No. 4

Remarks: Water leaks into the housing of the underwater lights.

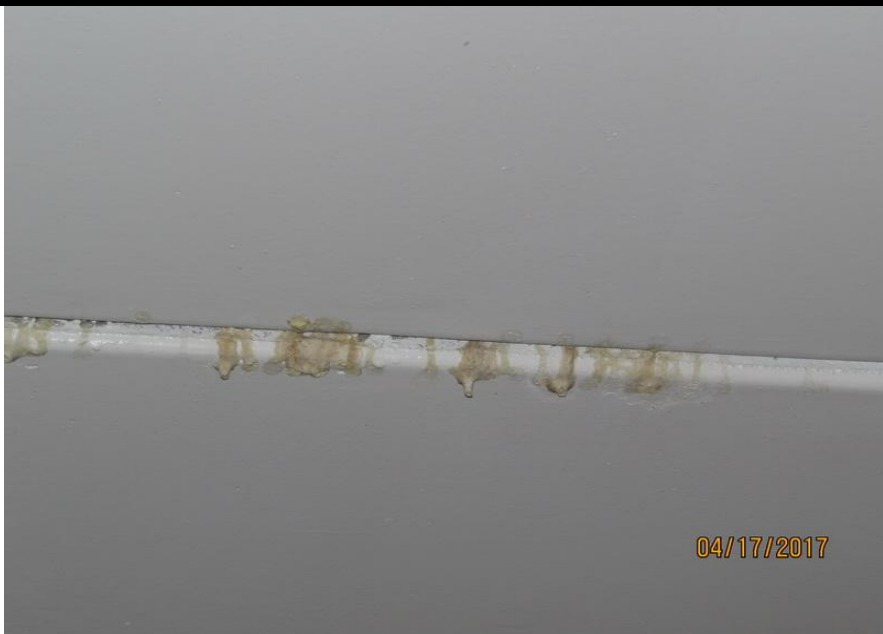
Photo No. 7

Remarks: Mineral Deposits hang from roof joints on men's and women's bathrooms.

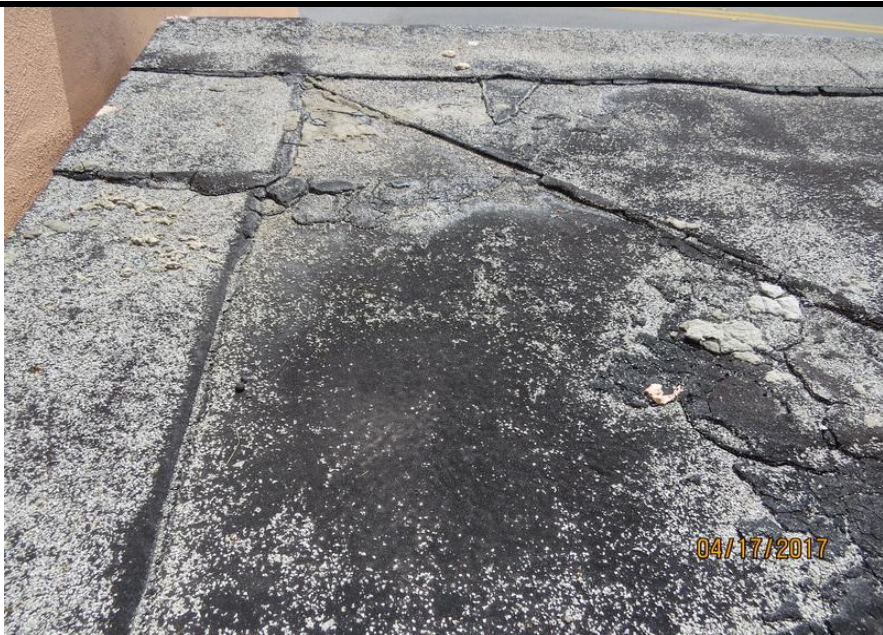
Photo No. 8

Remarks: Protective mineral granules on roof have been lost due to wear and foot traffic.

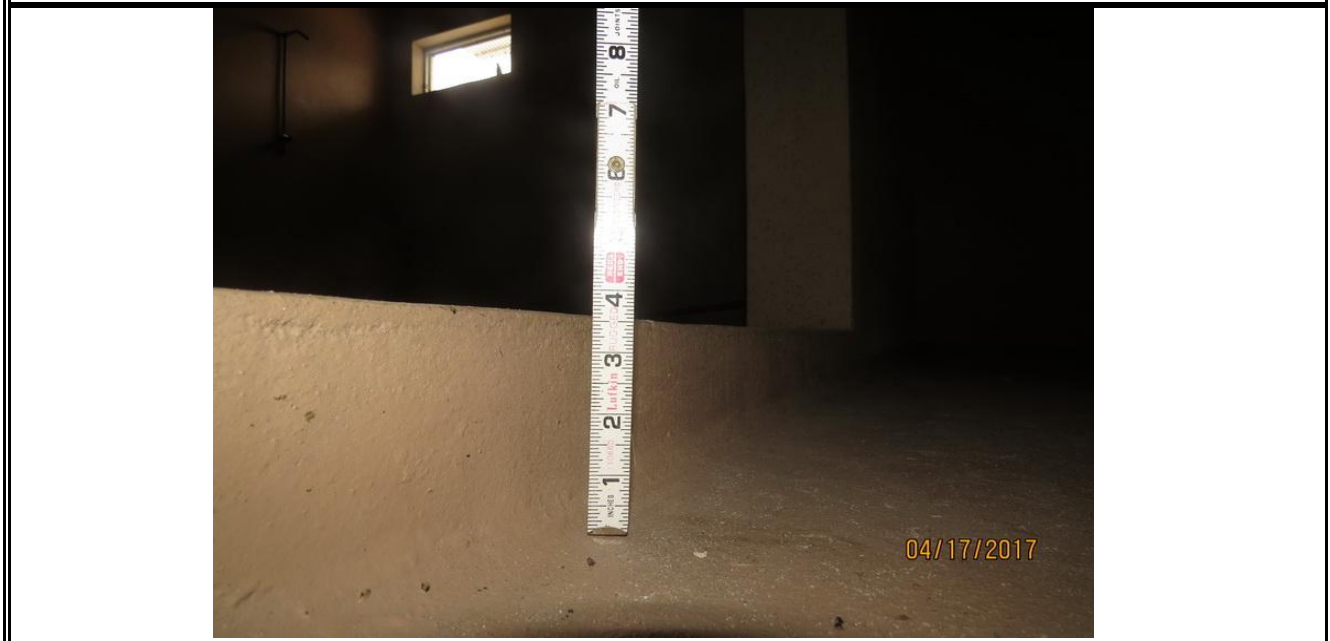
Photo No. 11

Remarks: Tripping hazard preventing ADA access to men's shower room.
Location: Pool Restrooms

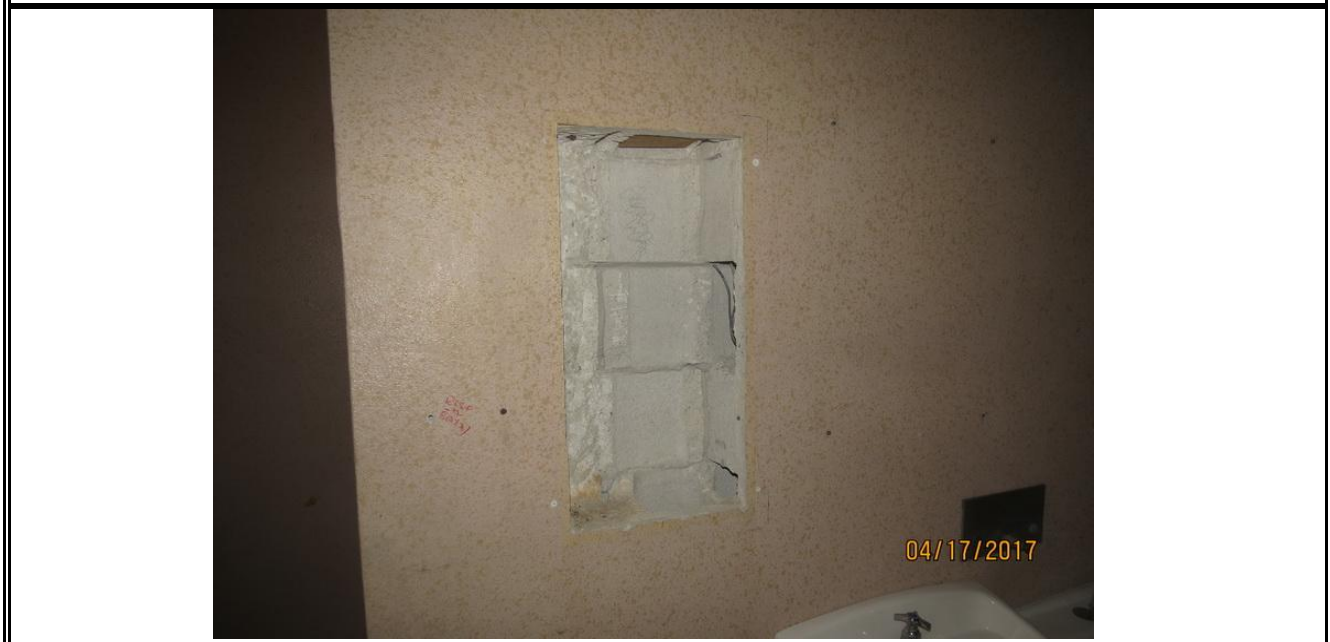
Photo No. 12

Remarks: Steel reinforcement was cut on masonry partition on women's bathroom.
Location: Pool Restrooms

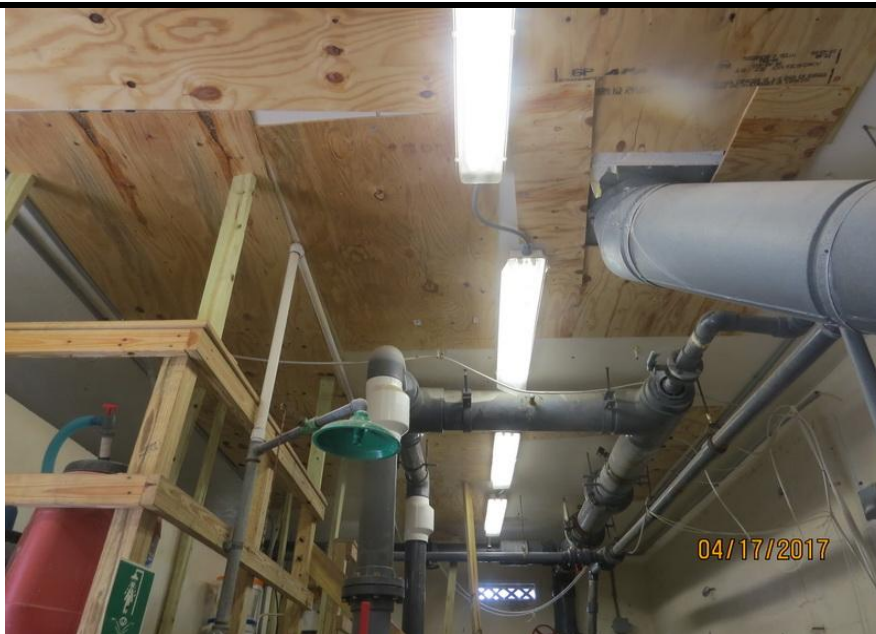
Photo No. 21

Remarks: Spalling at many roof locations mostly covered by half inch-thick plywood.

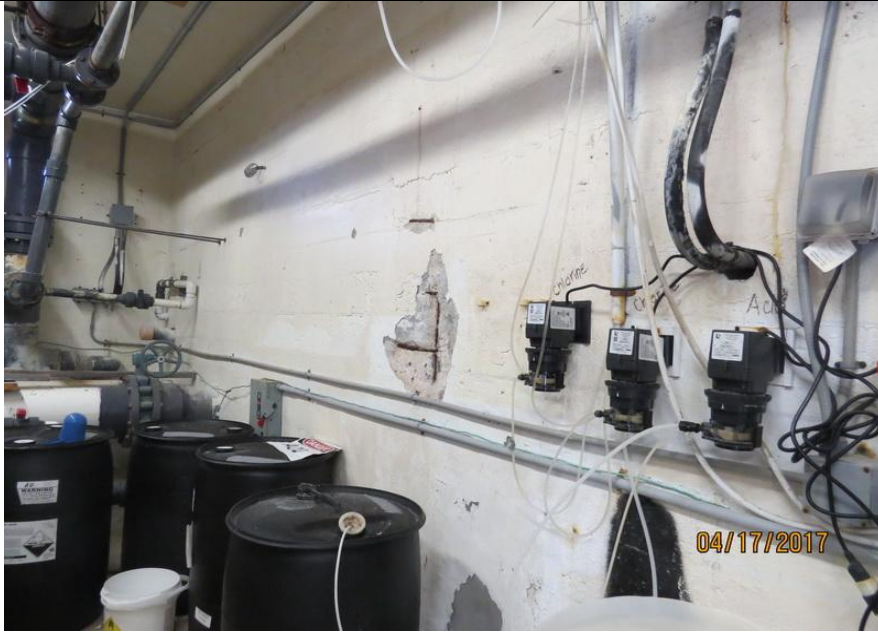
Photo No. 25

Remarks: Exposed reinforcing steel at interior face of one tie-column in the east wall of the pump room.

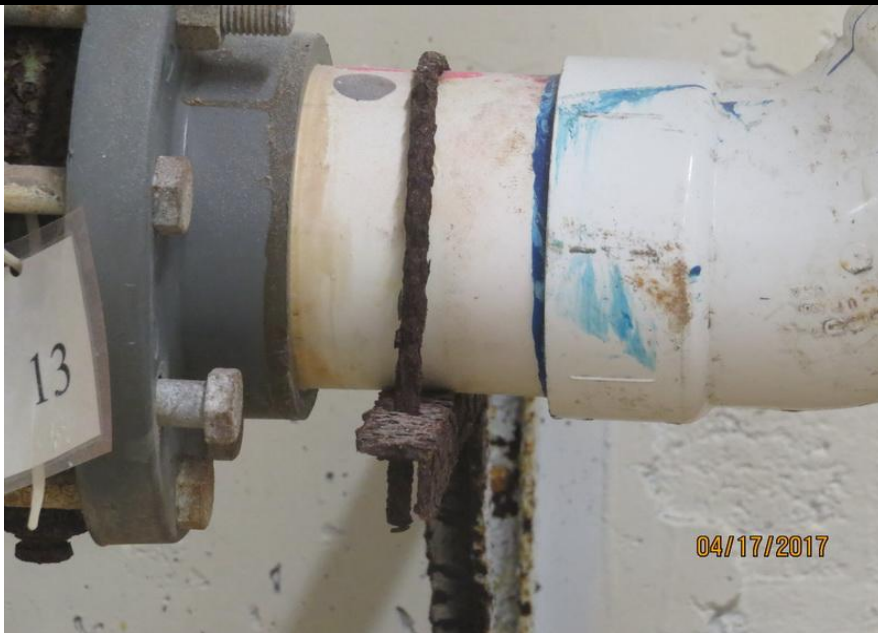
Photo No. 26

Remarks: Numerous repairs have been made to stop leaks including slip lining some pipe interiors.

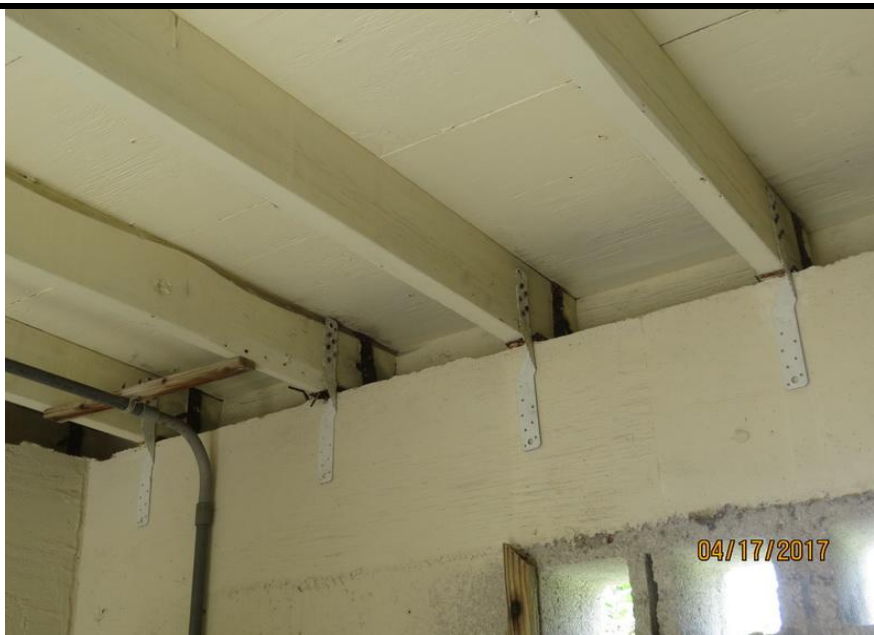
Photo No. 30

Remarks: Hurricane straps connecting the roof joists to the masonry walls are missing fasteners.

Location: Chlorine Storage Building

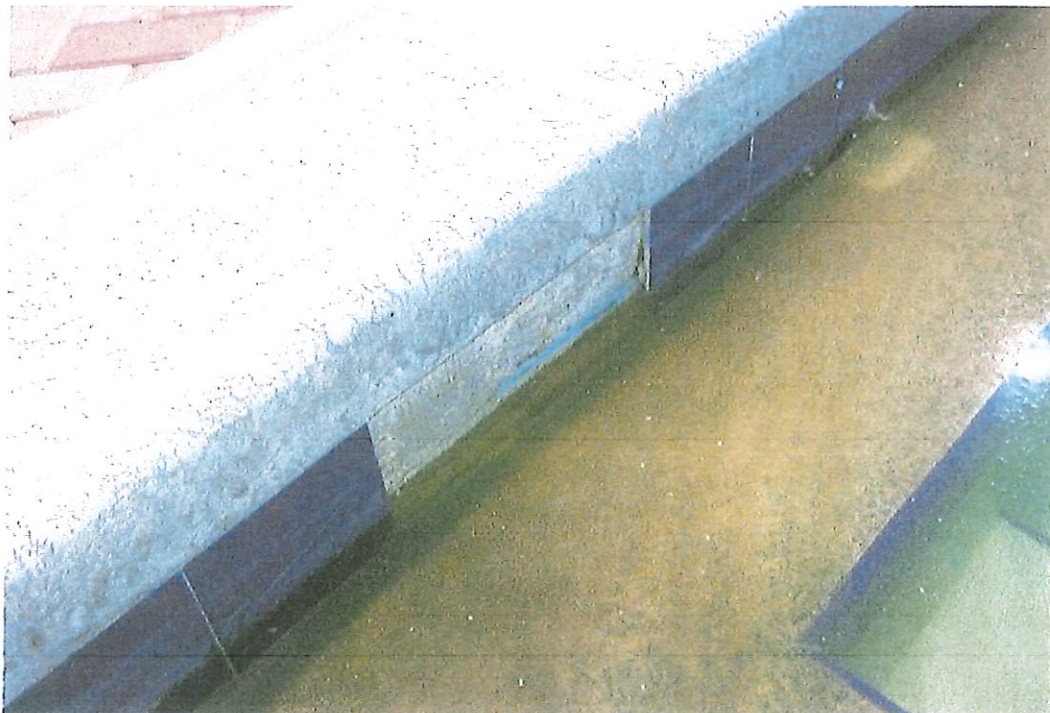
EXHIBIT 4. VIEW OF CRACKED WATERLINE TILES AND CRACKED POOL BEAM

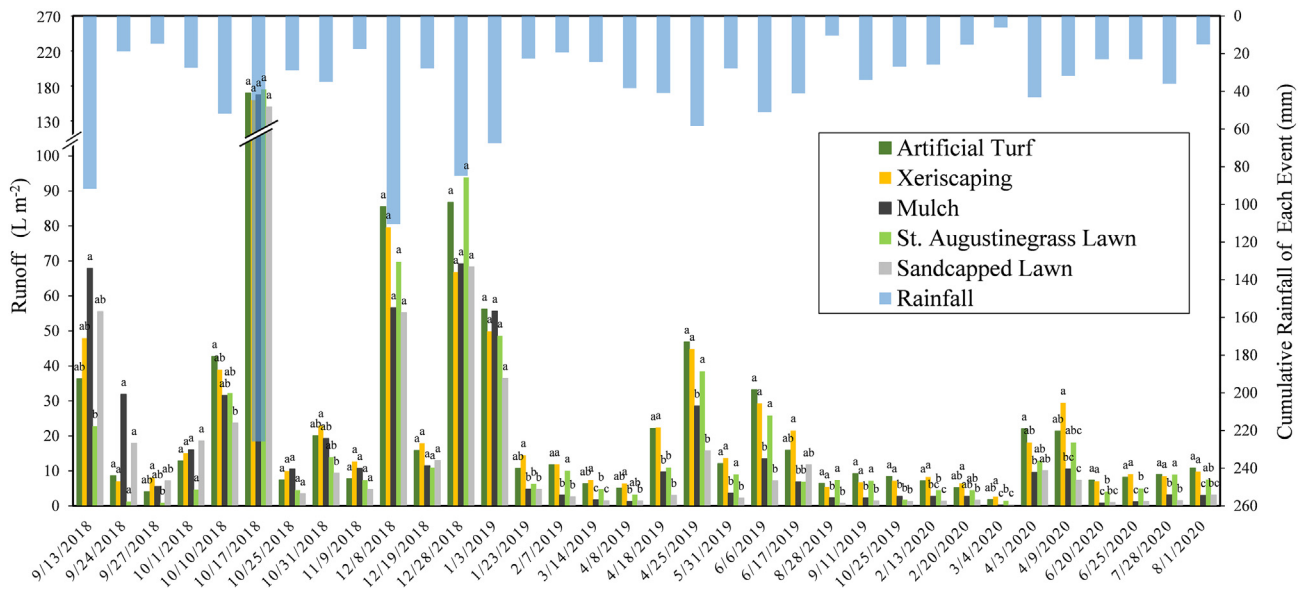
Fig. 3. Cumulative rainfall (mm) of each runoff event and total runoff ($L s^{-1}$) of all landscapes for each runoff event during the study period. Different lower-case letters signify a significant difference within each runoff event based on Fisher's LSD. A broken y axis was used to fit the 10/17/2018 event in the figure.

Beginning 23 Jan. 2019, the effects of landscape on runoff volumes became more pronounced, with Artificial Turf and Xeriscaping treatments generating significantly greater runoff volumes compared to other landscapes during most runoff events. In comparison, Mulch and Sand-Capped Lawn treatments yielded the least runoff, around 50% less than that of Artificial Turf and Xeriscaping treatments for most events. The effects of St. Augustine grass lawn on runoff volumes were more complicated than other landscapes. As such, St. Augustine grass Lawn showed similar runoff volumes compared to Artificial Turf and Xeriscaping on several dates including 25 April 2019, 6 June 2019, 31 May 2019 and 28 July 2020. On other dates during the growing season

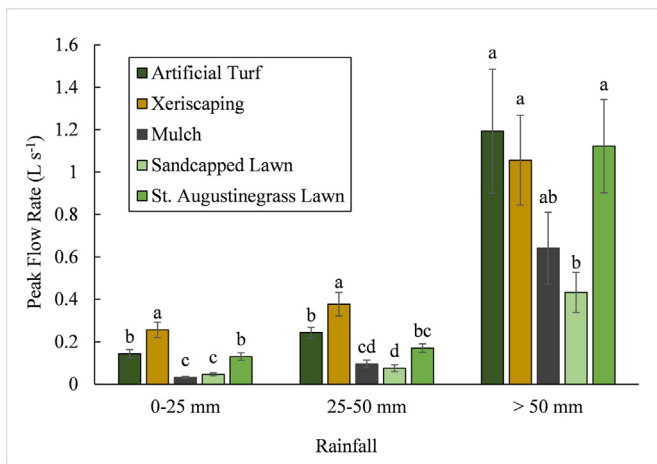
Fig. 7. Peak flow rate ($L s^{-1}$) of 5 urban residential landscapes under 3 rainfall levels. 0–25 mm, 25–50 mm, and > 50 mm, represents rain level of low to moderate, high, and very high, respectively. Data were pooled across all events that falls into each category. Different lower-case letters signify a significant difference based on Fisher's LSD at each rainfall level. Bars represent standard error.

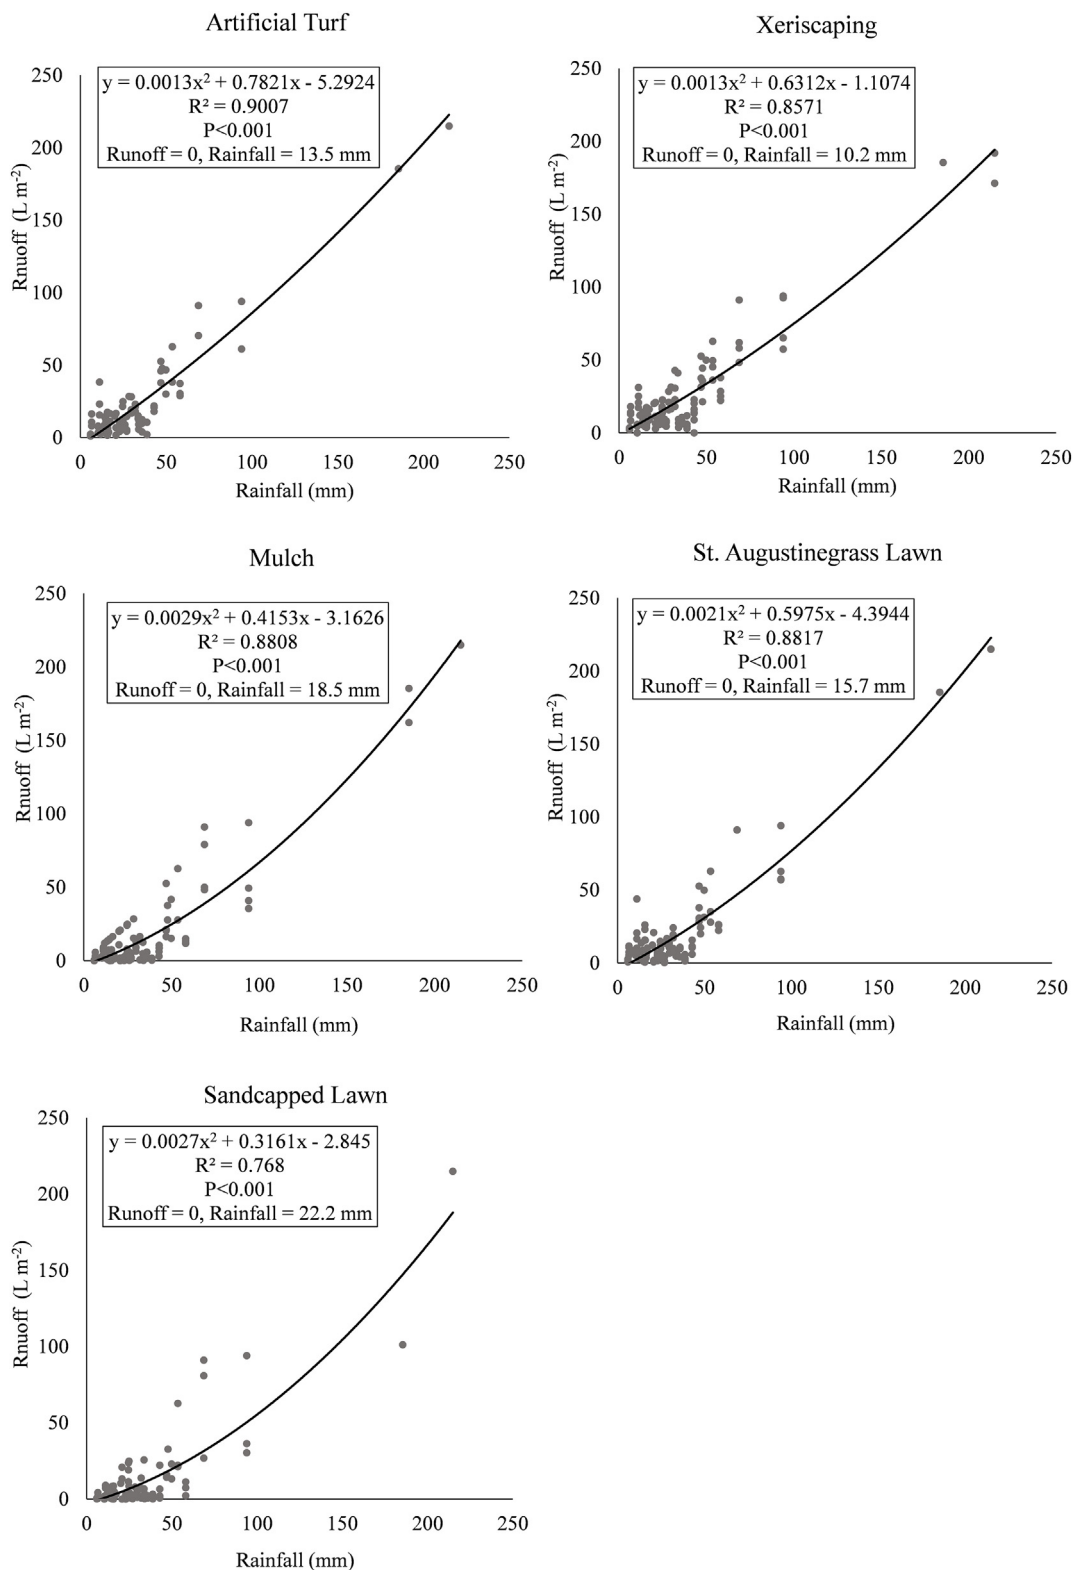
Fig. 8. Quadratic regression of rainfall (mm) and runoff (L m⁻²) for each landscape during the study period (September 2018 to August 2020). The least amount of rainfall that is required for each system to generate runoff was calculated according to the regression equation with setting runoff volume to 0.

Beginning spring 2019, after plots were established and settled in, and through the end of the study, Sand-Capped Lawn and Mulch generally had significantly lower runoff volumes than all other landscapes. The native soil-based St. Augustine grass Lawn maintained moderately low runoff volumes, while Xeriscaping and Artificial Turf each showed the highest runoff volumes (Fig. 3). It should be noted that, in addition to factors such as particle size density and infiltration rates of the basing material (decomposed granite, mulch, sand, or soil) used, antecedent soil moisture is another important consideration affecting runoff amounts. For example, on 28 July 2020, St. Augustine grass had just been irrigated prior to a 36 mm rainfall, which led to similarly high runoff volumes between St. Augustine grass, Artificial Turf, and Xeriscaping (the latter two of which received drip or no irrigation). Overall, rainfall immediately followed irrigation only three times during the study period. In addition, actively growing warm-season turfgrasses can

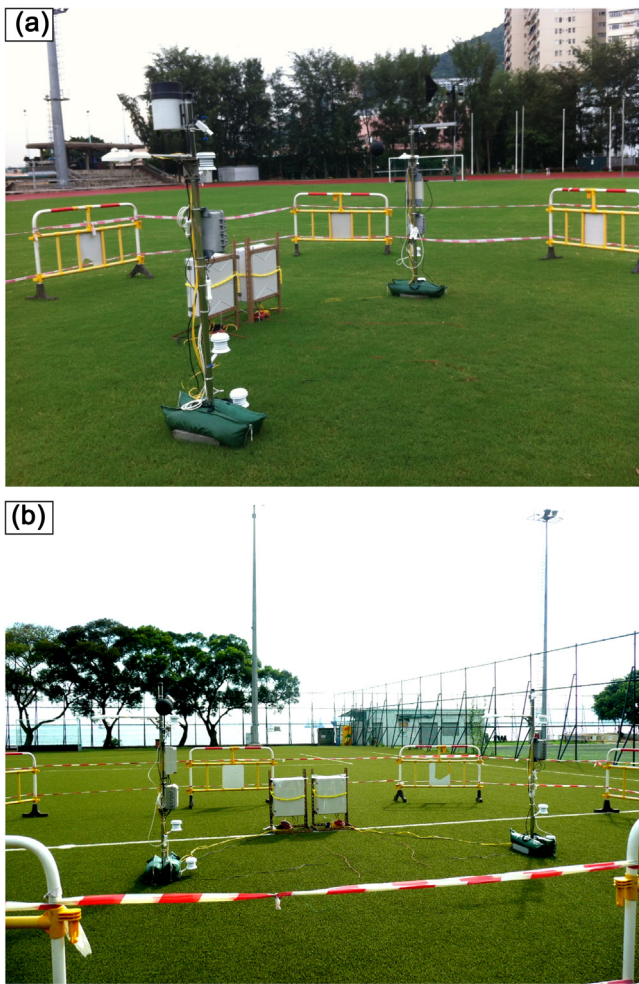
Fig. 3. The replicate microclimatic sensors and dataloggers installed at two fields at the sports center of the University of Hong Kong: (a) Natural turf (NT); and (b) Artificial turf (AT).

- Air temperature at 150, 50 and 15 cm from the ground using thermister probes equipped with radiation shield.
- Turf surface temperature using a non-contact infrared radiometer.
- Substrate temperature using a Pt100 soil temperature probe buried at 6 mm depth.
- Relative humidity at 150, 50 and 15 cm from the ground using the capacitive type of sensors.
- Wind speed and direction at 160 cm height using a cup anemometer and a wind vane.
- Rainfall at 160 cm height using a tipping-bucket rain gauge.

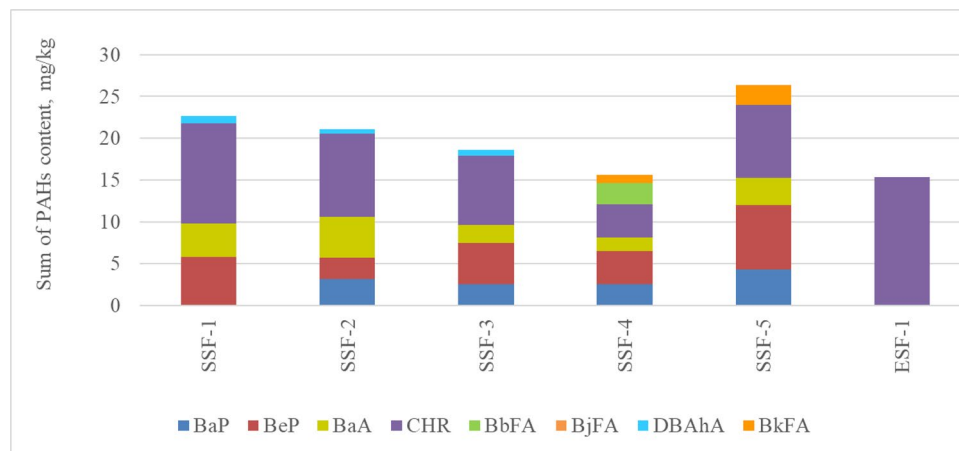
Figure 4. The sum of the PAHs content in the tested rubber granulate samples taken from the sport fields. *SSF* a sample of SBR granules from a sport field, *ESF* a sample of EPDM granules from a sport field.

The total PAHs content in the rubber granulate samples from a sport fields are shown in Fig. 4 and in the rubber granulate supplied by recyclers are shown in Fig. 5.
